Your Inspection Report

129 Springhurst Avenue
Toronto, ON M6K 1B9

RE: Report No. 3014
129 Springhurst Avenue
Toronto, ON
M6K 1B9

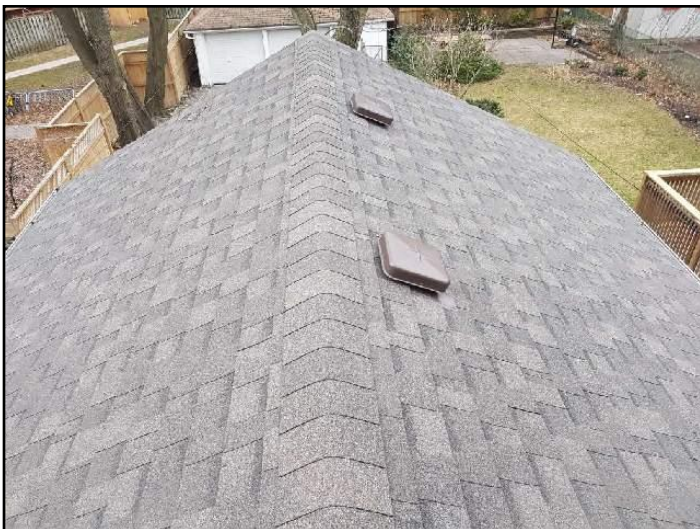
1. Asphalt shingles

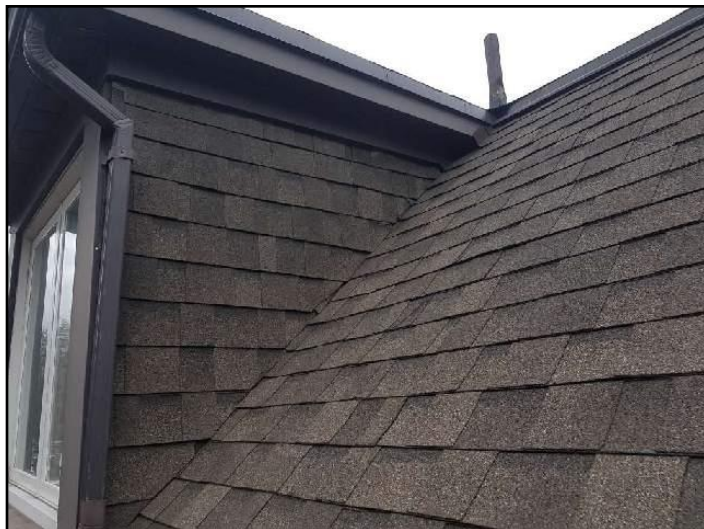
2. Asphalt shingles

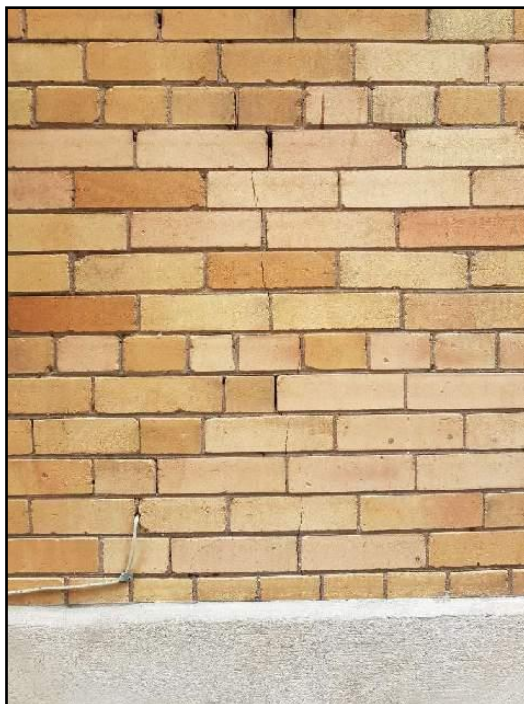
2. Condition: • Typical minor cracks, not structurally significant.

3. Typical minor cracks, not structurally...

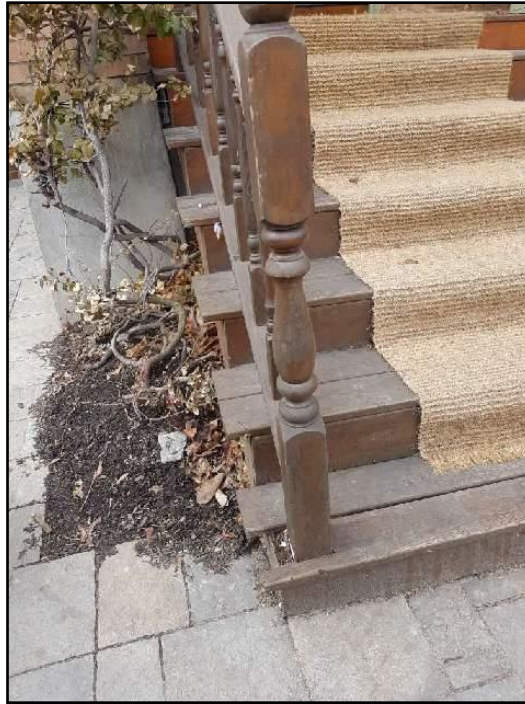
- 3. Condition: • [Loose](#)
- Implication(s): Fall hazard
- Location: East Porch
- Task: Repair

4. Loose

Time: Immediate

Cost: Minor

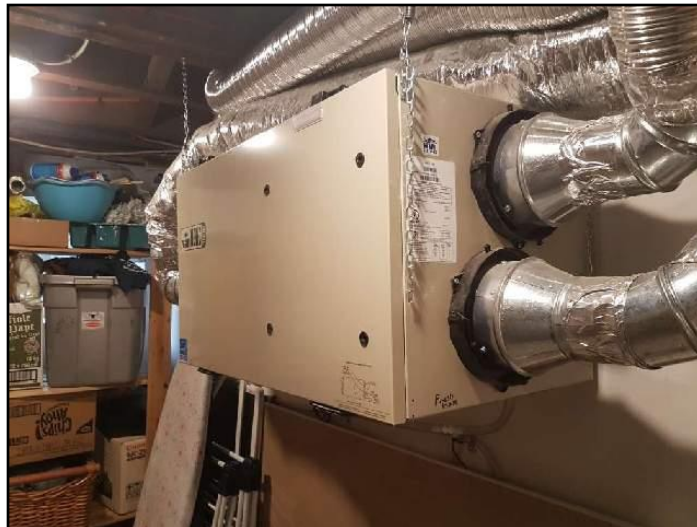
8. Heat recovery ventilator (HRV)

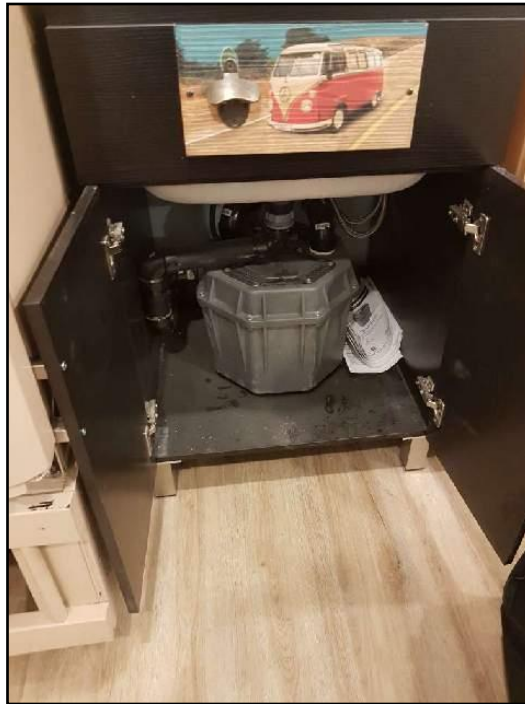
10. Laundry tub pump

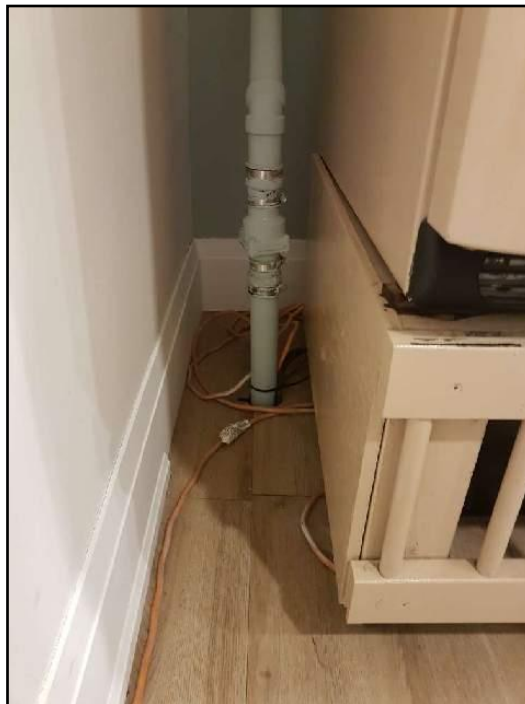
11. Sump pump
