# HOME INSPECTION REPORT

252 Macdonell Ave

Prepared for: High Park Real Estate Group

Inspection Date: July 9 2021

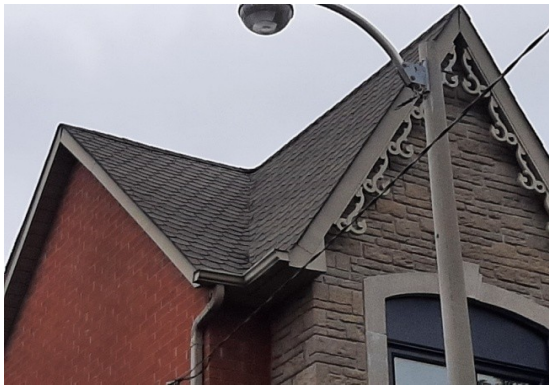
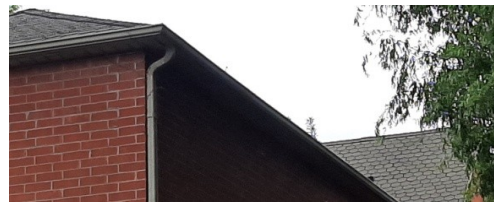
Sloped Surface: [cracking/curling, aging surface, budget to replace within 1-yr](#)

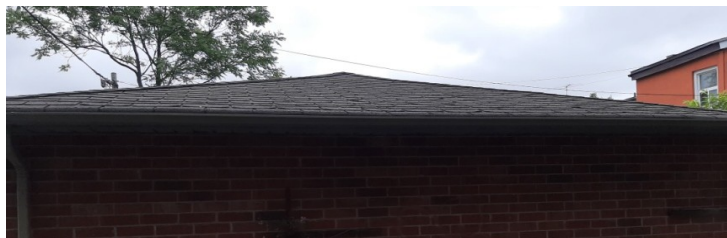
Garage: [aging surface, budget to replace within 1-yr](#)

[Note: Recommend Annual Maintenance Contract for Roof Surface, Flashing Details and Chimney\(s\)](#)

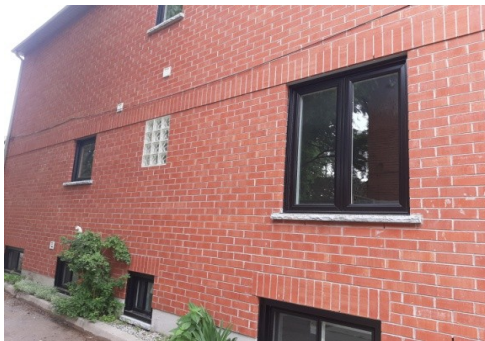
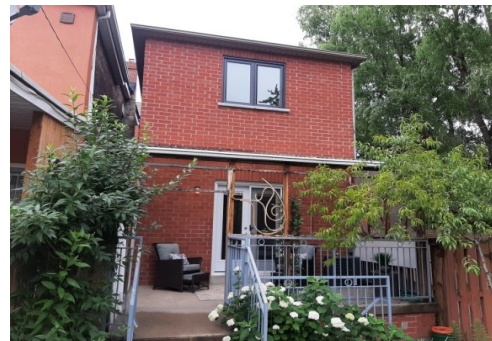
DOORS/WINDOWS: **newer units**

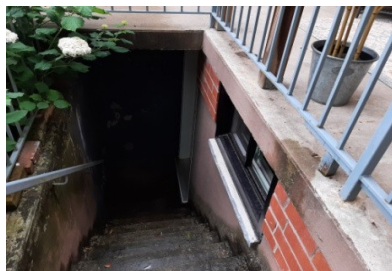
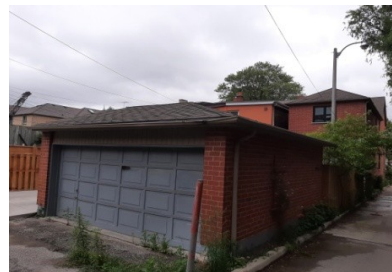
PORCH(es): **overall in good repair**

\*\*BASEMENT WALKOUT: **overall in good repair**

DETACHED GARAGE: **overall in good repair**

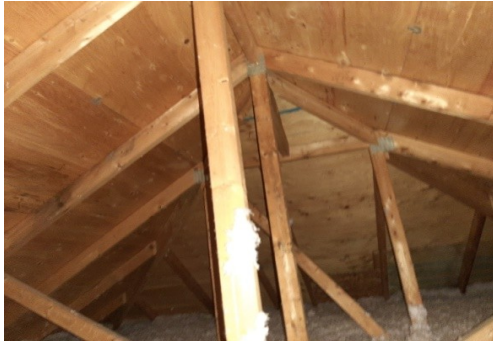
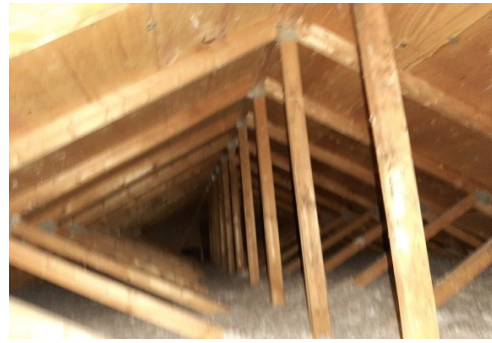
ROOF: overall in good repair

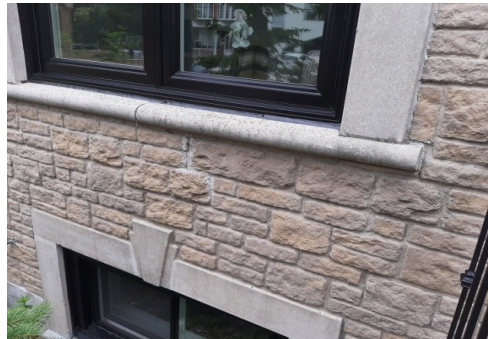
WALLS:  
Masonry Veneer: minor crack at front

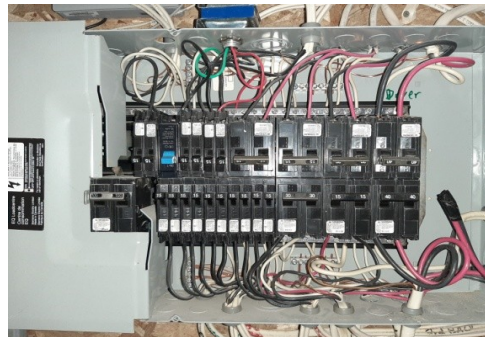
SERVICE PANEL: **overall in good repair**

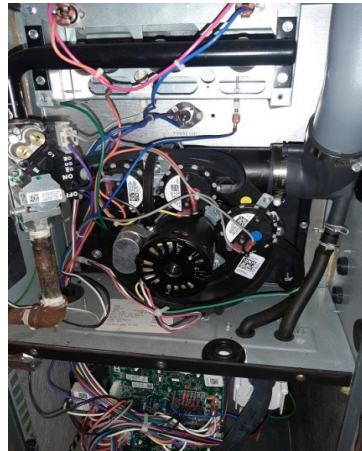
FORCED AIR FURNACE: [service annually](#)

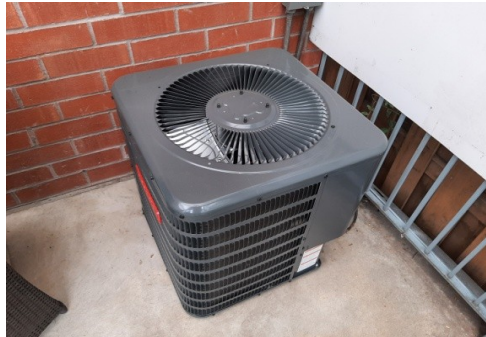
AIR CONDITIONER: [service annually](#)

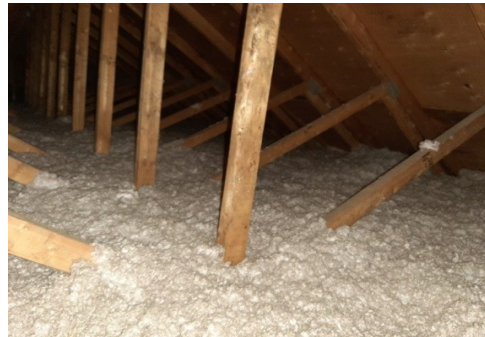
ROOF SPACE: insulation and ventilation is adequate
