# HOME INSPECTION REPORT

63 Cowan Ave  
Toronto

Prepared for: High Park Real Estate Group

Inspection Date: May 8 2021

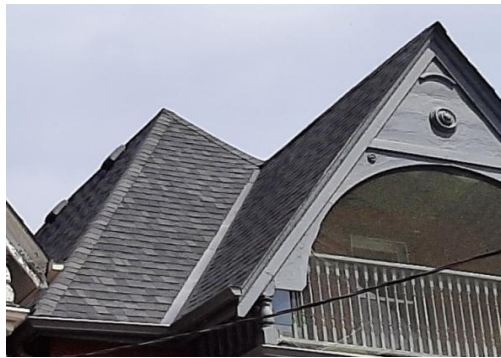
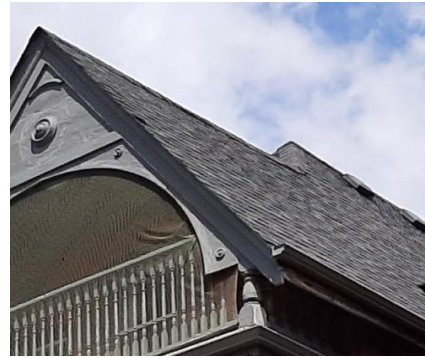
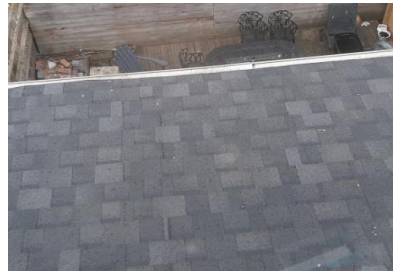
Sloped Surface: [overall surface in good repair](#)

[Note: Recommend Annual Maintenance Contract for Roof Surface, Flashing Details and Chimney\(s\)](#)

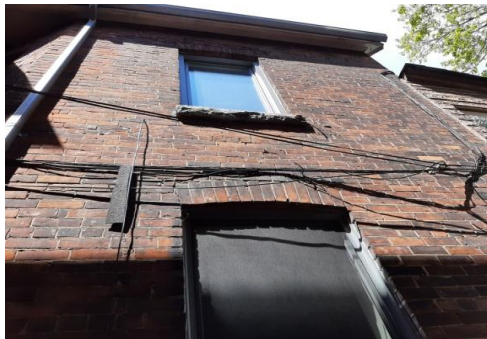
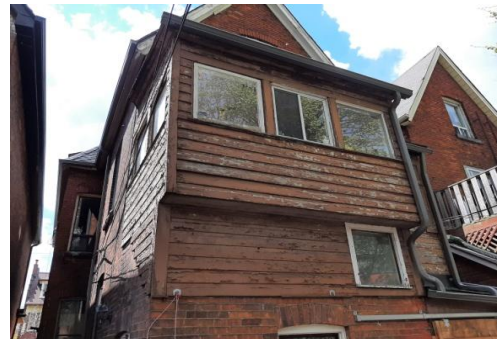
- Brick: overall in good repair
- Soffit & Fascia: requires general repairs and maintenance
- Wood siding: requires general repairs and maintenance

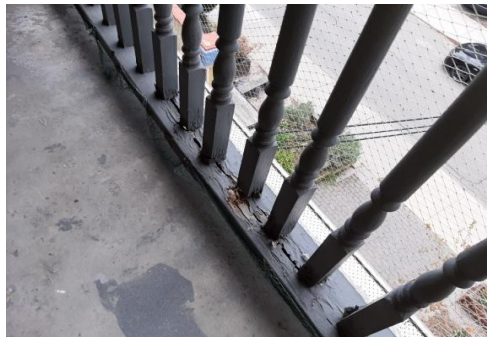
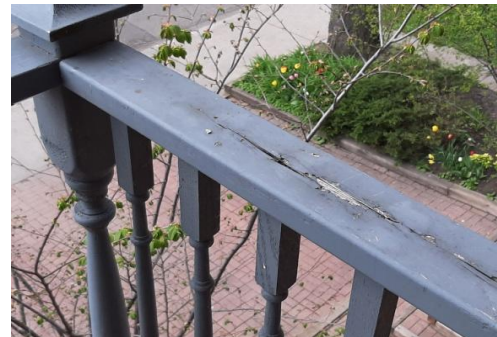
**BALCONIES:** safety rails requires repairs/replacement

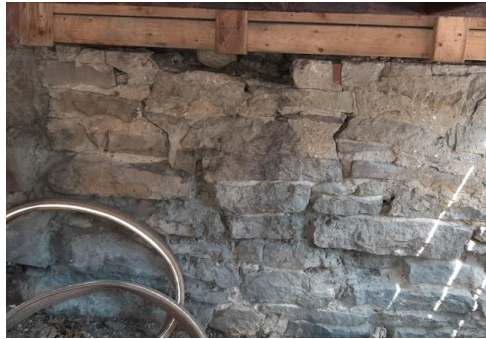
FOUNDATIONS: general mortar maintenance under front porch

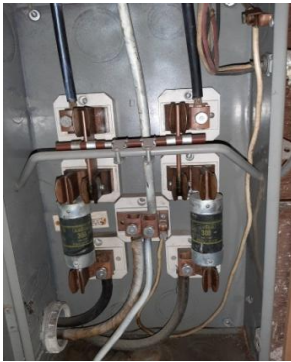
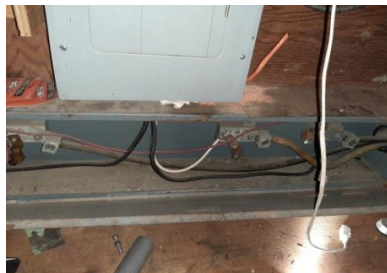
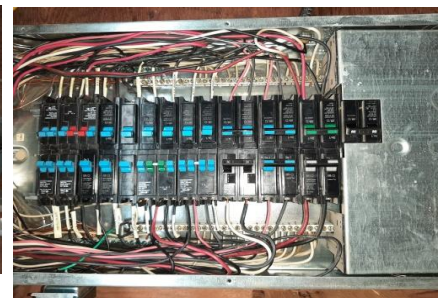
SERVICE ENTRANCE: **overall in good repair**  
 Main Disconnect: **overall in good repair**  
**splitter box in good repair**  
 SERVICE PANEL: **overall in good repair**

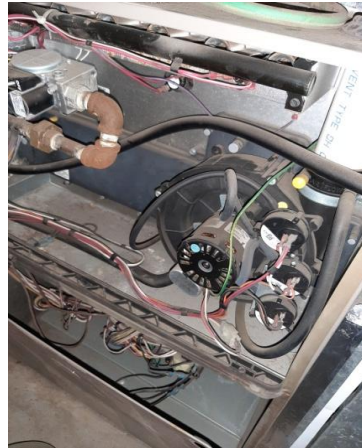
FORCED AIR FURNACE: [service annually](#)

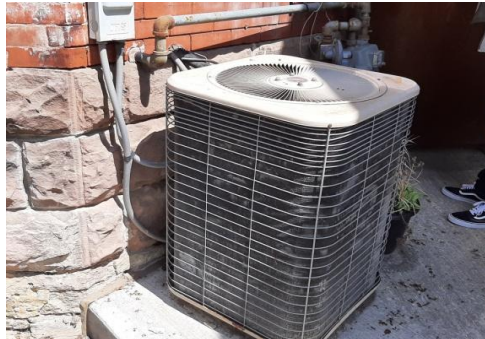
AIR CONDITIONER: **not tested: should be serviced before using old unit, continue servicing until replacement becomes necessary**

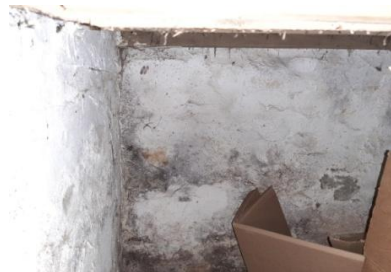
**\*\*Basement Leakage:** typical efflorescence, staining and dampness for older foundation  
 see steps below  
 recommend damp-proofing if renovating basement

minor mouldy areas - can be cleaned and treated

1. gutters, downspouts, grading, driveways: ongoing maintenance and repair/see Exterior
2. cracks/form ties on foundation: monitor/repair as required
3. excavation/damp-proofing: monitor basement, consider step 3 as a last resort
