HOME INSPECTION REPORT

111 Priscilla Ave

Toronto

Inspection Date: Sept 8 2021

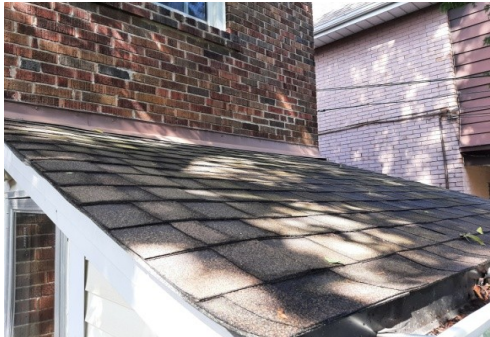
REFERENCE LINK	http://redbrickinspections.ca/docs/2_Roofing_Reference_Guide.pdf			
111 Priscilla Ave	ROOFING/Chimneys		Sept 8 2021	
Description				
Roofing Material:	Location:	Leakage Probability:	Chimney(s) Type:	Location:
Asphalt Shingles:	Slope:	Low	Brick Abandoned:	North
Asphalt Shingles:	Garage:	High		
Limitations				
Roof Inspected By:	Access Limited By:	Chimney Access Limited By:		
Binoculars From Edge				
Observations/Recommendations				
Tree Branches: retain arbourist for annual monitoring/trimming				
Sloped Surface: overall surface in good repair

Flashings:				
Chimney: leaking observed in closet 2nd level- repair flashing around chimney

Garage: old shingles, replace

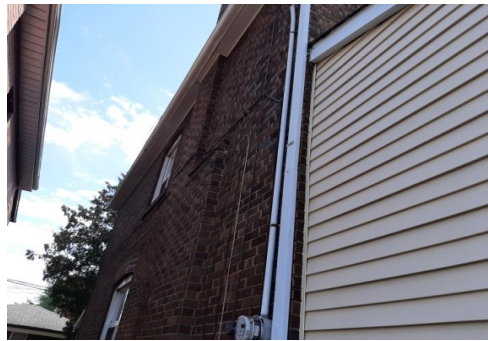
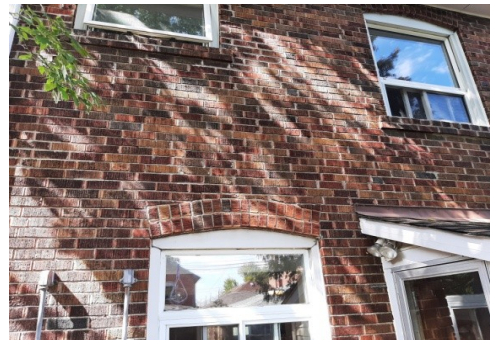
**Gutters/Downspouts: requires maintenance/cleaning
extend 6-ft away from house

WALL SURFACES: overall in good repair
DOORS/WINDOWS: overall in good repair

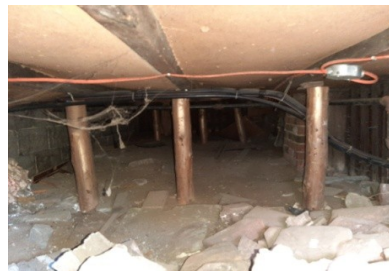
PORCH floor is shored up with wood posts - budget to reinforce/sister joists
and remove posts

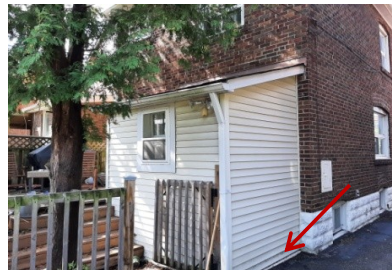
Wood Sill: rear extension: framing close to grade- further evaluation, repair and seal perimeter from moisture

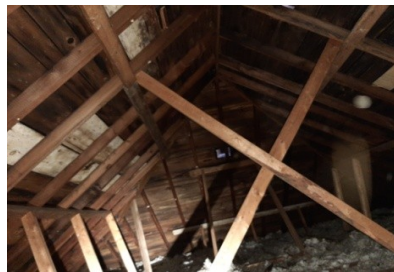
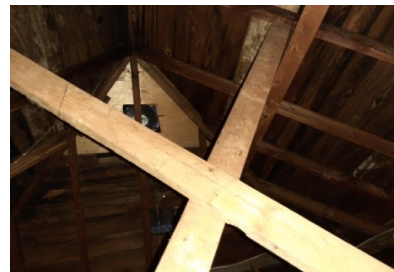
ROOF: overall in good repair, rafters shored up in some areas

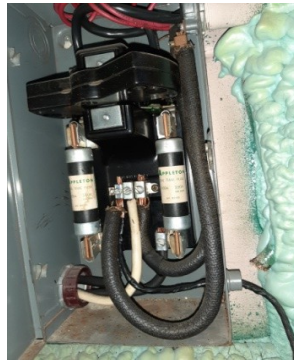
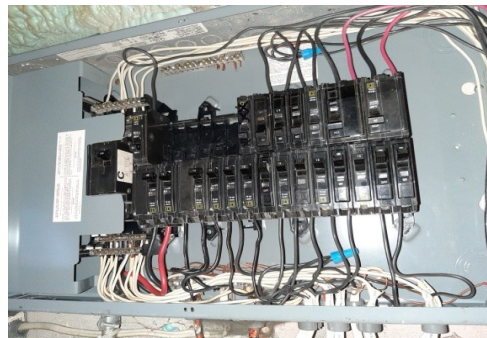
Main Disconnect: **overall in good repair**

SERVICE PANEL: **overall in good repair**

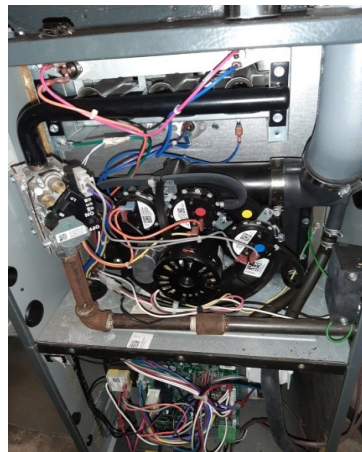
FORCED AIR FURNACE: [service annually](#)

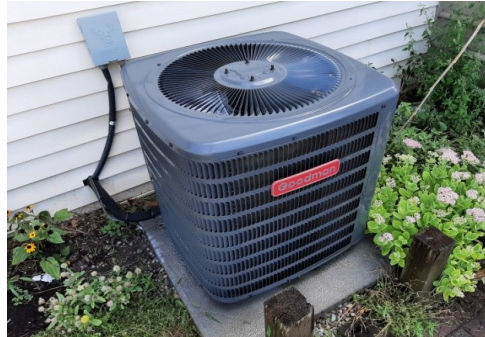
AIR CONDITIONER: [service annually](#)

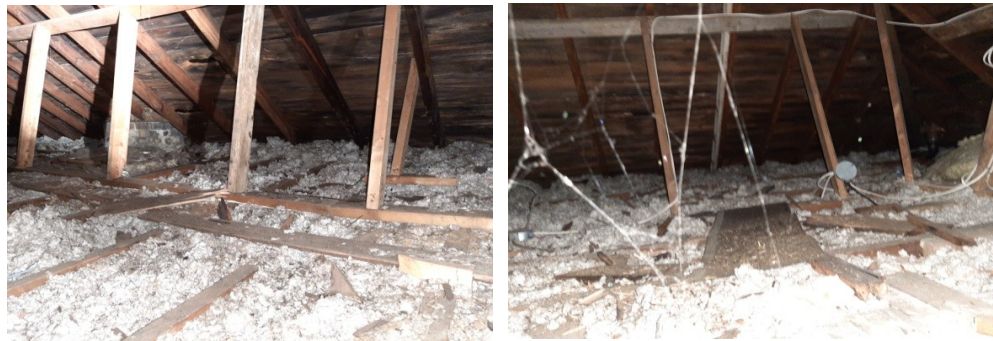
ROOF SPACE: recommend upgrading insulation to improve comfort and efficiency
Exhaust Fan Vents: cannot determine if washroom vents to exterior-requires further evaluation
