HOME INSPECTION REPORT

75 Sorauren Ave

Toronto

Inspection Date: Sept 2 2021

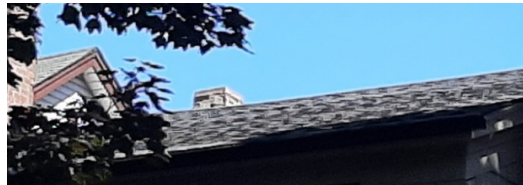
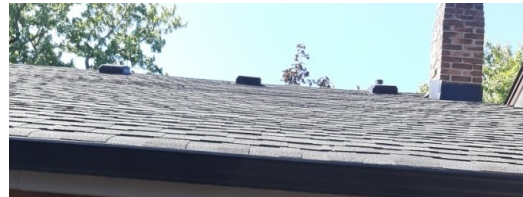
Sloped Surface: [overall surface in good repair](#)

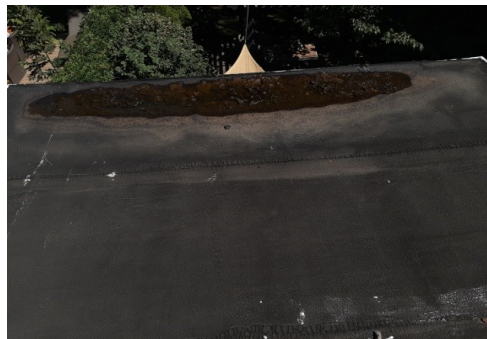
Flat Surface: [older, ponding, loose seams at edges- requires repairs, budget to replace](#)

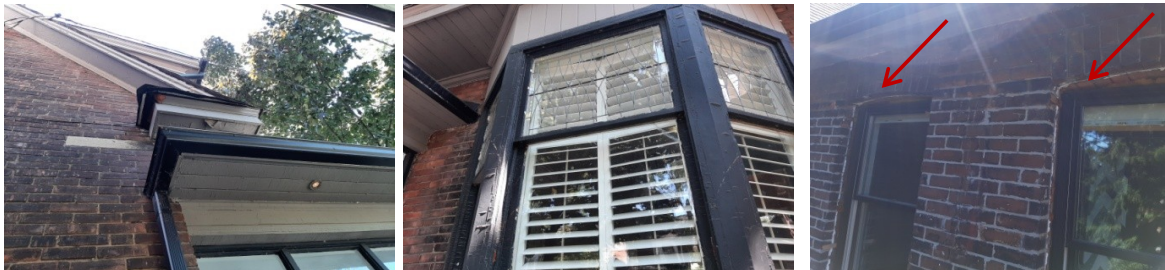
**Gutters/Downspouts: requires maintenance/cleaning
 PORCH typical settlement
 Soffit & Fascia: requires general repairs and maintenance in some areas
 DOORS/WINDOWS: requires general repairs and maintenance, painting, etc.
 incomplete installation at east 2nd level units

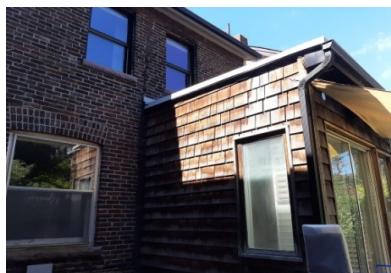
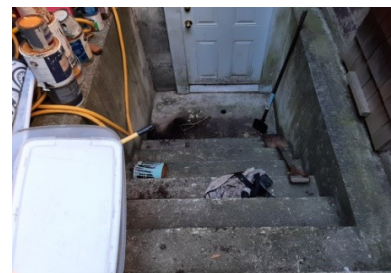
**BASEMENT WALKOUT: requires safety railings

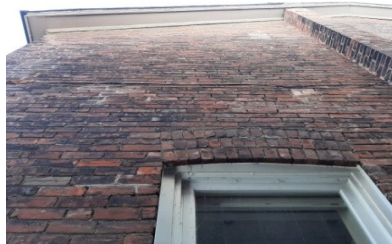
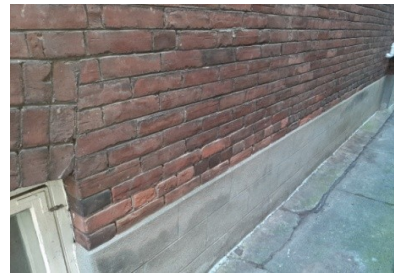
Masonry: minor typical surface spalling on north side
mortar repairs as required - typical

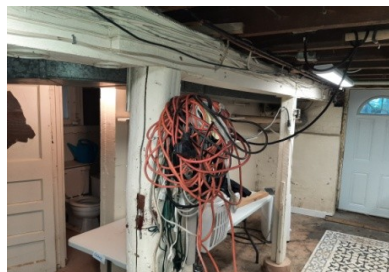
Wood Column: old timber columns in basement, typical splitting, replace if renovating basement

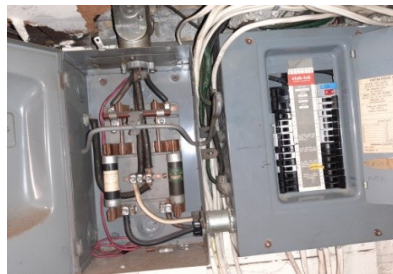
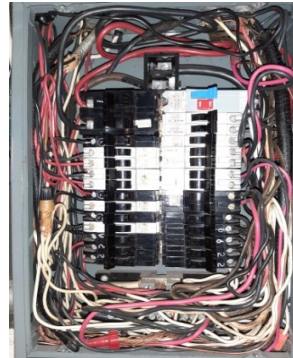
Main Disconnect: **older, overall in good repair**
 SERVICE PANEL: **crowded, install larger panel if required/when renovating**

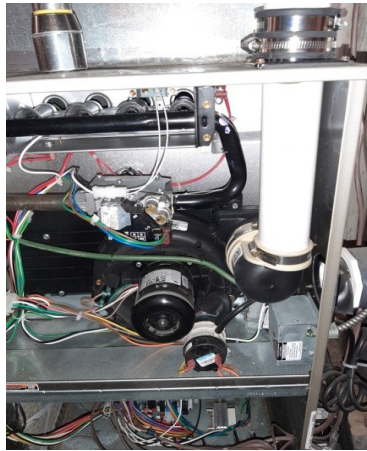
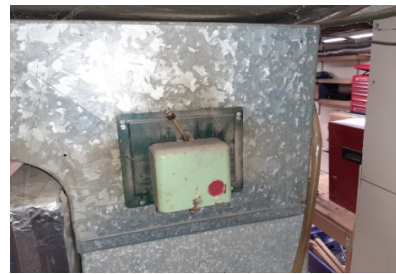
FORCED AIR FURNACE: [service annually](#)
 Humidifier: [remove abandoned unit](#)

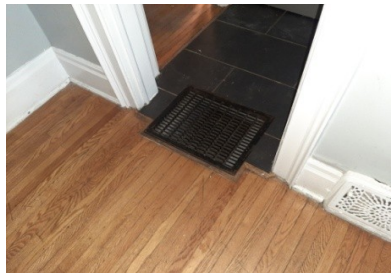
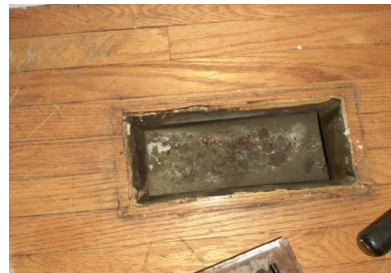
Registers: [unusual location for some return units- improve if renovating](#)
[insulation around some registers may contain asbestos](#)
 encapsulating the insulation is often the best approach
 Environmental Consultants can assist if this is a concern

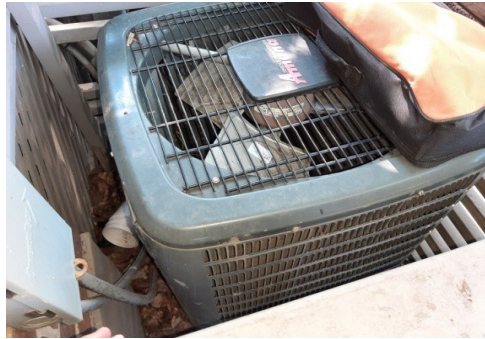
AIR CONDITIONER: [aging unit, continue servicing until replacement becomes necessary](#)

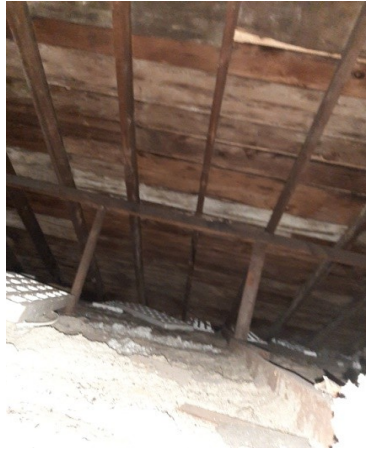
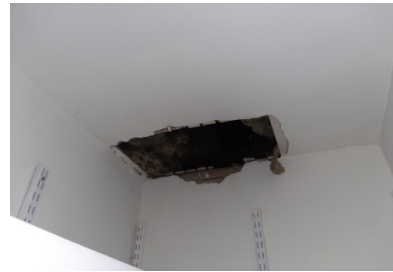
ROOF SPACE: recommend upgrading insulation to improve comfort and efficiency
 Roof Access Hatch: provide: insulate and weather-strip access hatch to roof space

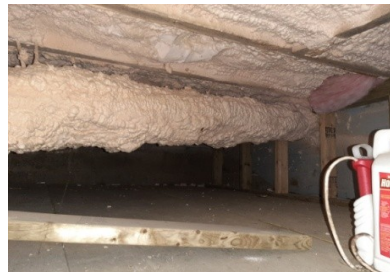
Crawlspace Floor: rear extension: insulated with spray foam which is above average
