# HOME INSPECTION REPORT

1550 King St W  
Toronto

Prepared by: Bob Papadopoulos P.Eng., RHI \*

Inspection Date: Nov 30 2021

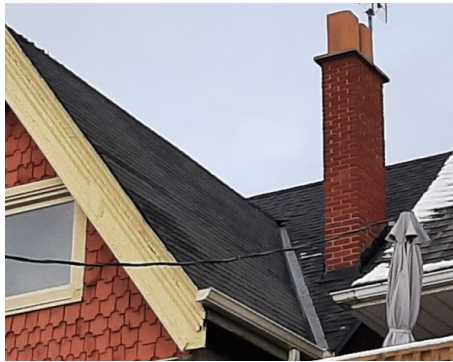
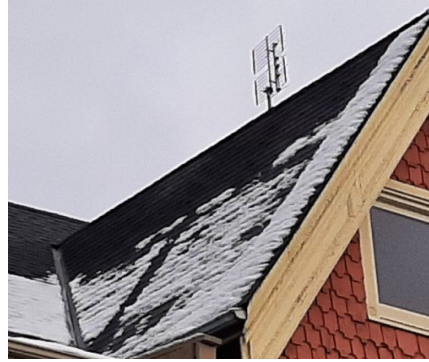
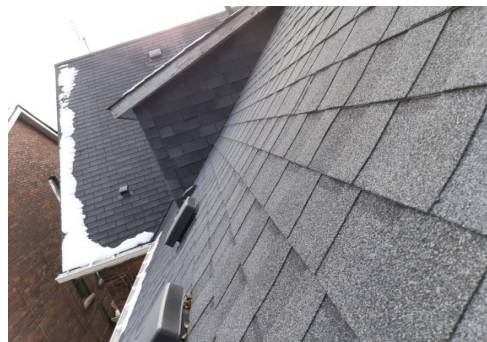
Sloped Surface: [overall surface in good repair](#)

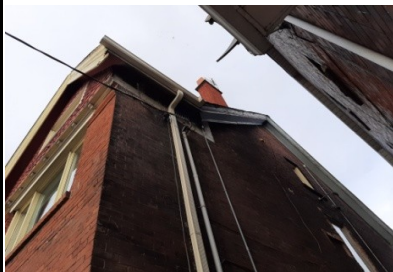
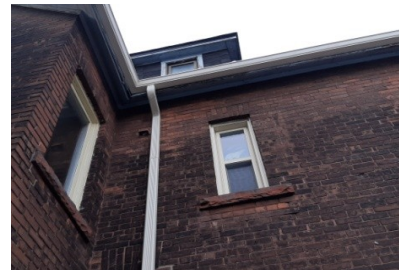
**DOORS/WINDOWS:** overall in good repair, general maintenance to some east units

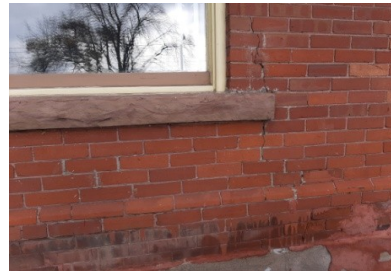
Masonry: typical settlement cracks

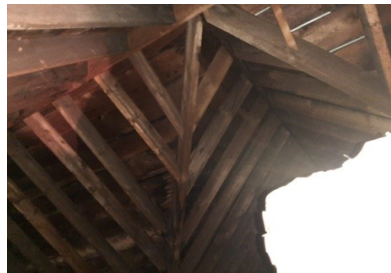
Party Walls: recommend installing in roof space

STRUCTURE Overall well built house. Recommend installing party (fire) wall in roof space between attached neighbour.

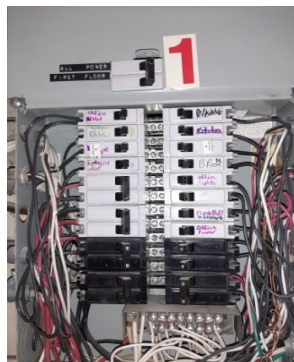
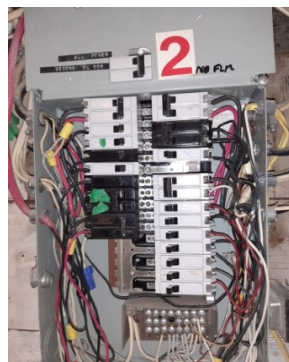
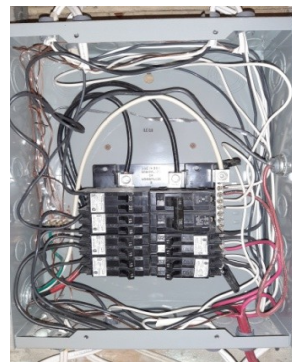
SERVICE PANEL: overall in good repair  
Auxiliary Panel: overall in good repair

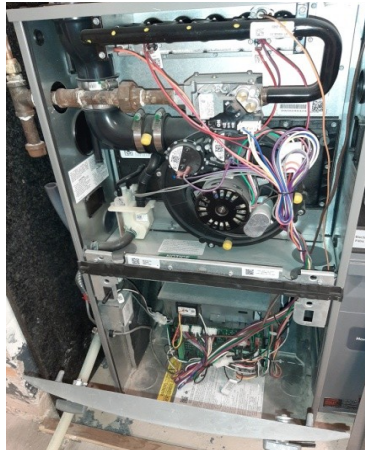
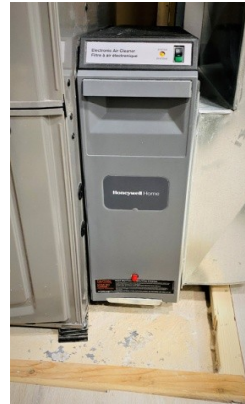
FORCED AIR FURNACE: [service annually](#)  
Electronic Filter: [newly installed with furnace](#)

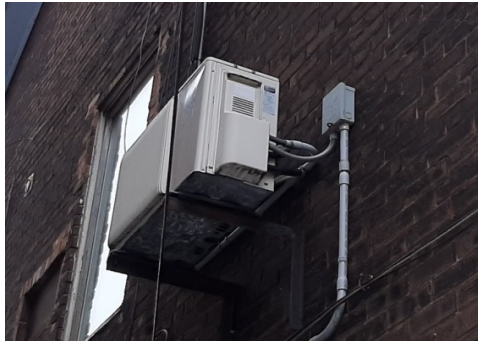
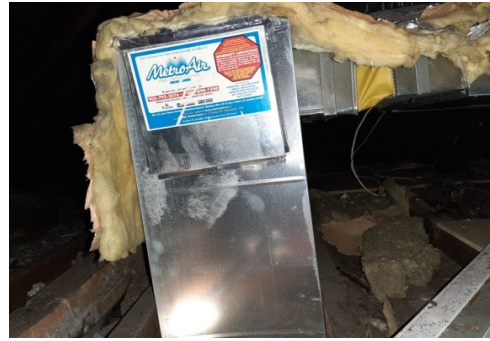
HEAT PUMP: [service annually](#)

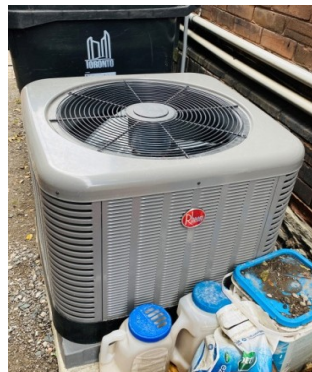
AIR CONDITIONER: [not tested: should be serviced before using](#)

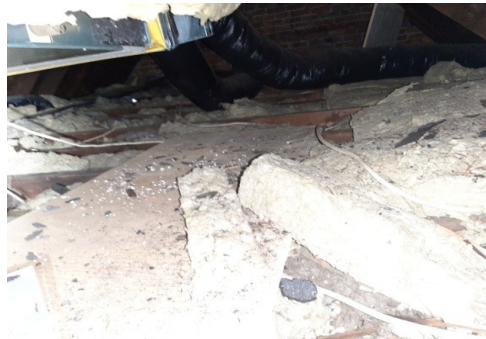
- ROOF SPACE: recommend upgrading insulation to improve comfort and efficiency
- Ducts in Roof: recommend insulation to improve comfort and efficiency
- Roof Access Hatch: insulate and weather-strip access hatch to roof space

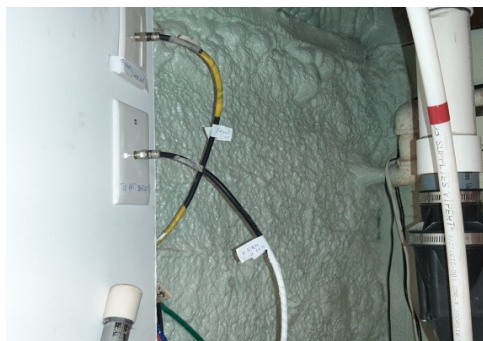
Basement Walls: insulated with spray foam which is above average

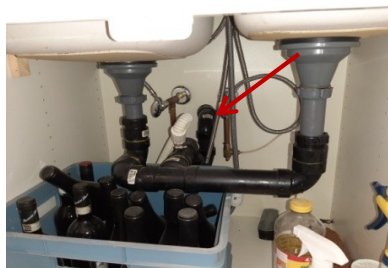
Kitchen Sink: main level: drain arrangement prone to back up - repair if required
