HOME INSPECTION REPORT

115 Cowan Ave
Toronto

Inspection Date: Feb 4 2022

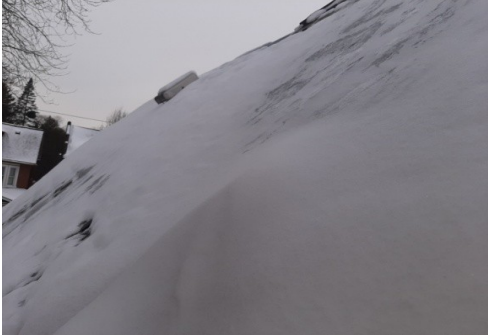
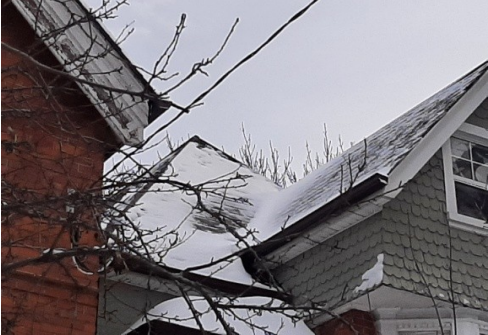
REFERENCE LINK		http://redbrickinspections.ca/docs/2_Roofing_Reference_Guide.pdf		
115 Cowan Ave		ROOFING/Chimneys		Feb 4 2022
Description				
Roofing Material:	Location:	Leakage Probability:	Chimney(s) Type:	Location:
Slate	Slope:	Medium	Brick:	South
Not Determined	Flat:	?		
Limitations				
Roof Inspected By:	Access Limited By:	Chimney Access Limited By:		
Binoculars	Height	Deck	Height	
Skylight	Slope			
Observations/Recommendations				
<p>Roofing: mostly not visible due to deck</p> <p>Sloped Surface: slate roof requires annual maintenance</p> <div style="display: flex; justify-content: space-around;">

</div>				
<p>Note: Recommend Annual Maintenance Contract for Roof Surface, Flashing Details and Chimney(s)</p>

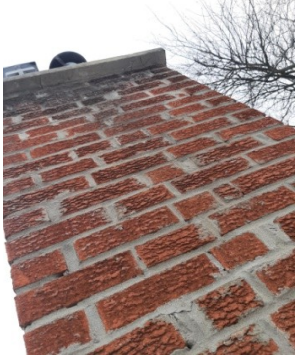
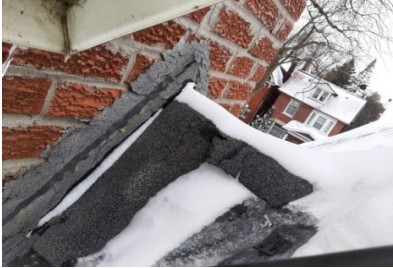
</div> <p>Flat Surface: not visible</p> <p>Chimney(s): rebuilt and in good repair</p> <p>Flashings: requires maintenance</p> <div style="display: flex; justify-content: space-around;">

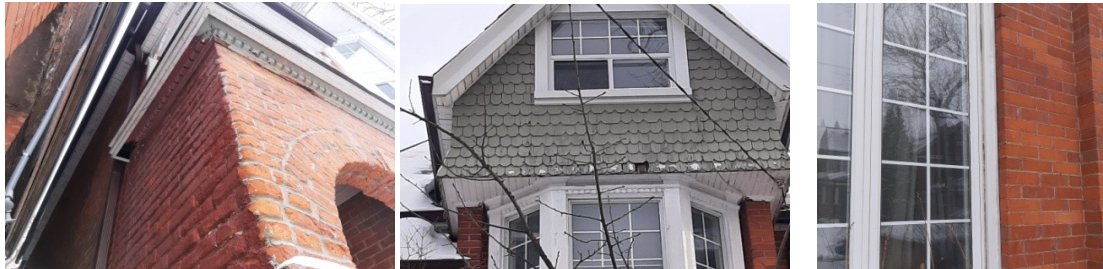
WALL SURFACES:

Brick: minor surface spalling - repair as required

Wood Shingles: requires general repairs and maintenance

DOORS/WINDOWS: requires general maintenance

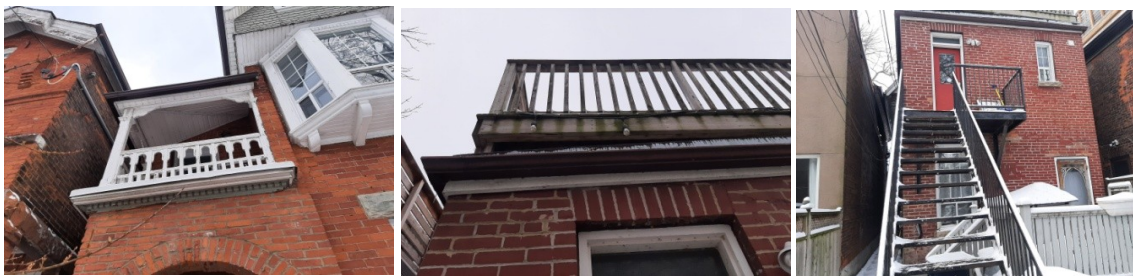
PORCH requires general repairs and maintenance

spindle spacing too wide (max 4 inches) - safety concern - repair

Stairs: rear: continue to maintain, length of steps is a safety concern, also a slip hazard

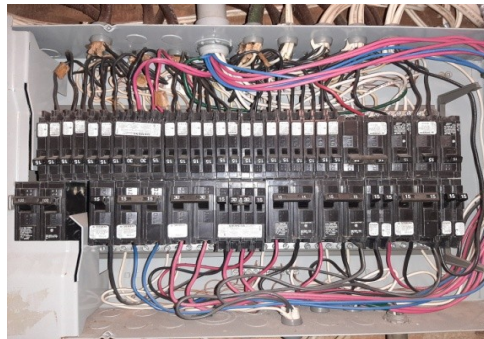
SERVICE PANEL: overall in good repair

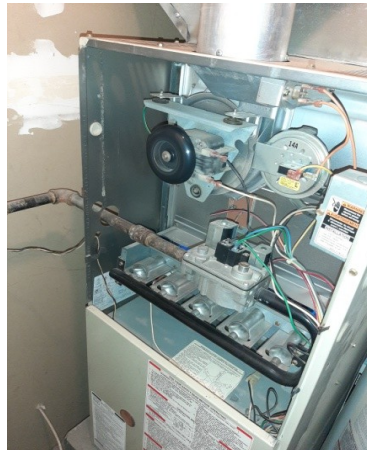
FORCED AIR FURNACE: [continue servicing until replacement becomes necessary](#)
