# HOME INSPECTION REPORT

231 Riverside Dr  
Toronto

Prepared by: Bob Papadopoulos P.Eng., RHI \*

Inspection Date: Feb 18 2022

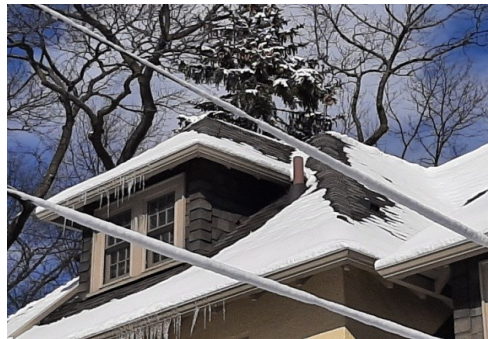
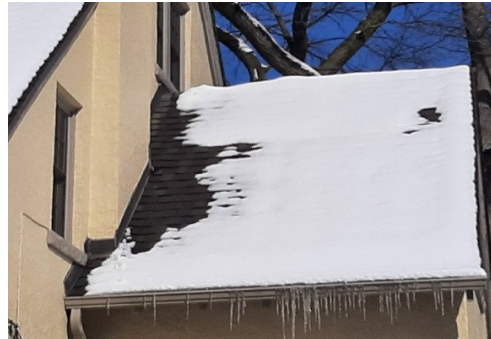
Sloped Surface: [overall surface in good repair where visible](#)

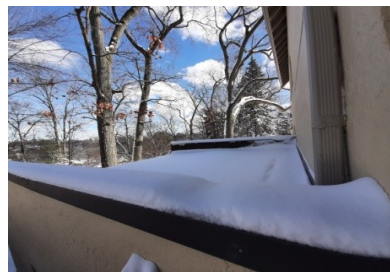
Garage: [not visible](#)

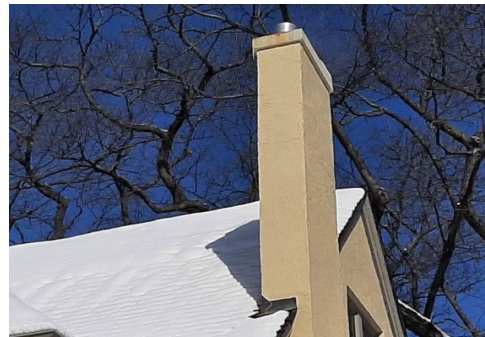
Chimney(s): [overall in good repair](#)

[Note: Recommend Annual Maintenance Contract for Roof Surface, Flashing Details and Chimney\(s\)](#)

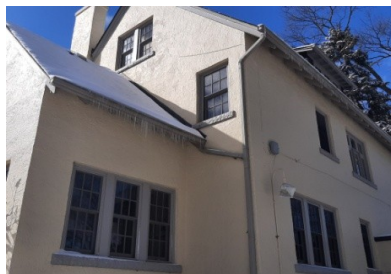
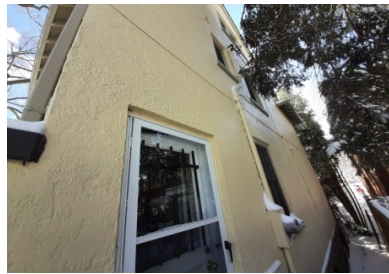
WALL SURFACES: overall in good repair  
DOORS/WINDOWS: overall in good repair

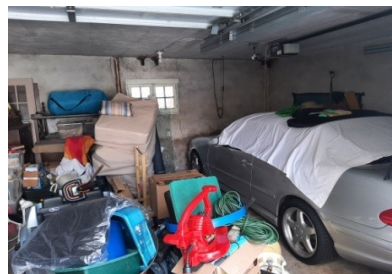
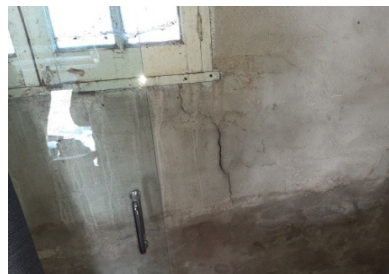
**ATTACHED GARAGE:** overall in good repair, auto door mech inoperative- repair if required  
minor settlement crack at rear wall- monitor

**\*\*BASEMENT WALKOUT:** overall well built, drain not visible

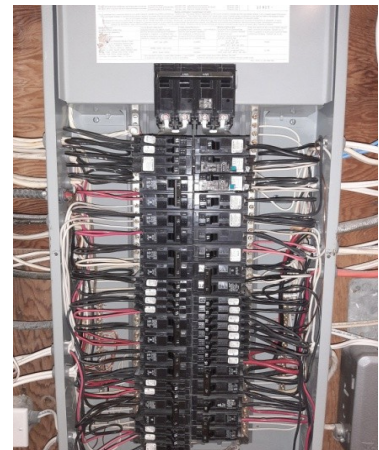
**SERVICE PANEL: older mast: upgrade as required/renovating**

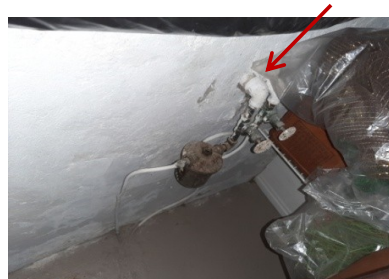
Comments: [piping and valves at southwest corner of basement indicate buried oil tank, it was reported by home owner that the buried oil tank was removed, requires documents for and/or third party verification](#)
