HOME INSPECTION REPORT

70 Fuller Ave

Prepared by: Bob Papadopoulos P.Eng., RHI *

Inspection Date: Feb 8 2022

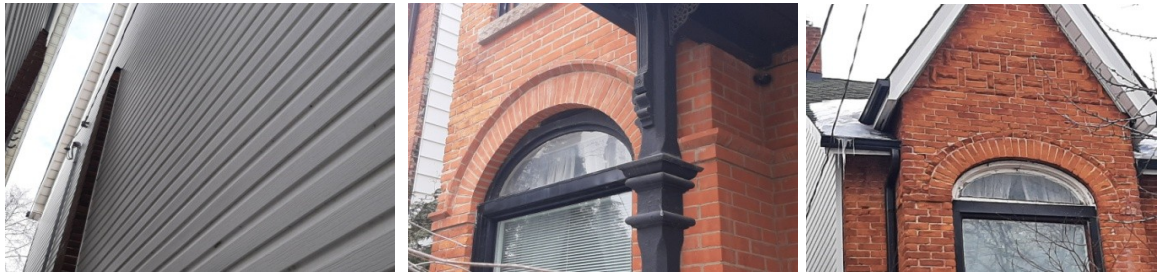
Brick: prior repairs noted, minor surface spalling, overall in good repair

Vinyl Siding: overall in good repair

DOORS/WINDOWS: overall in good repair

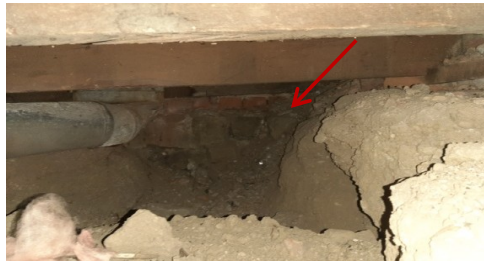
FOUNDATIONS: rear crawlspace: minor displacement of stone foundation, appears to be older condition, monitor, budget to repair

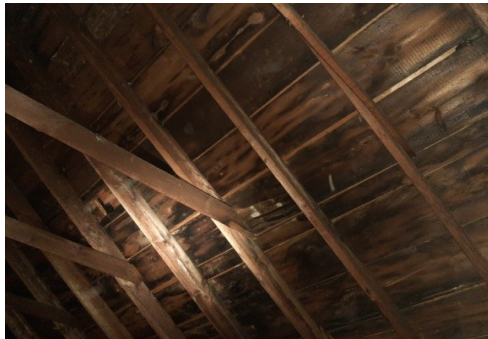
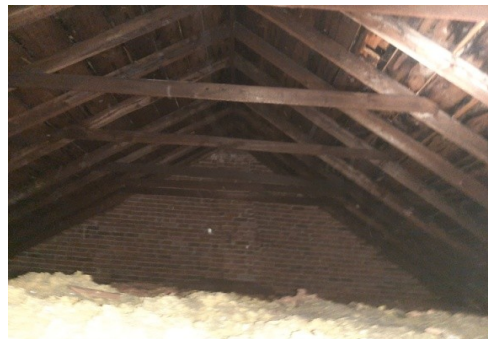
WALLS: exterior front: prior repairs, replacement of arch, overall in good repair

ROOF: overall in good repair, stains typical, sheathing has been installed
Party (Fire) Walls: recommend installing in roof space between adjoining neighbour

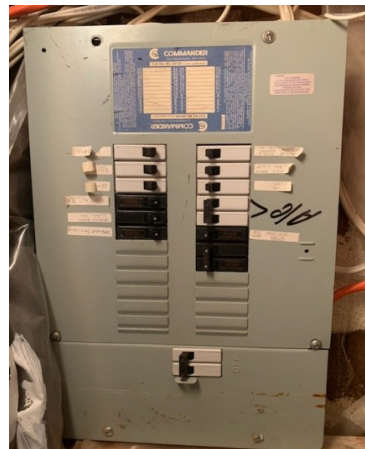
SERVICE PANEL: **overall in good repair**

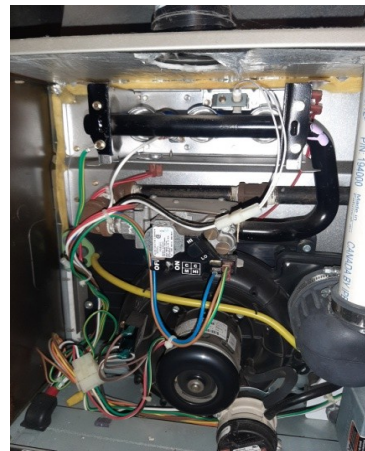
FORCED AIR FURNACE: [service annually](#)
Filter: [replace 1-per-3 months](#)

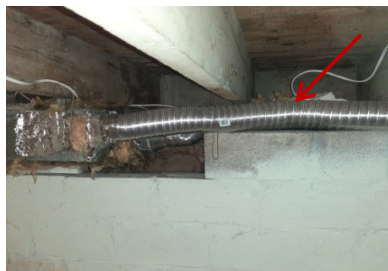
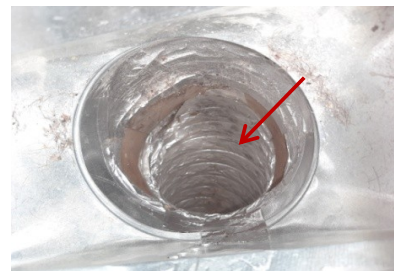
Ducts: [low quality material in some areas - overall not critical](#)

Registers: [insulation around some registers may contain asbestos](#)
[encapsulating the insulation is often the best approach](#)
[Environmental Consultants can assist if this is a concern](#)

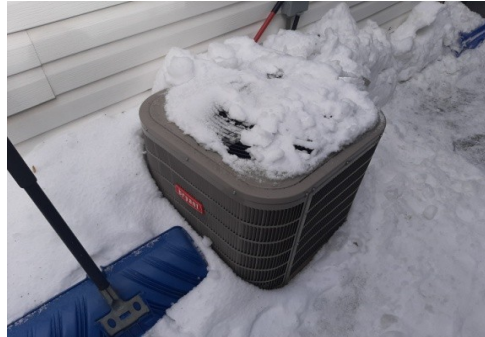
AIR CONDITIONER: not tested: should be serviced before using

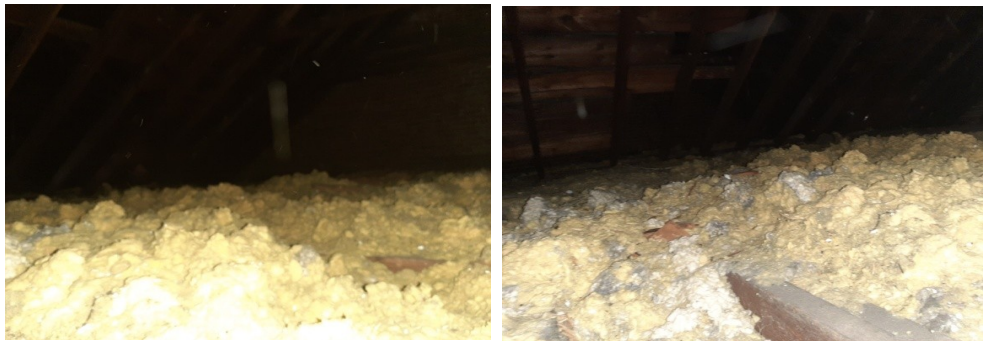
ROOF SPACE: recommend upgrading insulation to improve comfort and efficiency
 Roof Access Hatch: insulate and weather-strip access hatch to roof space

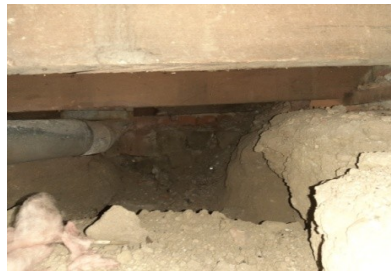
Crawlspace Floor: recommend covering soil with moisture barrier
 also considering removing soil to wall retaining wall (masonry block) height
 Crawlspace Walls: recommend installing spray foam around perimeter
 Ducts in Crawlspace: recommend insulating ducts in this space to improve efficiency
