HOME INSPECTION REPORT

130 Springhurst Ave
Toronto

Prepared by: Bob Papadopoulos P.Eng., RHI *

Inspection Date: Nov 12 2021

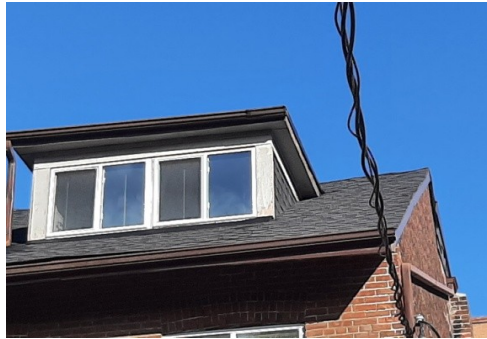
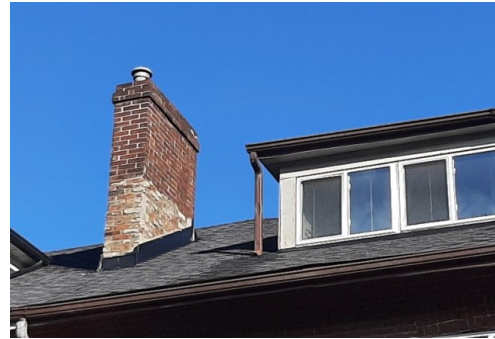
Sloped Surface: [overall surface in good repair](#)
Chimney(s): [top portion rebuilt, overall in good repair](#)

[Note: Recommend Annual Maintenance Contract for Roof Surface, Flashing Details and Chimney\(s\)](#)

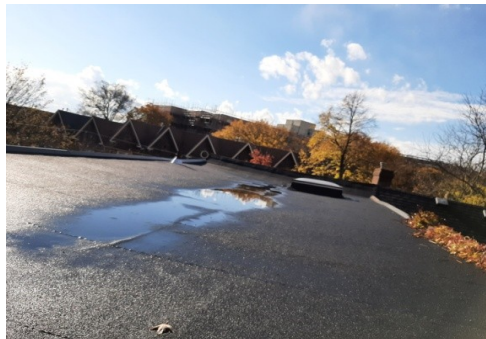
Flat Surface: [overall in good repair](#)

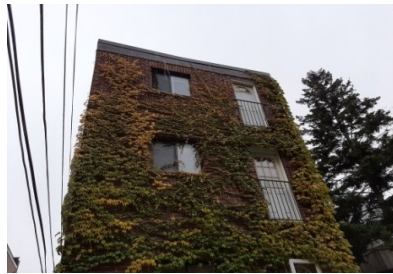
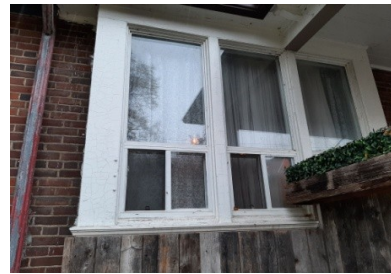
DOORS/WINDOWS: overall in good repair, basement walkout incomplete finishes- minor repair

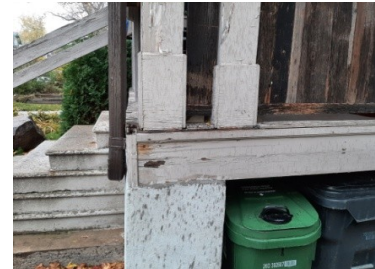
PORCH requires general repairs and maintenance

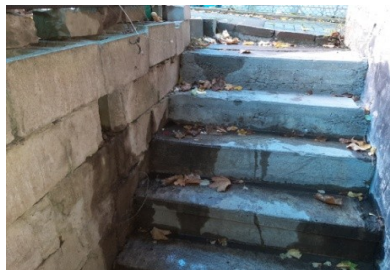
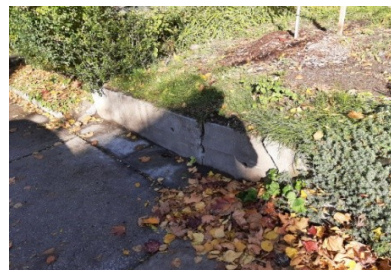
****BASEMENT WALKOUT:** wall repairs required, grading repairs around wall provide handrails to steps

RETAINING WALL: front yard: budget to replace

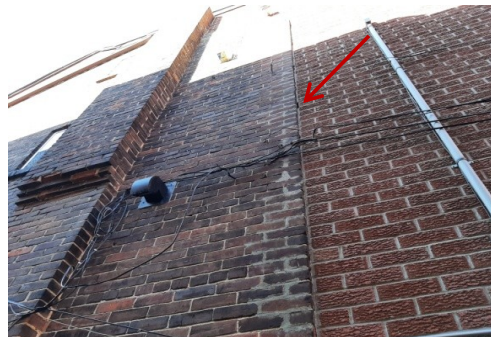
Masonry Arch: typical settlement cracks/loose brick - monitor/repair
general mortar repairs on south side

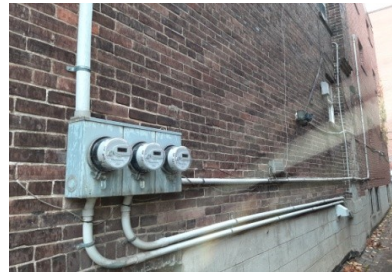
SERVICE ENTRANCE: upgraded to 200 amp divided into three 100 amp panels (each unit)

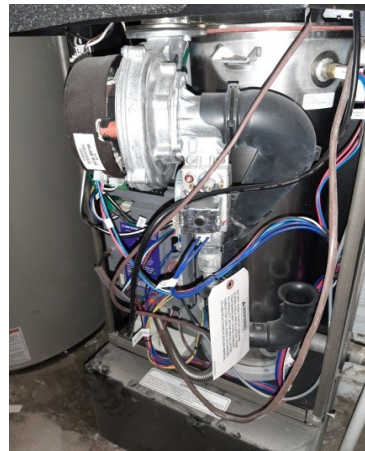
HOT WATER BOILER: [service annually](#)

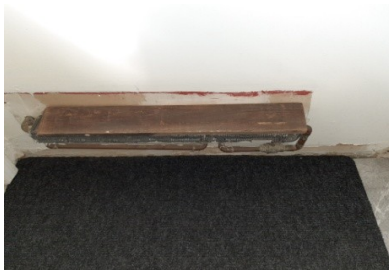
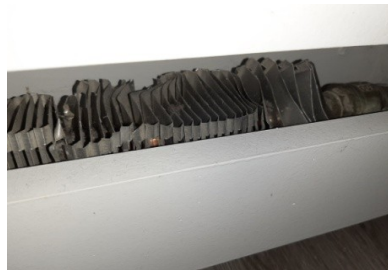
Radiator(s): [minor fin damage to some convector units though functional](#)
[door entrance: provide proper cover, newer rads in good repair](#)
[recommend installing in basement apartment east wall](#)

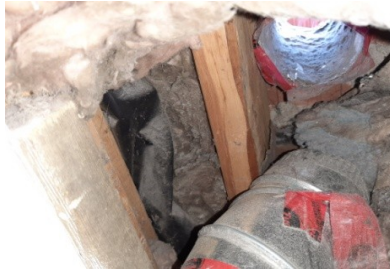
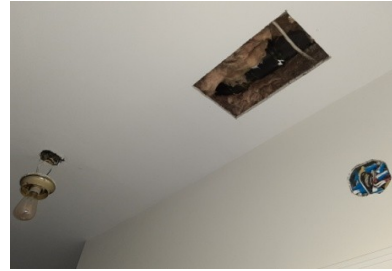
WALLS: [exposed wall/ceiling frame/insulation - repair](#)
Exhaust Fan Vents: [loose dryer vent- repair](#)
[washroom missing cover](#)
[recommend kitchen vents to exterior](#)
