# HOME INSPECTION REPORT

165 Westminster Ave  
Toronto

Prepared by: Bob Papadopoulos P.Eng., RHI \*

Inspection Date: March 14 2022

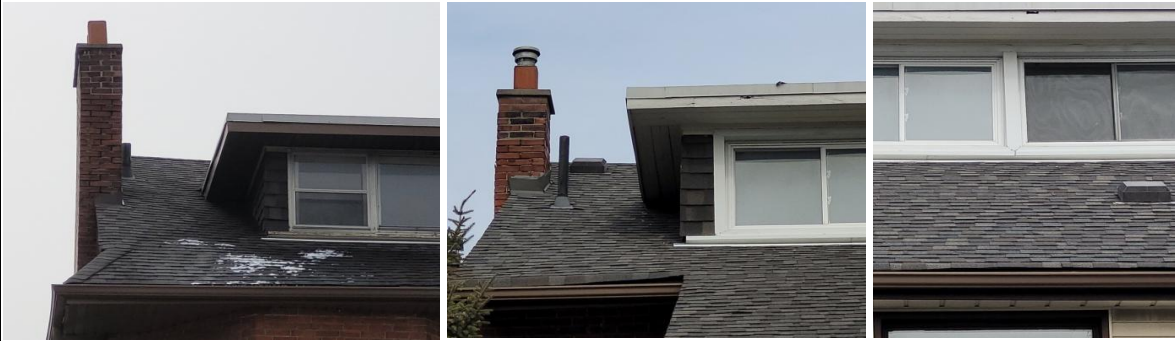
Sloped Surface: [overall surface in good repair](#)

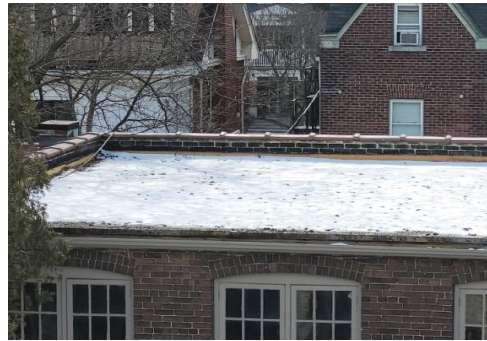
Garage: [Coach House: older surface recommend replacing before renovating](#)

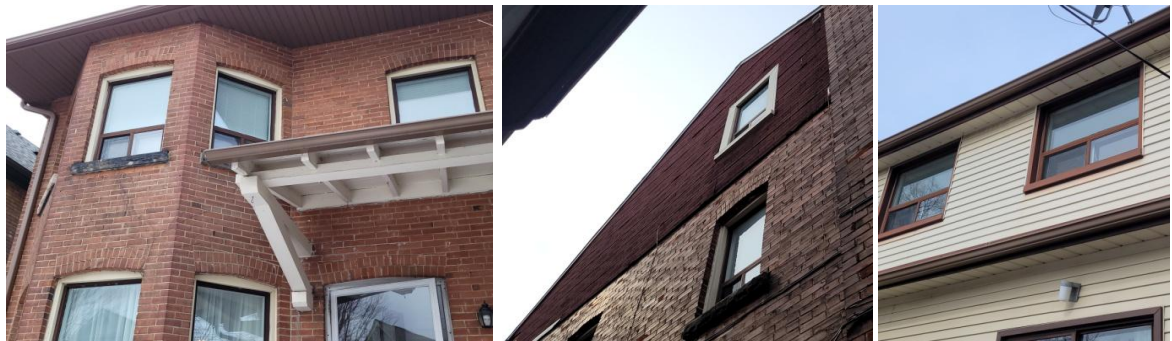
WALL SURFACES: overall in good repair  
 Brick: minor surface spalling, repair as required  
 Insulbrick: may require covering with metal siding for insurance  
 repair seams as required, budget to cover/replace with metal siding  
 DOORS/WINDOWS: overall in good repair  
 Soffit & Facia: require general repairs and maintenance

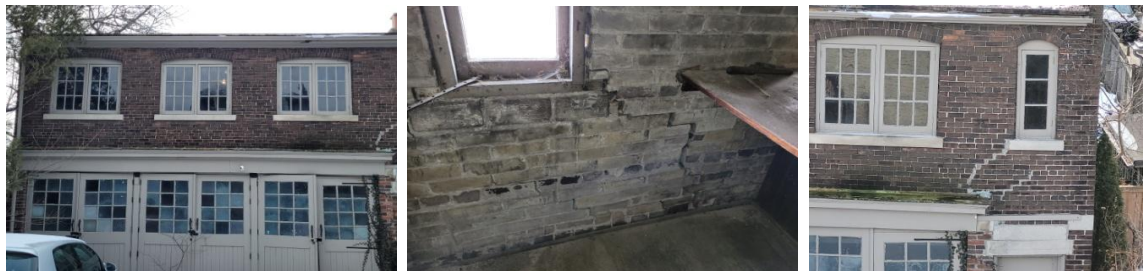
DETACHED GARAGE: Coach House: older, typically ongoing repairs, settlement at northwest corner  
 should be repaired when renovating- consult with specialist

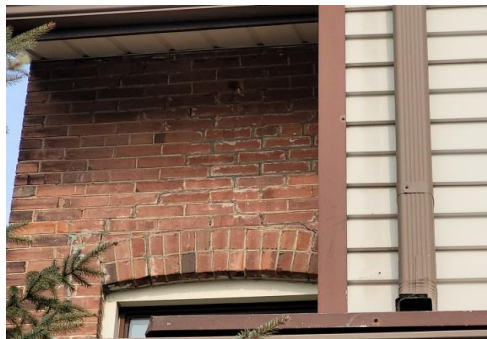
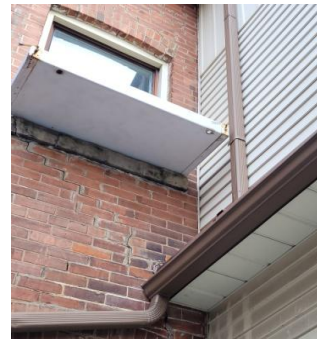
Masonry: southwest corner typical settlement cracks - repair

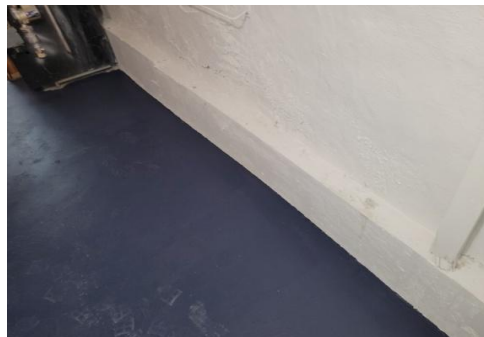
FOOTINGS/FOUNDATIONS basement floor has been lowered

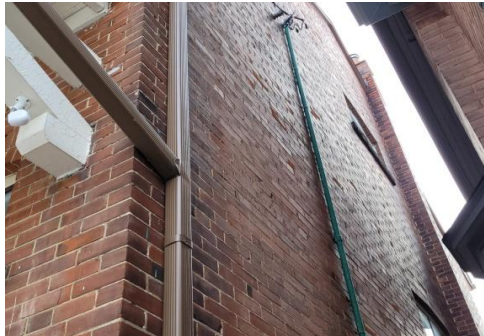
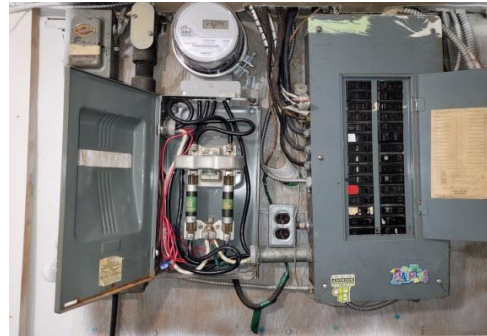
Mast: **older, recommend upgrading**

Main Disconnect: **older, recommend upgrading**

SERVICE PANEL: **older, recommend upgrading**

Service Size: **recommend upgrading to 200 AMP when renovating**

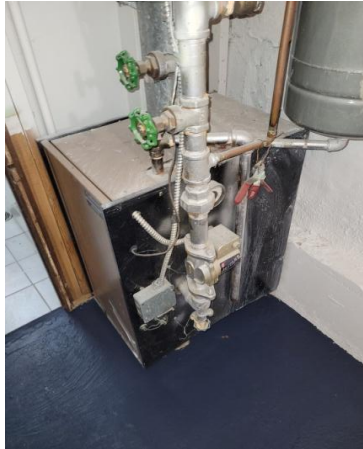
**HOT WATER BOILER:** continue servicing until replacement becomes necessary  
annual CO test mandatory for this type of unit  
recommend upgrading to high efficiency unit when renovating

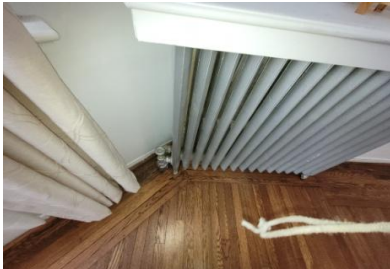
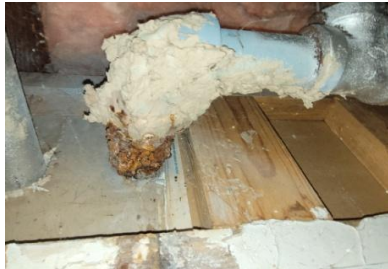
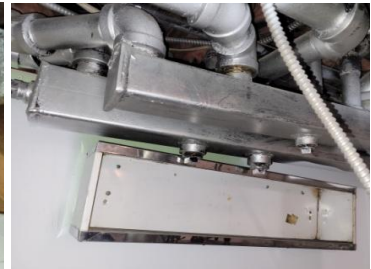
**Piping:** corroded connection in basement ceiling, overall further evaluation to piping system when renovating
