# HOME INSPECTION REPORT

25 Huntsmoor Rd

Prepared by: Bob Papadopoulos P.Eng., RHI \*

Inspection Date: March 25 2022

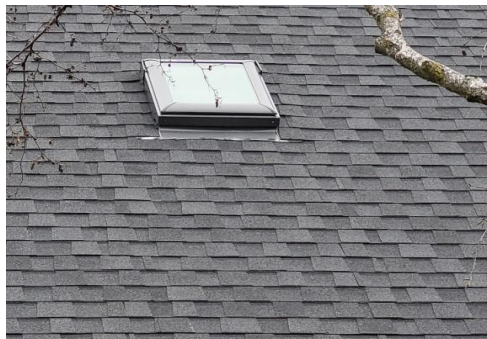
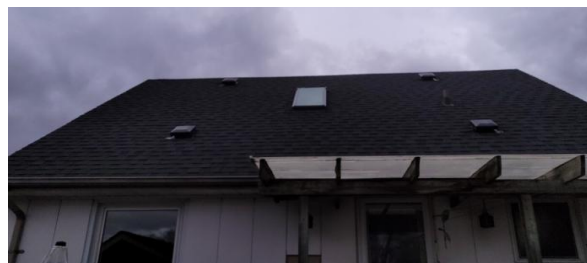
Sloped Surface: [overall surface in good repair](#)

[Note: Recommend Annual Maintenance Contract for Roof Surface, Flashing Details and Chimney\(s\)](#)

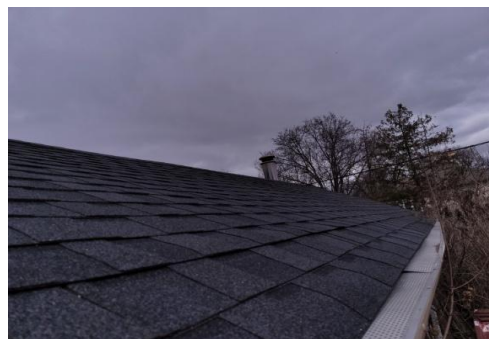
Garage: [overall surface in good repair](#)

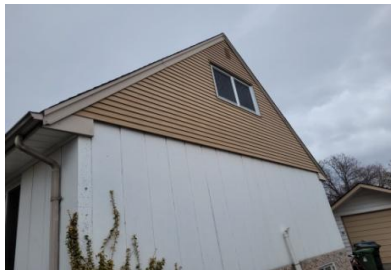
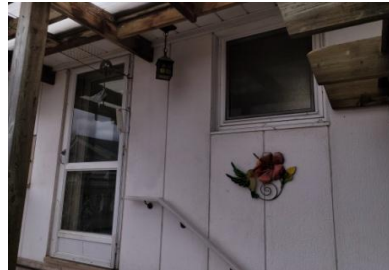
WALL SURFACES: overall in good repair  
DOORS/WINDOWS: overall in good repair

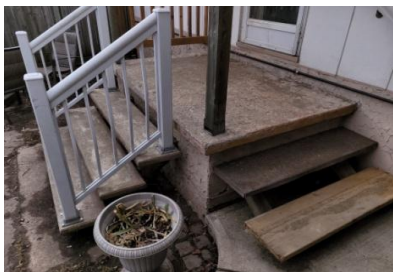
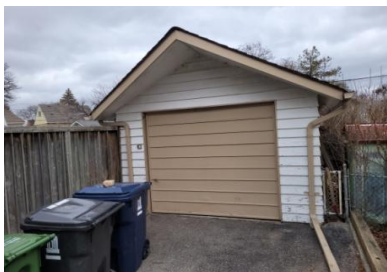
PORCH(es): overall in good repair  
DETACHED GARAGE: older, typically ongoing repairs  
wood stove: recommend inspection by W.E.T.T. Certified technician ([www.wettinc.ca](http://www.wettinc.ca))

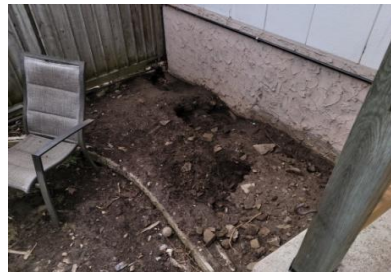
\*\*Lot Grading: slope away from house

Note: Maintain Gutters & Downspouts annually. Extend Downspouts at least 6-feet away from the house

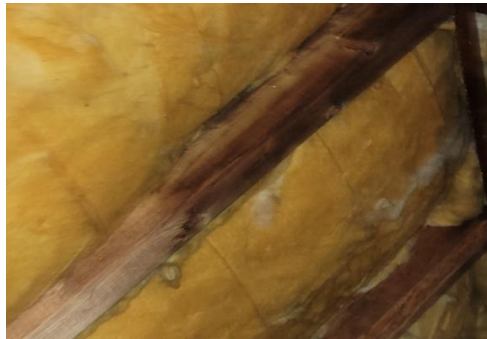
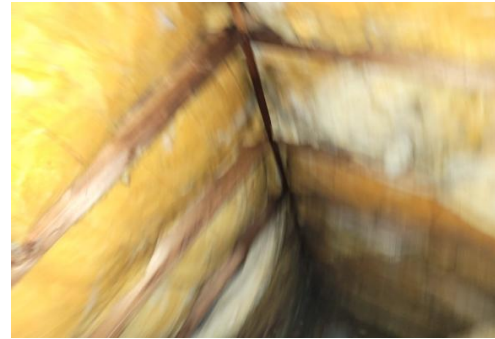
overall well built house

ROOF: overall in good repair

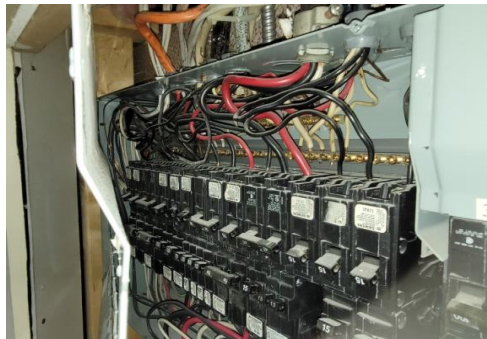
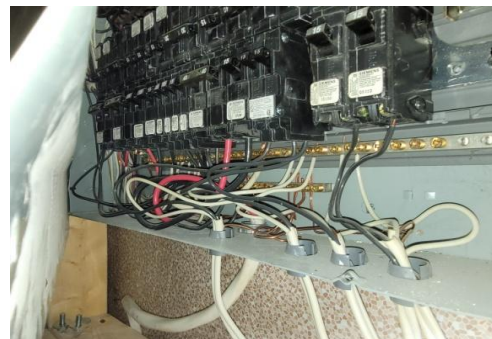
SERVICE PANEL: **overall in good repair**

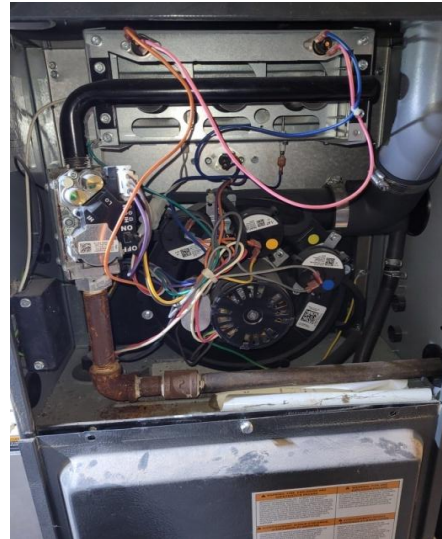
FORCED AIR FURNACE: [service annually](#)

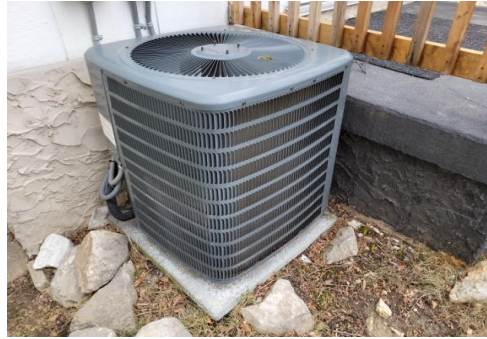
HEAT PUMP: [not tested: should be serviced before using](#)

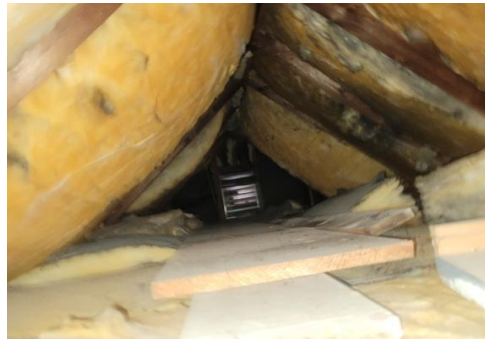
ROOF SPACE: insulation and ventilation is adequate  
unusual to be insulating rafters - not critical
