# HOME INSPECTION REPORT

159 Dunn Ave

Prepared by: Bob Papadopoulos P.Eng., RHI \*

Inspection Date: March 31 2022

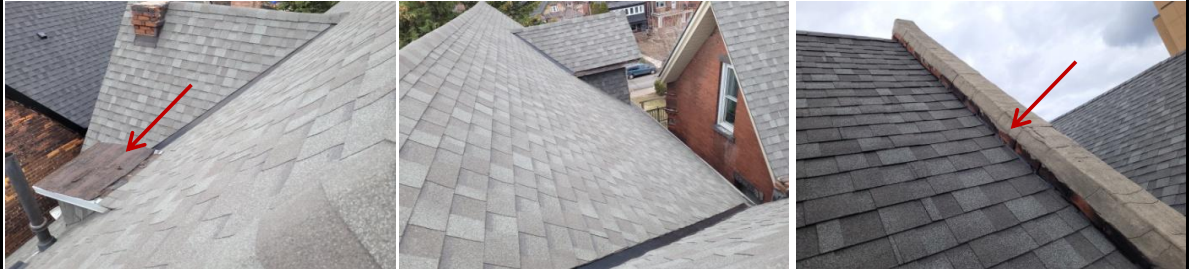
Sloped Surface: **overall surface in good repair**  
 Dormer(s): **south side central -old surface -replace**  
 Parapet Wall: **north side- recommend installing flashing/cap flashing**

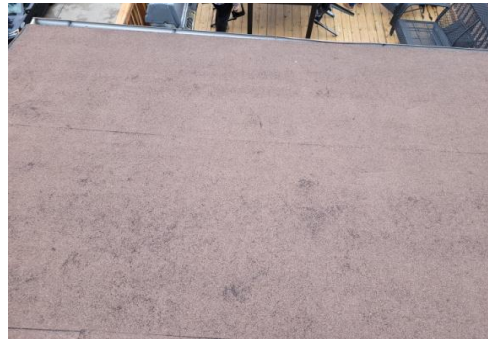
Flat Surface: **overall surface in good repair**

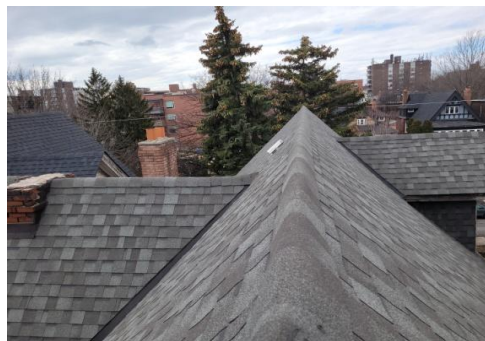
Chimney: **overall in good repair**

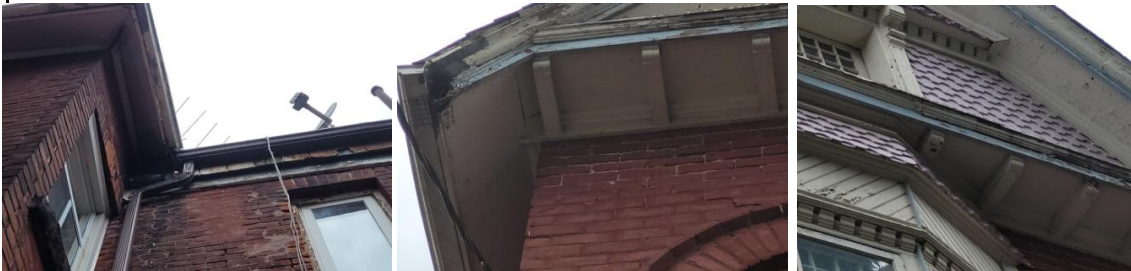
**\*\*Gutters/Downspouts:** requires general repairs and maintenance, replacement likely more cost effective

Soffit & Facia: damaged, requires general repairs and maintenance, replacement likely more cost effective

Wood Shingles: requires general repairs and maintenance

Brick: typical surface spalling, see Structure

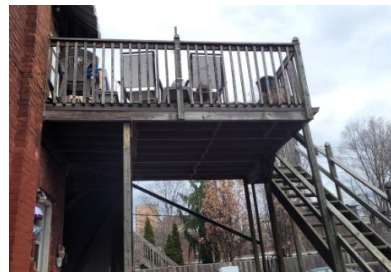
**DECK(s):** older, budget to replace, repair as required, recommend reinforcing with cross bracing of columns

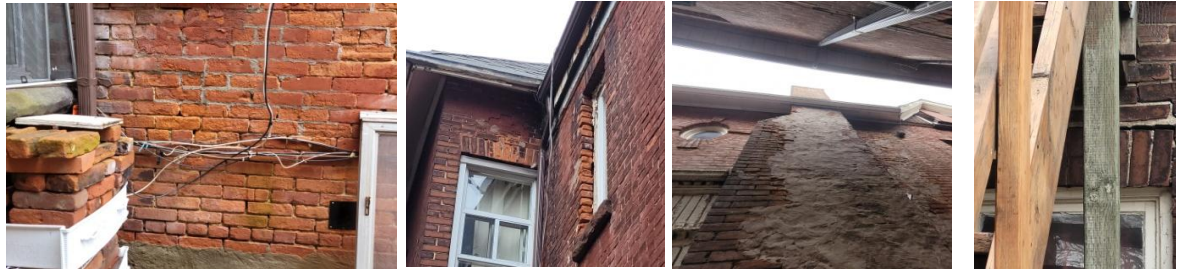
WALLS:  
 Masonry: typical surface spalling- repair as required  
 Masonry Arches: cracks above arch typical, repair mortar

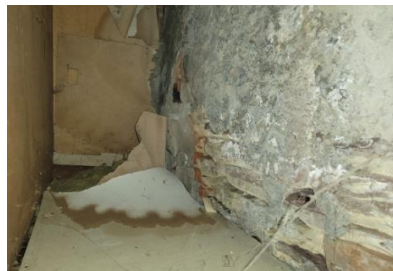
FOUNDATIONS: expect foundation mortar repairs/maintenance when renovating basement

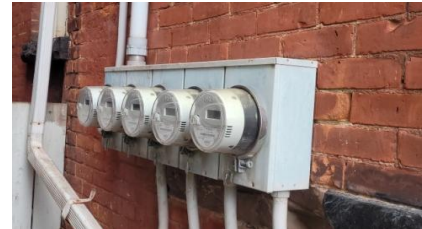
SERVICE ENTRANCE: **upgraded mast, 5 meter base**

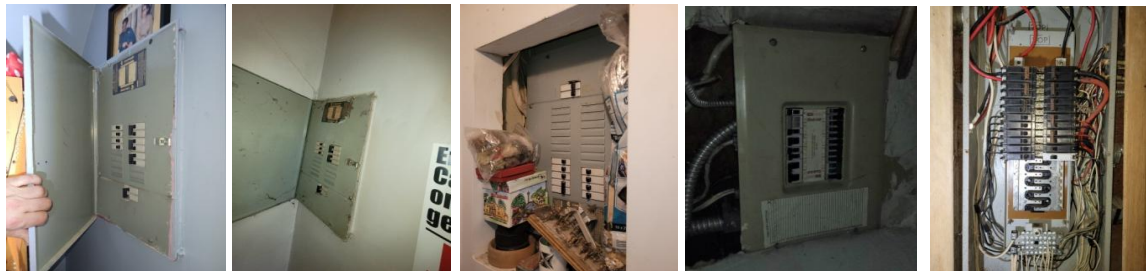
SERVICE PANEL: **5 units in good repair**

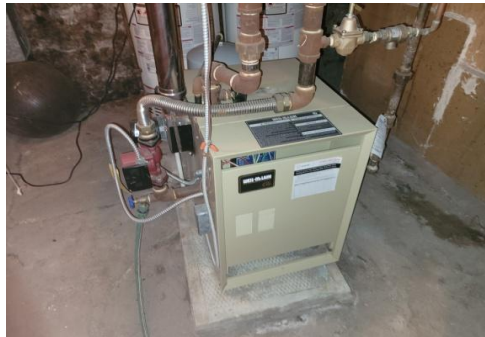
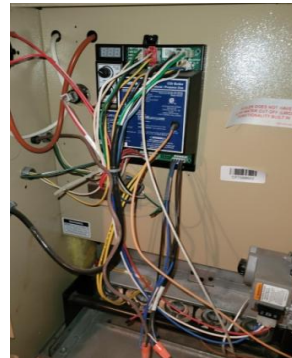
HOT WATER BOILER: [service annually](#)

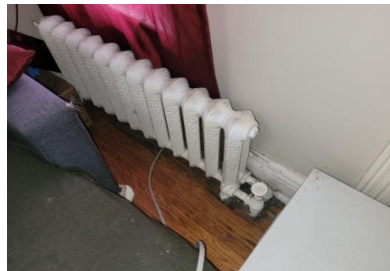
Radiator(s): [older, monitor/repair valves as required](#)

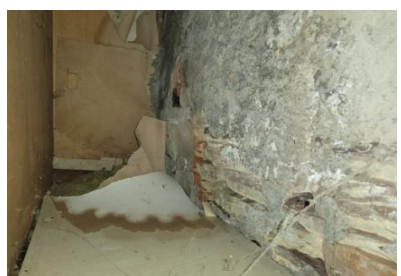
Ceilings: some mouldy areas - remove and remediate- see below  
 Floors/Walls/Ceilings: repair as required/budget to renovate  
 Trim/Cabinets/Counters: repair as required/budget to renovate  
 Windows/Doors: older units, upgrade as required or if renovating  
 \*\*Evidence of Basement Leakage: mouldy drywall/materials, etc. remove and remediate areas  
 long term moisture may result in visible or concealed mould growth.  
 Environmental Consultants can assist if this is a concern  
 recommend damp-proofing if renovating basement
