# HOME INSPECTION REPORT

292 Heslop Rd

Milton

Inspection Date: May 5 2022

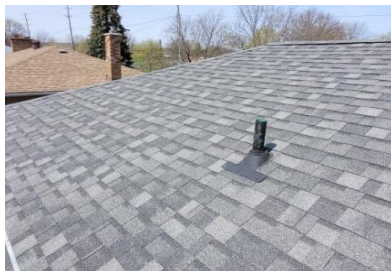
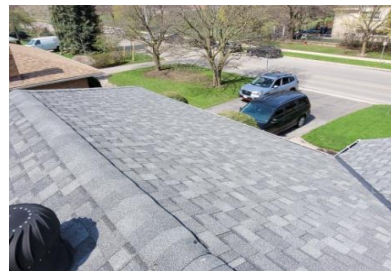
Sloped Surface: [overall surface in good repair](#)

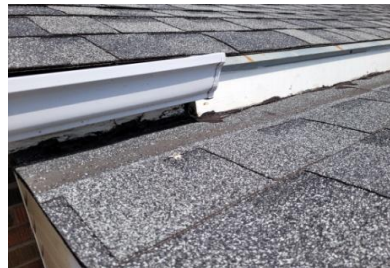
2nd Slope: [overall surface in good repair, lower slope more prone to ice dams seal along edges](#)

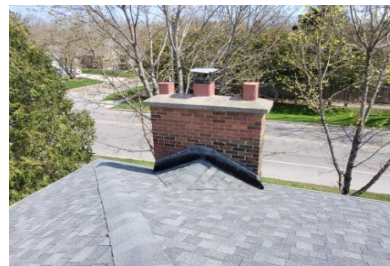
Chimney(s): [overall in good repair](#)

[Note: Recommend Annual Maintenance Contract for Roof Surface, Flashing Details and Chimney\(s\)](#)

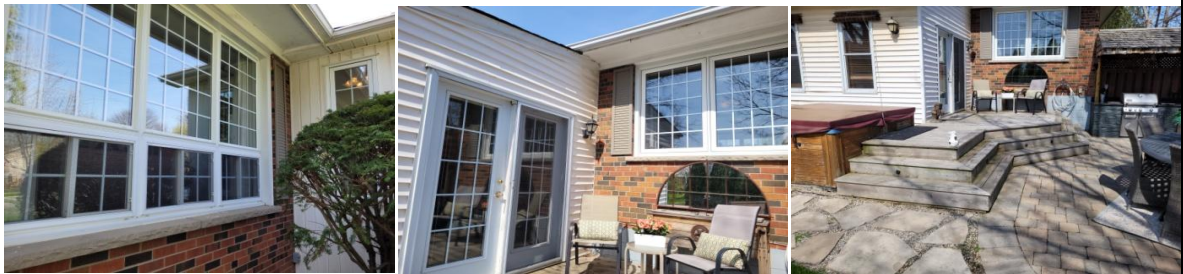
WALL SURFACES: overall in good repair  
DOORS/WINDOWS: overall in good repair  
DECK provide hand railings for safety

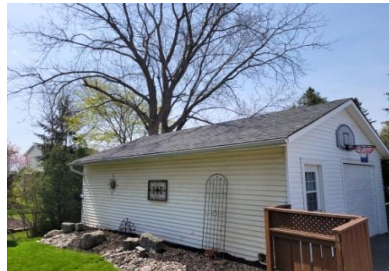
DETACHED GARAGE: overall well built  
old door - replace

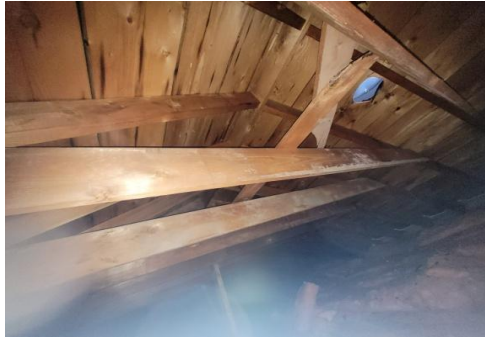
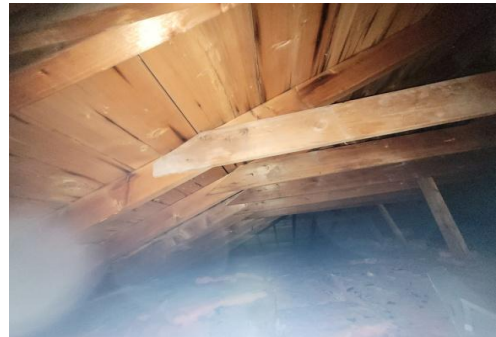
overall well built house

ROOF: overall in good repair

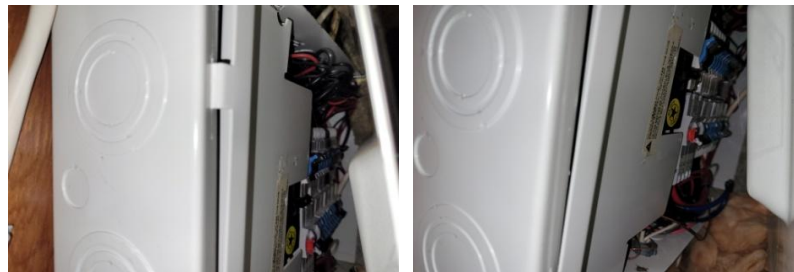
SERVICE PANEL: **panel obstructed by cabinet - cover not removed, further evaluation**

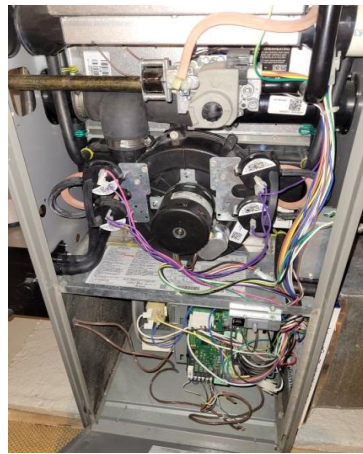
FORCED AIR FURNACE: [service annually](#)

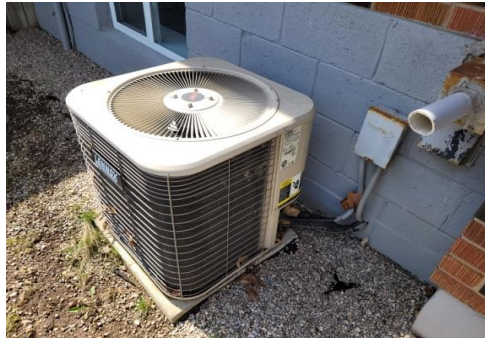
AIR CONDITIONER: **not tested: should be serviced before using**  
**aging unit, continue servicing until replacement becomes necessary**

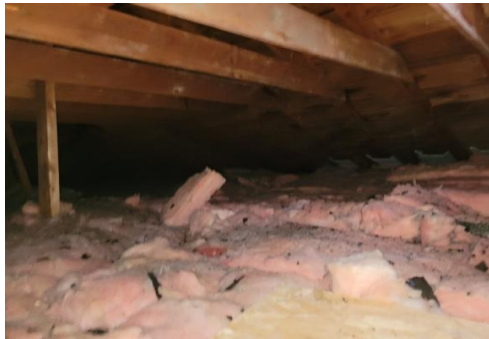
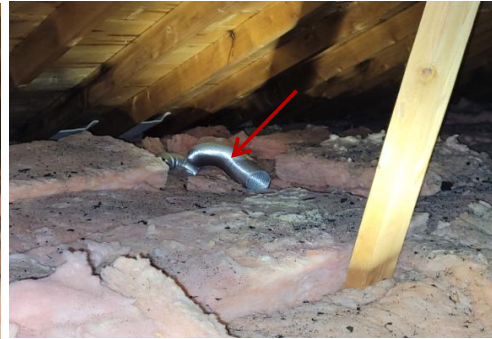
ROOF SPACE: insulation and ventilation is adequate  
uneven- improve

Exhaust Fan Vents: vent to exterior
