HOME INSPECTION REPORT

46 Saint Clarens Ave
Toronto

Inspection Date: April 8 2022

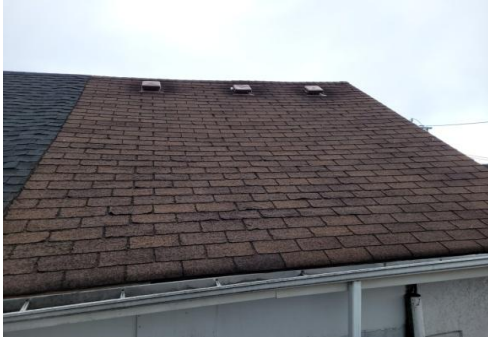
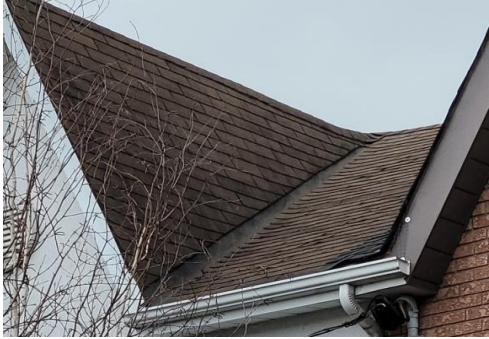
REFERENCE LINK		http://redbrickinspections.ca/docs/2_Roofing_Reference_Guide.pdf		
46 Saint Clarens Ave		ROOFING/Chimneys		April 8 2022
Description				
Roofing Material:	Location:	Leakage Probability:	Chimney(s) Type:	Location:
Asphalt Shingles:	Slope:	Medium		
Modified Bitumen:	Flat:	Medium		
Modified Bitumen:	Lower Flat:	Medium		
Not Determined	Porch(s):			
Limitations				
Roof Inspected By:	Access Limited By:	Chimney Access Limited By:		
Binoculars Walking On From Edge	Deck			
Observations/Recommendations				
Sloped Surface: aging surface, budget to replace within 5 yrs.

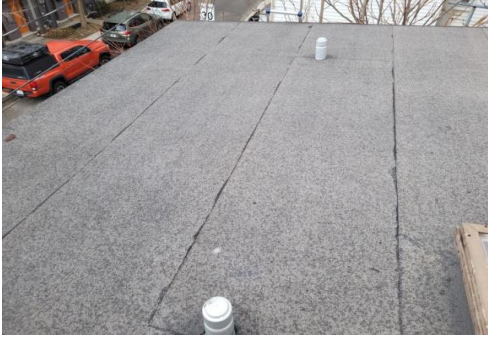
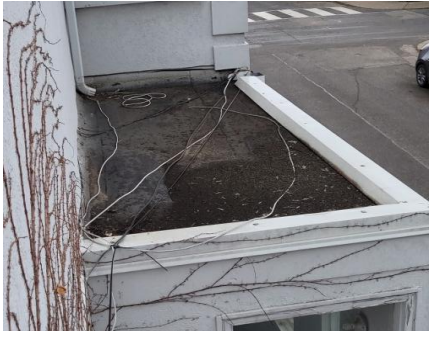
Flat Surface: aging surface though overall in good repair				
Lower Flat: requires cleaning/maintenance

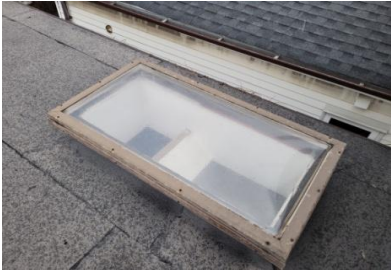
Skylight: overall in good repair

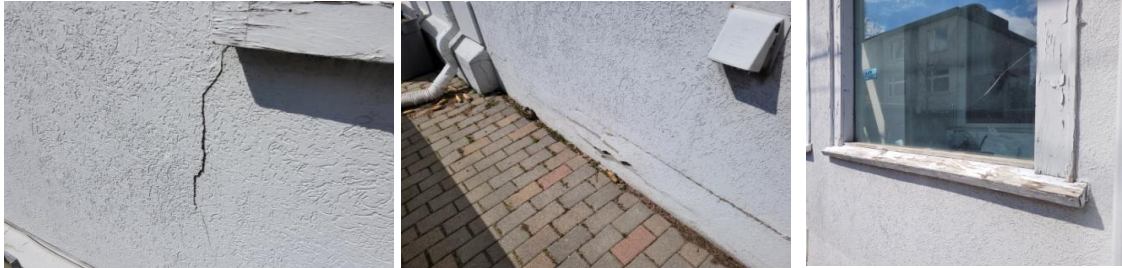
Stucco: [cracks/loose in some areas requires repairs](#)

DOORS/WINDOWS: [requires general repairs and maintenance](#)

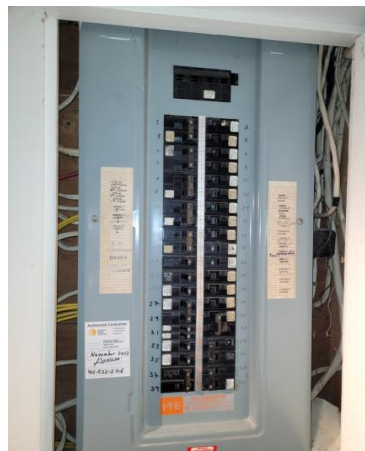
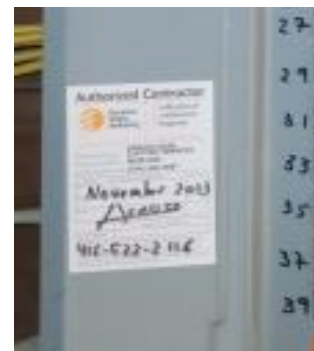
SERVICE PANEL: overall in good repair
 panel obstructed by cabinet - cover not removed, last inspected 2013 by ESA

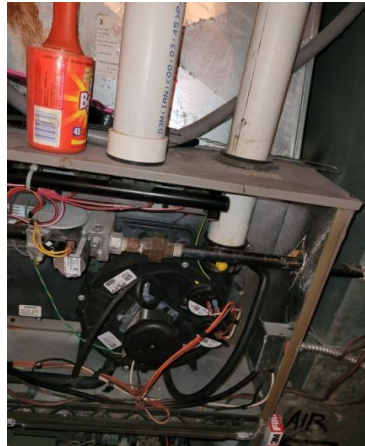
FORCED AIR FURNACE: [service annually](#)

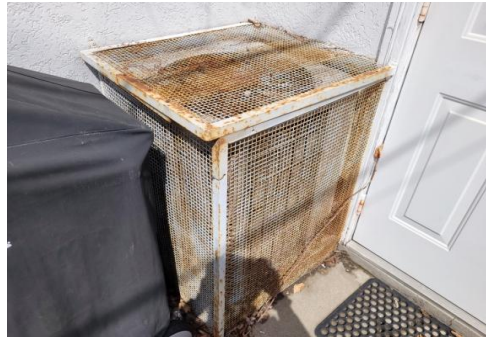
AIR CONDITIONER: not tested: should be serviced before using
aging unit, continue servicing until replacement becomes necessary
