HOME INSPECTION REPORT

42 Springhurst Ave
Toronto

Prepared for: [High Park Realty Group](#)

Inspection Date: July 7 2022

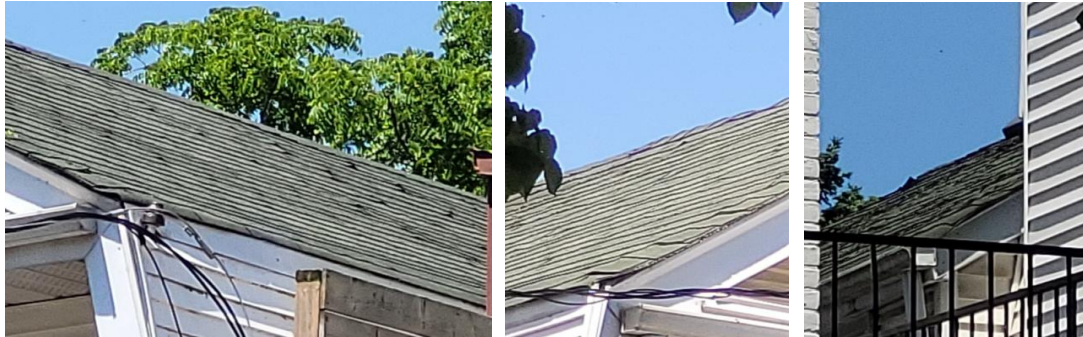
Sloped Surface: [aging surface, budget to replace within 1 yrs.](#)
[west side more worn, multi-layered therefore will cost extra to dispose](#)

ROOFING West side older asphalt shingles, replace within 1-yrs. Should consider replacing throughout.

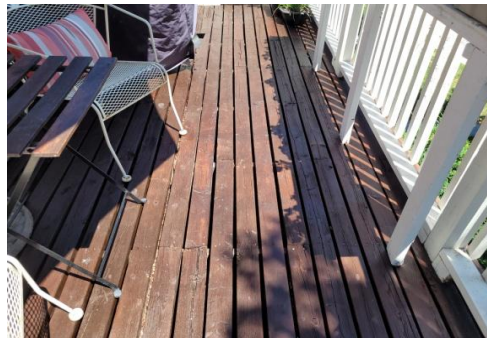
Main Flat: [front deck - not visible](#)

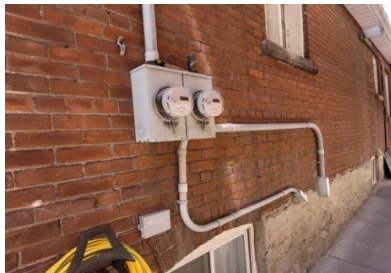
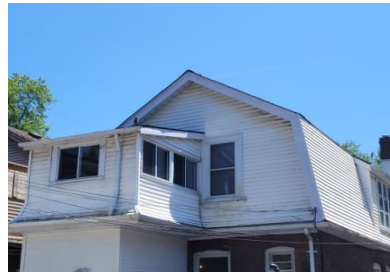
DOORS/WINDOWS: overall in good repair

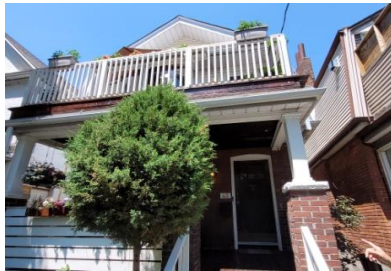
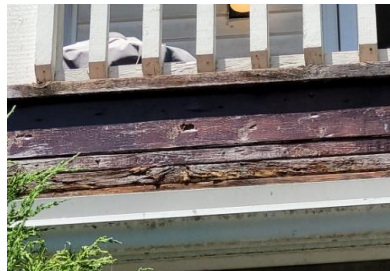
DECK overall in good repair, minor framing rot at edge - monitor
PORCH restored , in good repair

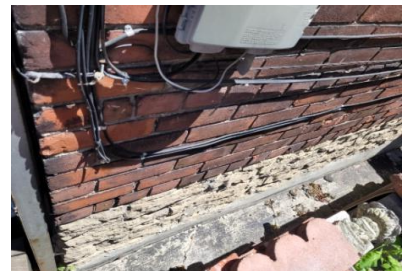
****Walk(s):** seal gaps along foundation wall
****Window Well:** provide cover

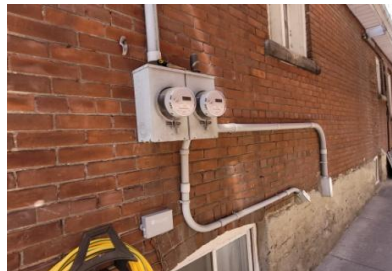
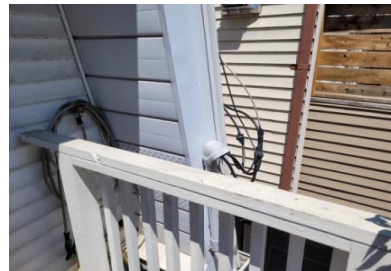
SERVICE ENTRANCE: **two meter base: overall in good repair**
 Clearance: **2nd level deck - provide barrier**

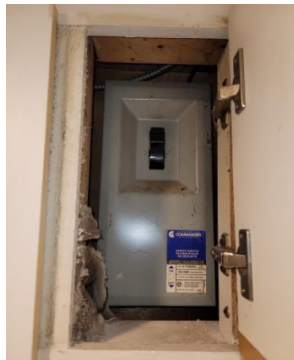
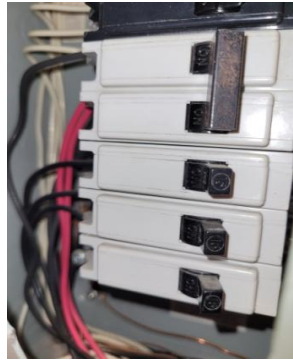
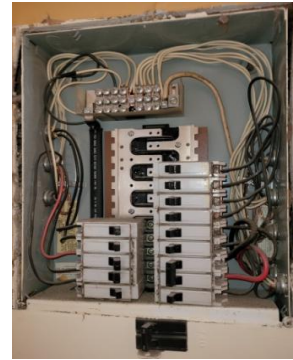
Main Disconnect: **overall in good repair**
 SERVICE PANEL: **overall in good repair, double tap electric heaters - add breakers if required**
 Auxiliary Panel: **overall in good repair**

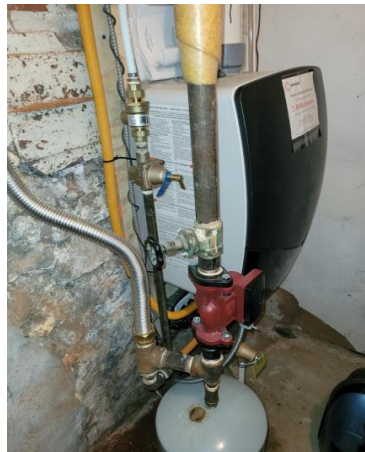
HOT WATER BOILER: [rented: service annually](#)
COMBINATION SYSTEM: [provides house heating and domestic hot water](#)

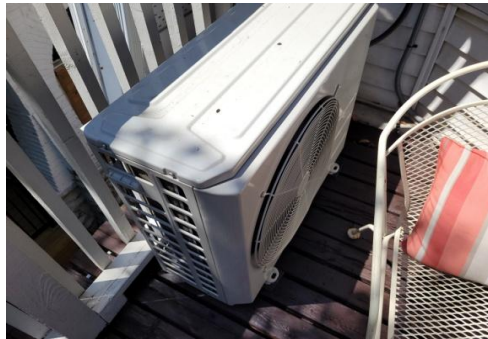
DUCTLESS A/C: two zone - main level/2nd level, service annually
