HOME INSPECTION REPORT

456 Pape Ave

Prepared by: Bob Papadopoulos P.Eng., RHI *

Inspection Date: July 14 2022

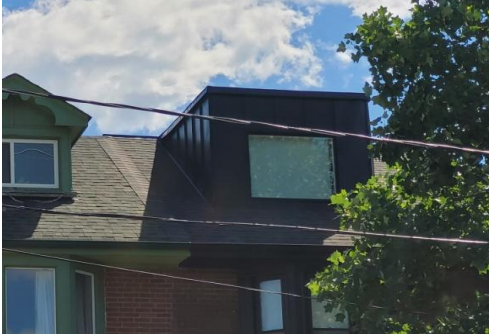
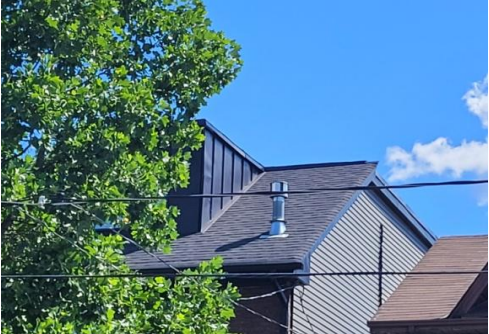
Chimney(s): overall in good repair

<p>Note: Recommend Annual Maintenance Contract for Roof Surface, Flashing Details and Chimney(s)</p>

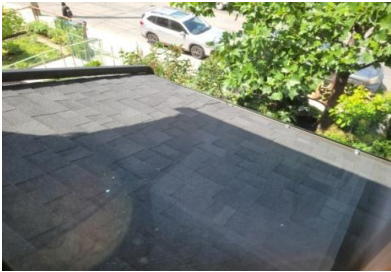
Porch(s): approx. 5-yrs old with typical life expectancy of over 20-yrs

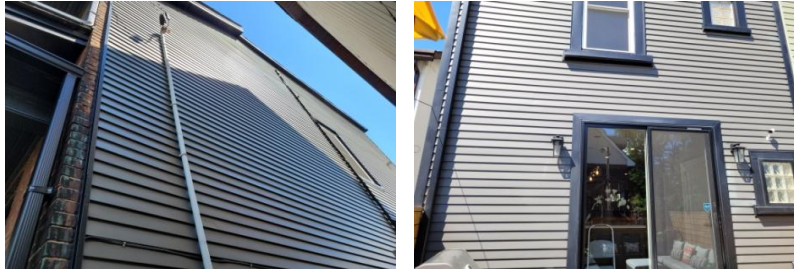
WALL SURFACES: overall in good repair
DOORS/WINDOWS: overall in good repair

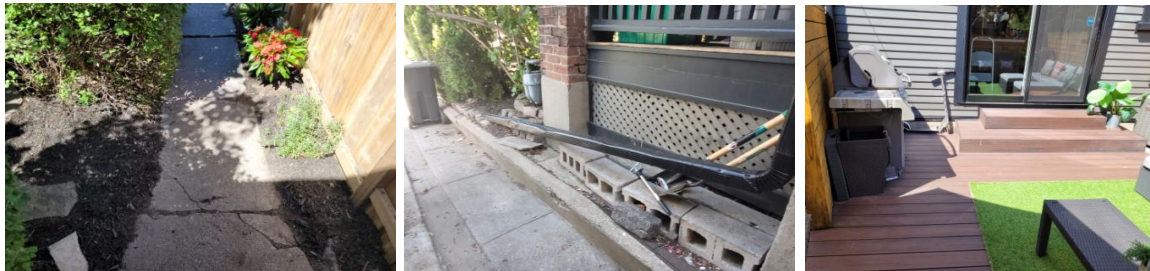
**Walk(s): require general repairs and maintenance
RETAINING WALL: front garden: movement, budget to replace
DECK overall well built

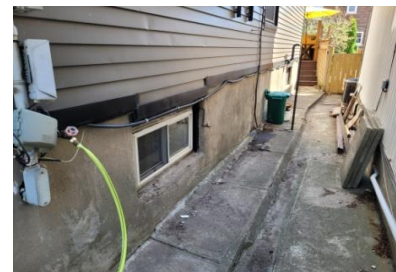
**Walk(s): seal gaps along foundation wall

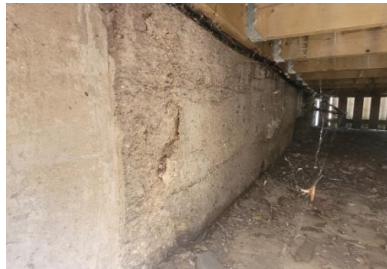
FOUNDATIONS: under deck - repair foundation spalling as required

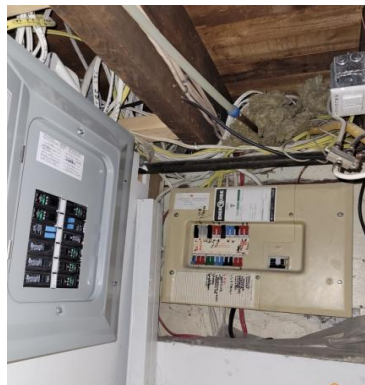
SERVICE PANEL: panel obstructed by cabinet - cover not removed, further evaluation

Auxiliary Panel: panel obstructed by cabinet - cover not removed, further evaluation

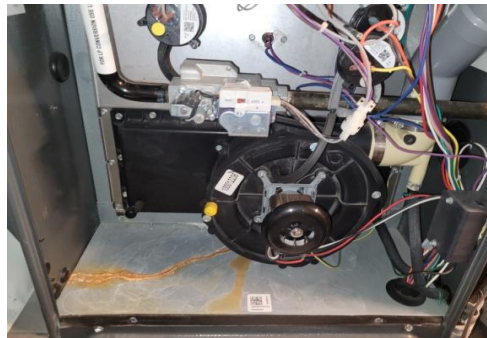
FORCED AIR FURNACE: [service annually](#)
[typical rusting for age](#)
[recommend obtaining replacement parts/servicing contract](#)
Filter: [replace 1-per-6 to 12 months](#)

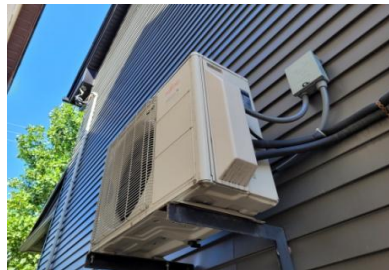
AIR CONDITIONER: [service annually](#)

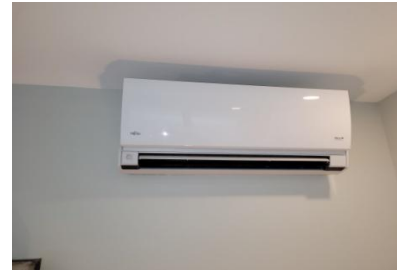
DUCTLESS A/C: [service annually](#)
