HOME INSPECTION REPORT

9 Cowan St
Toronto

Prepared by: Bob Papadopoulos P.Eng., RHI *

Inspection Date: Oct 3 2022

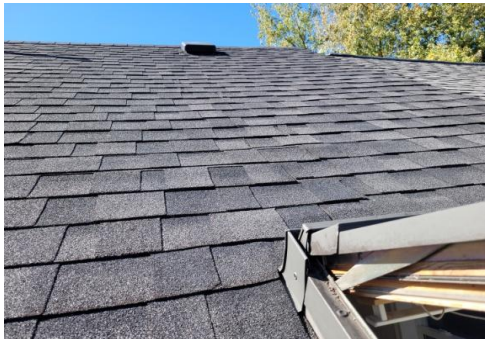
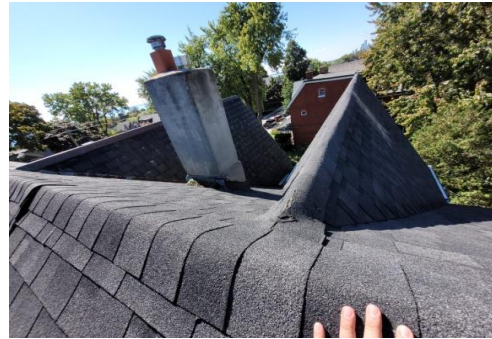
Sloped Surface: [overall surface in good repair](#)

Chimney(s): [overall in good repair](#)

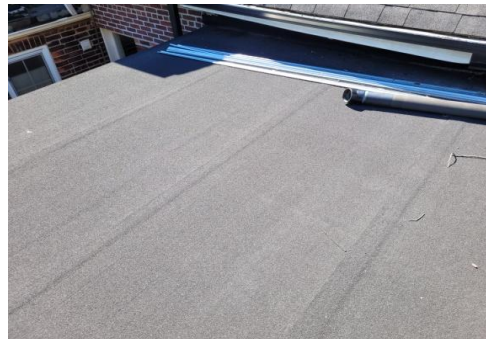
Flat Surface: [overall in good repair](#)

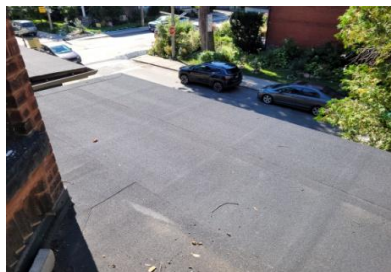
Porch(s): [overall in good repair, provide railings for safety](#)

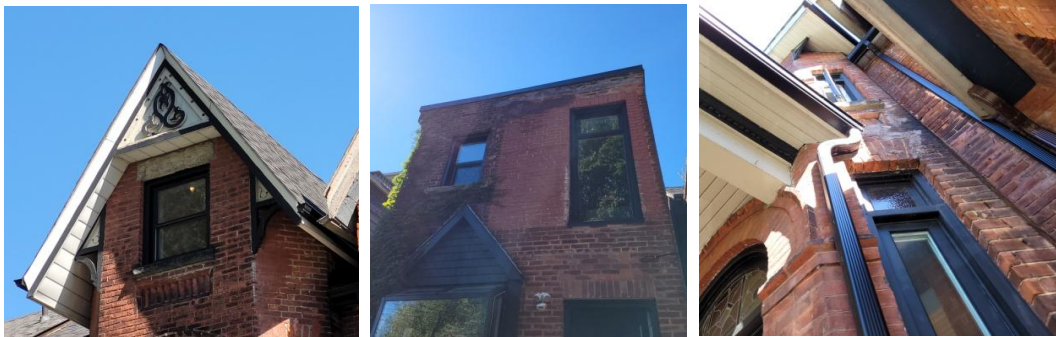
WALL SURFACES: overall in good repair, trim vines as required
 Soffit & Fascia: overall in good repair
 DOORS/WINDOWS: overall in good repair

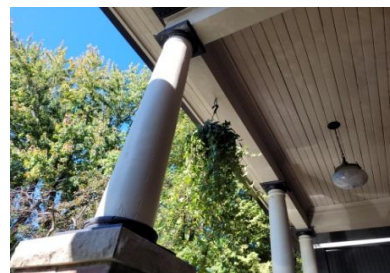
PORCH in good repair, column minor leaning typical
 DECK recently repaired

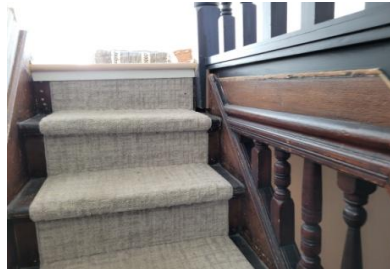
FLOORS: minor sagging around stair areas though typical for older house

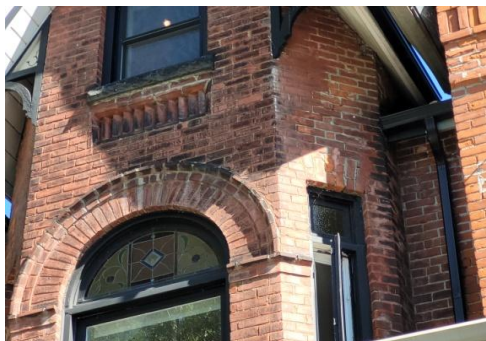
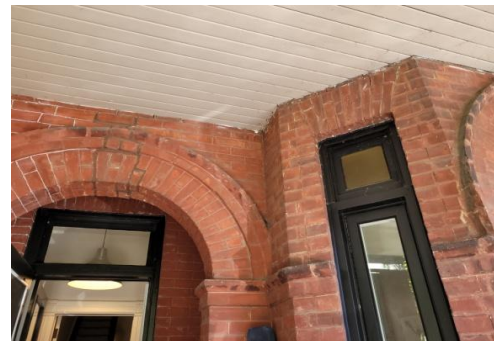
Masonry: cracks above arch typical, monitor/repair mortar as required
typical surface spalling - repair as required

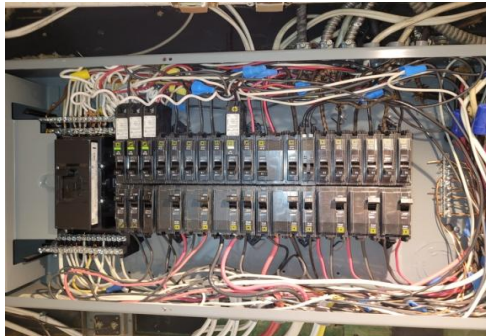
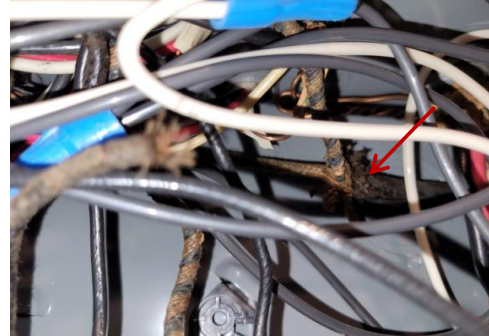
SERVICE ENTRANCE: overall in good repair
 SERVICE PANEL: overall in good repair
 BRANCH WIRING: panel: some ungrounded wiring typical, no knob and tube observed during random sampling

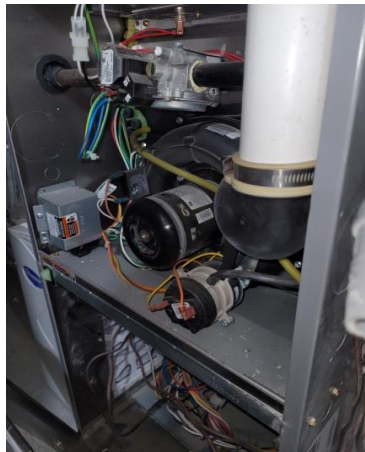
FORCED AIR FURNACE: [service annually](#)
[recommend obtaining replacement parts/servicing contract](#)

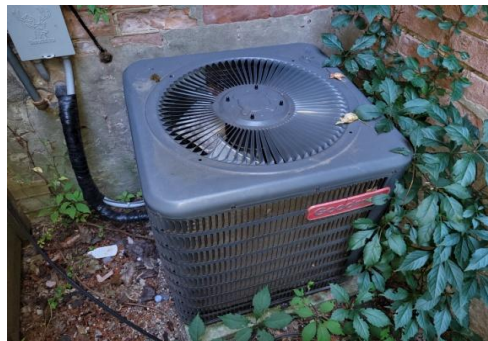
AIR CONDITIONER: [service annually](#)
[recommend obtaining replacement parts/servicing contract](#)

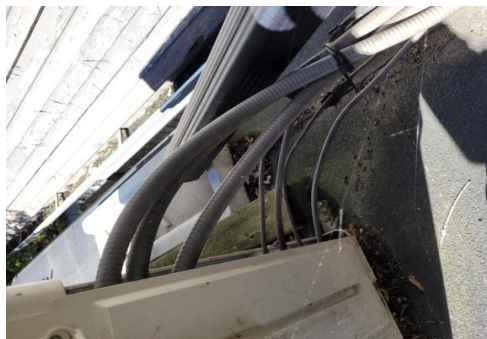
DUCTLESS HEAT PUMP: [service annually, repair/replace insulation on refrigerant lines](#)
[recommend obtaining replacement parts/servicing contract](#)
 unit provides cooling and supplemental heating
