HOME INSPECTION REPORT

1211 Dovercourt Rd

Prepared by: Bob Papadopoulos P.Eng., RHI *

Inspection Date: Nov 2 2022

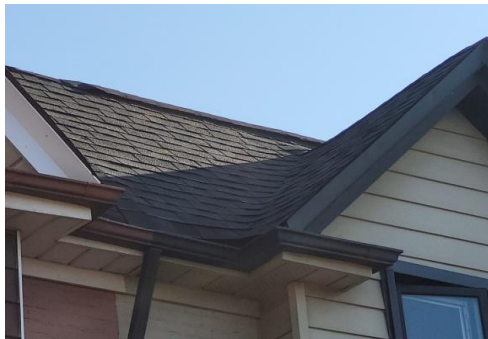
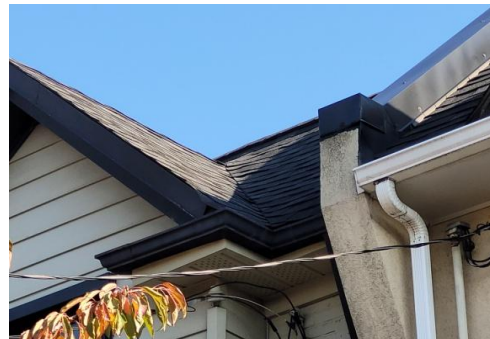
Sloped Surface: [new surface in good repair](#)

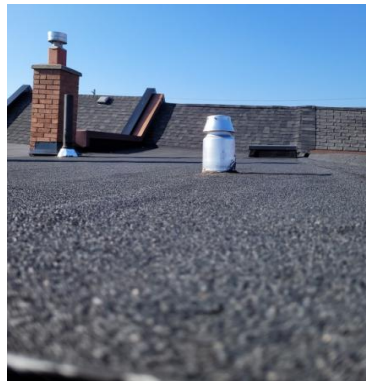
Flat Surface: [new surface in good repair](#)

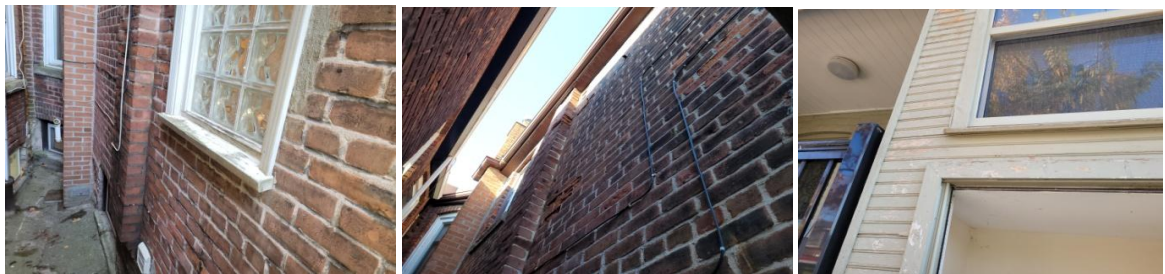
DOORS/WINDOWS: general painting maintenance to wood components

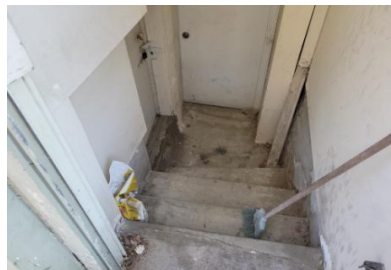
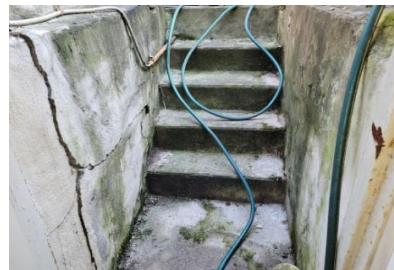
****BASEMENT WALKOUT:** front: install handrails, service landing drain annually
rear: wall movement cracks, budget to repair

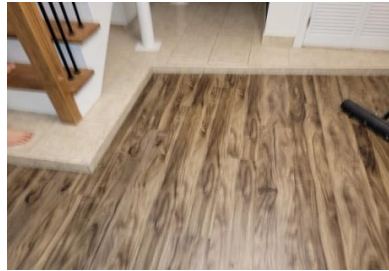
FOOTINGS/FOUNDATIONS basement floor has been lowered

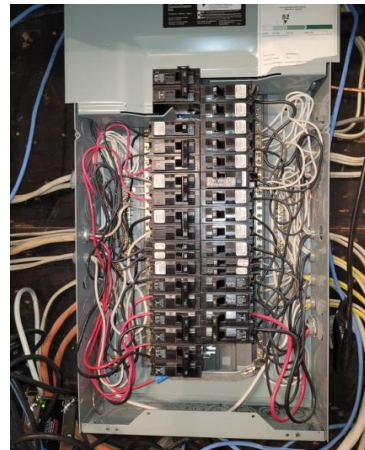
SERVICE PANEL: overall in good repair

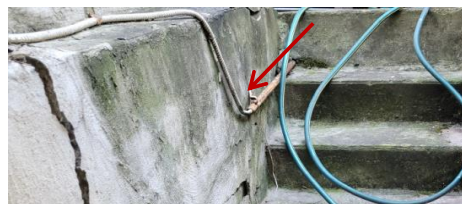
BRANCH WIRING: random sampling determined the wiring has been upgraded throughout
 Comments: rear walkout: wire/conduit poor location - prone to damage

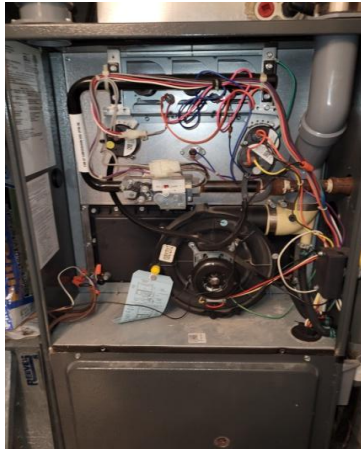
FORCED AIR FURNACE: [service annually, noisy draft fan](#)
[recommend obtaining replacement parts/servicing contract](#)

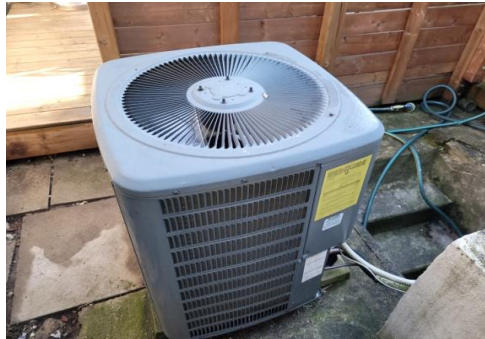
AIR CONDITIONER: [service annually](#)
[recommend obtaining replacement parts/servicing contract](#)

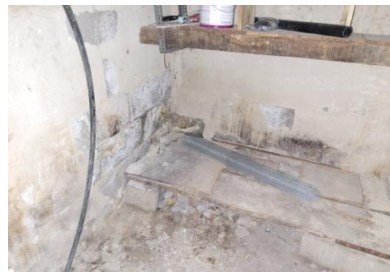
**Basement Leakage: presently no leaking detected with moisture meter random sampling along dry walled areas
 front exterior storage room: typical efflorescence, staining and dampness, some mouldy areas can be cleaned and treated

** Steps recommended in order to minimize basement leakage

1. gutters, downspouts, grading, driveways: ongoing maintenance and repair/see Exterior
2. cracks/form ties on foundation: monitor/repair as required
3. excavation/damp-proofing: monitor basement, consider step 3 as a last resort
