HOME INSPECTION REPORT

9 Alhambra Ave

Toronto

Inspection Date: Nov 16 2022

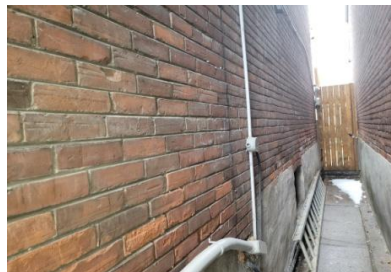
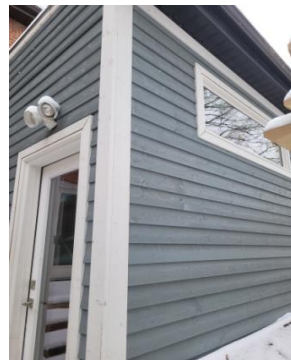
WALL SURFACES: overall in good repair
DOORS/WINDOWS: overall in good repair

DETACHED GARAGE: overall well built, exterior wall maintenance required and recommend installing gutters/downspouts

****Walk(s):** low area at southwest corner - repair and grade away from wall

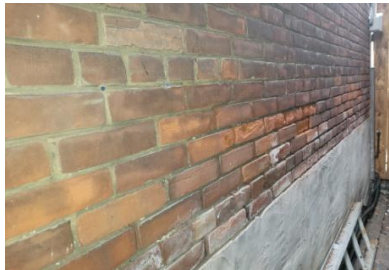
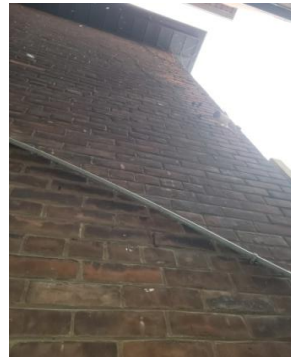
Masonry: exterior walls typical surface spalling, monitor and repair as required

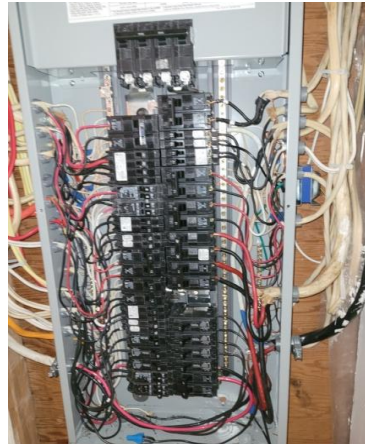
SERVICE ENTRANCE: **overall in good repair**
 SERVICE PANEL: **overall in good repair**

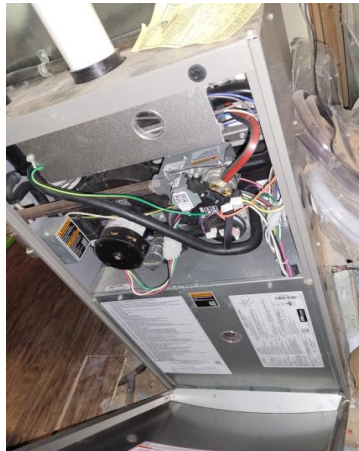
FORCED AIR FURNACE: [service annually](#)

Comments: [portable supplemental heater noted in 3rd level,](#)
[recommend installing fixed heater i.e. electric baseboard](#)

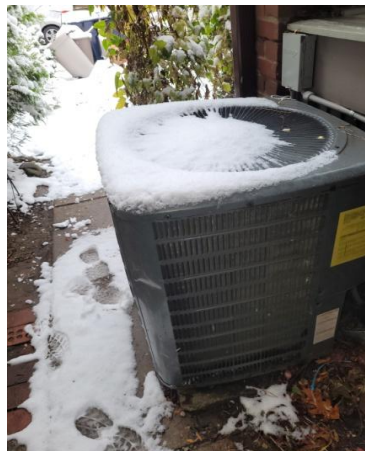
AIR CONDITIONER: not tested: should be serviced before using
aging unit, continue servicing until replacement becomes necessary

Comments: 3rd level typically more difficult to cool- portable supplemental unit
in use, recommend budget for wall mounted ductless unit
