HOME INSPECTION REPORT

38 Pearson Ave
Toronto

Prepared by: Bob Papadopoulos P.Eng., RHI *

Inspection Date: Jan 25 2023

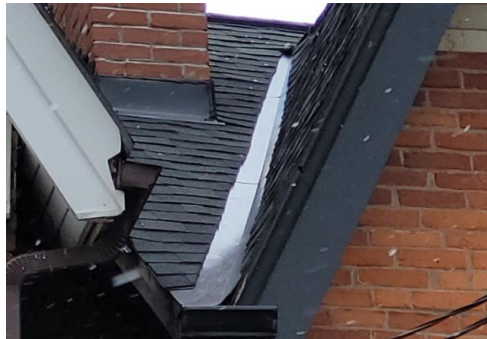
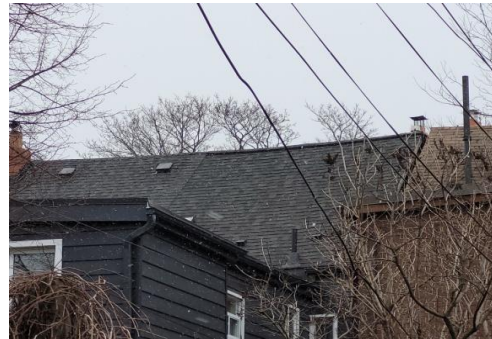
Sloped Surface: [overall surface in good repair](#)

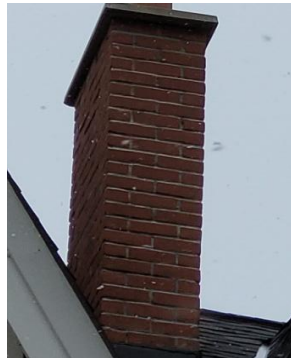
Chimney: [rebuilt and in good repair](#)

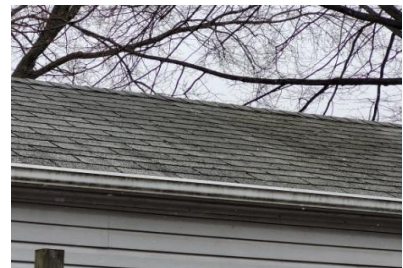
Garage(s): [aging shingles - budget to replace within 5-yrs](#)

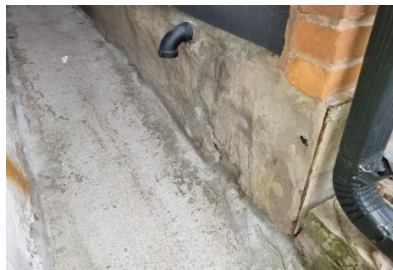
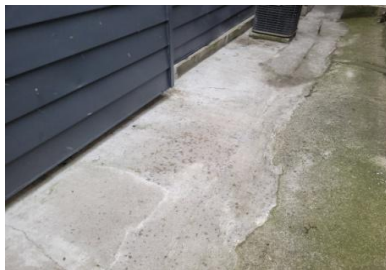
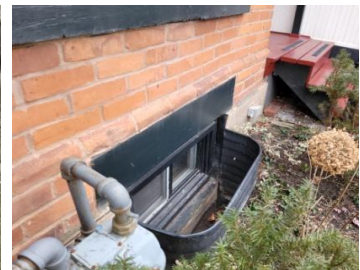
- DETACHED GARAGE:** well built detached garage, monitor tree near structure
- PORCH:** overall in good repair
- DECK:** older, continue to service floor boards

- **Walk(s): overall in good repair
- **Window Well: recommend cover

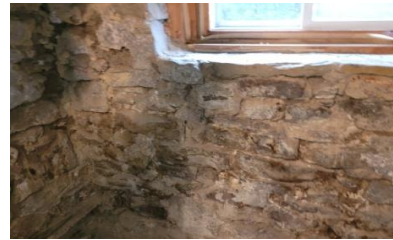
FOUNDATIONS: stone: repair mortar as required

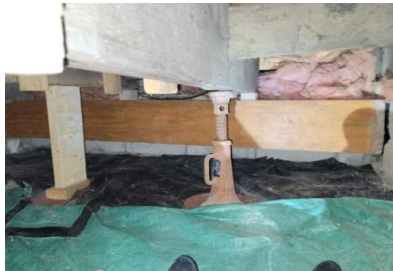
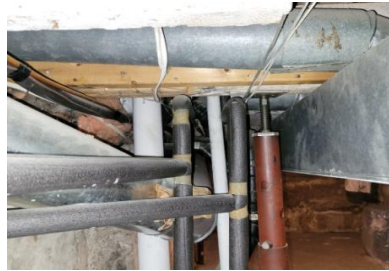
Termites: evidence of past termite treatment, contact specialist for ongoing monitoring, re-treatment might be required in future

FLOORS: basement/crawlspace shored up in some areas, overall performance is adequate, basement: if renovating will require structural engineer to evaluate and improve, continue to monitor

Wood Beam: minor termite damage- old, see above

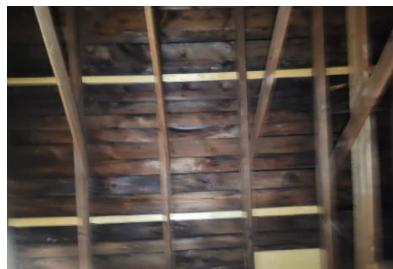
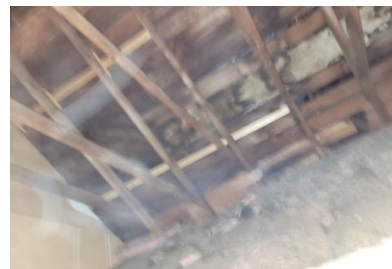
ROOF: overall in good repair, typical staining for older house at under side, sheathing has been in stalled older over planks when roof was re-shingled

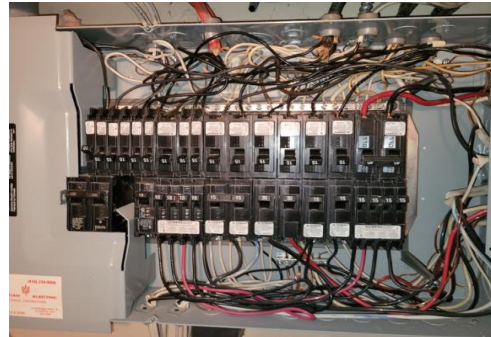
SERVICE ENTRANCE: **overall in good repair**
 SERVICE PANEL: **overall in good repair**

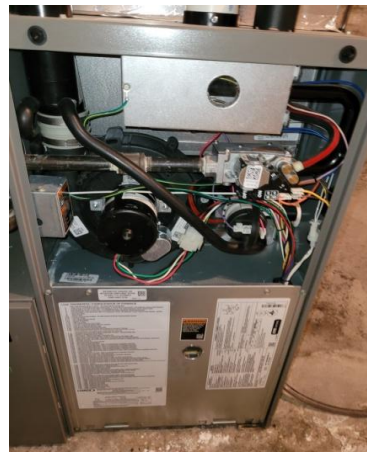
FORCED AIR FURNACE: [service annually](#)

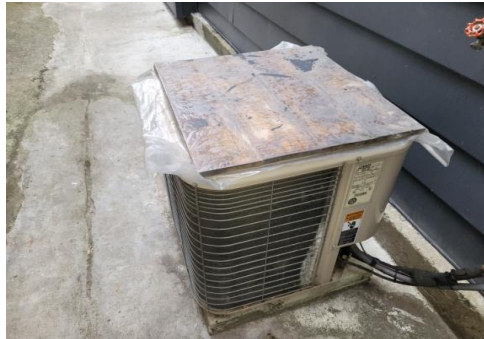
HEAT PUMP: [not tested: should be serviced before using old unit, continue servicing until replacement becomes necessary](#)

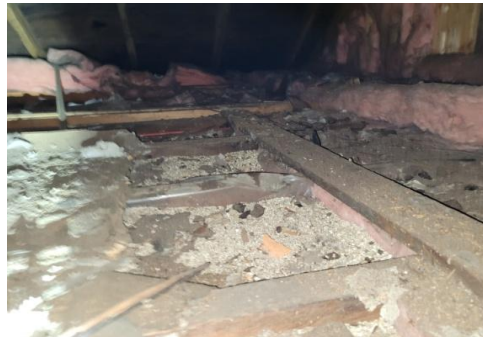
Vermiculite Insulation: insulation contains traces of asbestos - refer to Report by
 Envirosolve Canada February 7, 2023
 encapsulating the insulation is often the best approach
 Environmental Consultants can assist if this is a concern
