HOME INSPECTION REPORT

23 Silver Ave
Toronto

Prepared by: Bob Papadopoulos P.Eng., RHI *

Inspection Date: [March 22 2023](#)

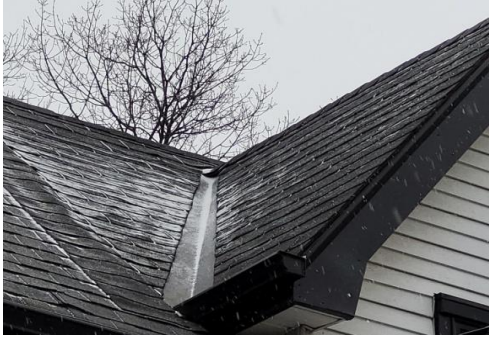
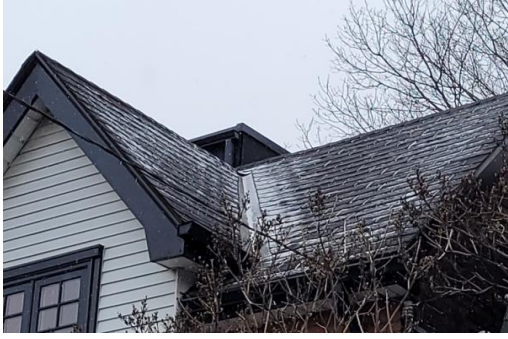
REFERENCE LINK		http://redbrickinspections.ca/docs/2_Roofing_Reference_Guide.pdf		
23 Silver Ave		ROOFING/Chimneys		March 22 2023
Description				
Roofing Material:	Location:	Leakage Probability:	Chimney(s) Type:	Location:
Asphalt Shingles:	Slope:	Medium	Brick:	Northwest
Modified Bitumen:	Flat:	Medium		
Limitations				
Roof Inspected By:	Access Limited By:	Chimney Access Limited By:		
Binoculars	Height Snow	Height		
Observations/Recommendations				
Tree Branches: retain arbourist for annual monitoring/trimming				
Sloped Surface: aging surface, budget to replace within 5 to 10-yrs.

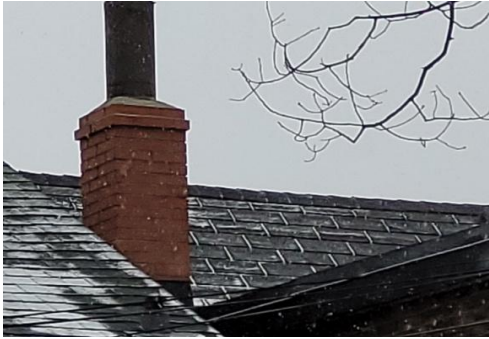
Flat Surface: not accessible - reported to be approximately 15 yrs old typical life expectancy over 20 yrs				
Chimney(s): overall in good repair

Note: Recommend Annual Maintenance Contract for Roof Surface, Flashing Details and Chimney(s)

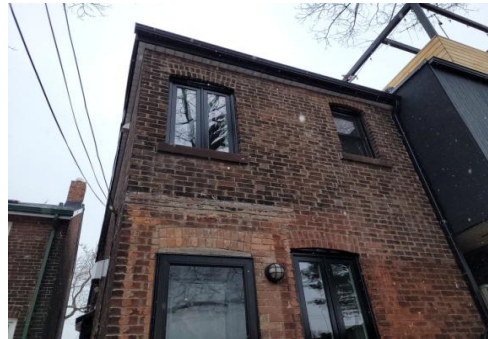
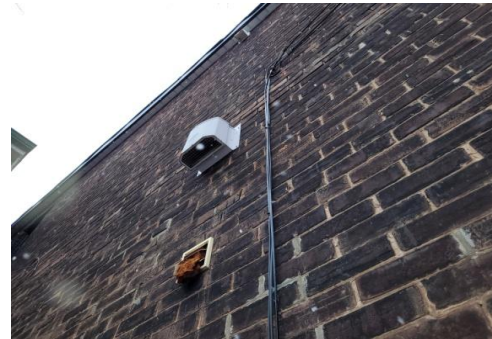
** Downspouts: extend 6-ft away from house

WALL SURFACES: overall in good repair

DOORS/WINDOWS: overall in good repair

Note: Maintain Gutters & Downspouts annually. Extend Downspouts at least 6-feet away from the house

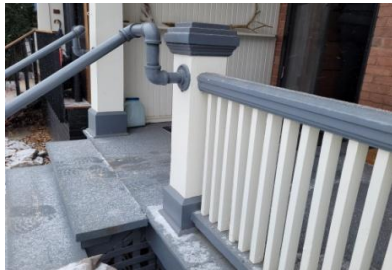
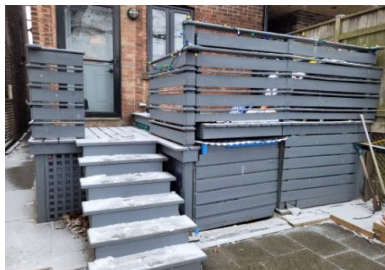
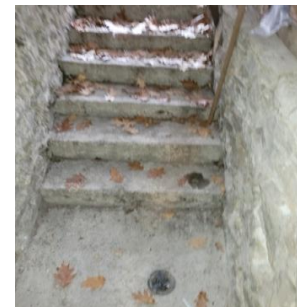
PORCH overall in good repair

DECK overall in good repair, spindles should be vertical for safety/rails for steps

**BASEMENT WALKOUT: overall well built, should have hand rails for steps

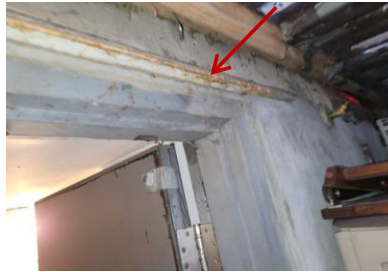
Metal Lintel: basement walkout: paint lintel

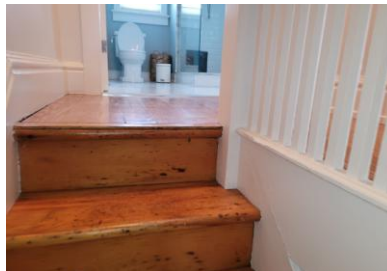
Stair Opening: minor sagging around stair areas though typical for older house

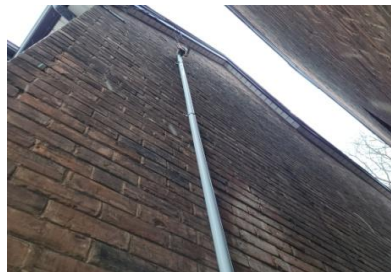
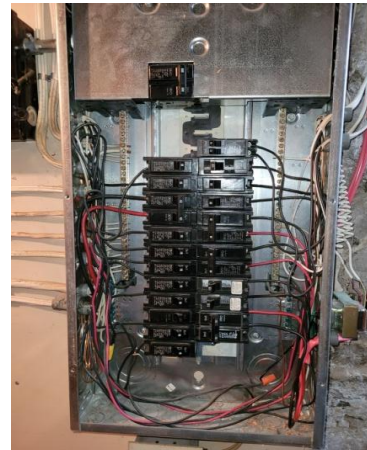
SERVICE ENTRANCE: overall in good repair

SERVICE PANEL: overall in good repair

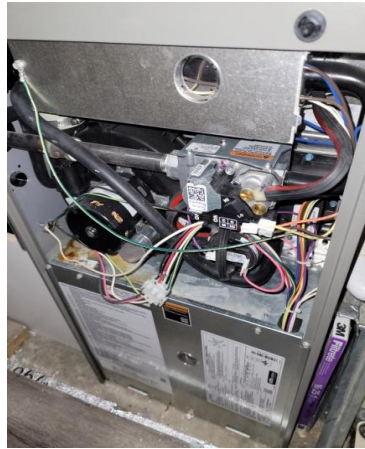
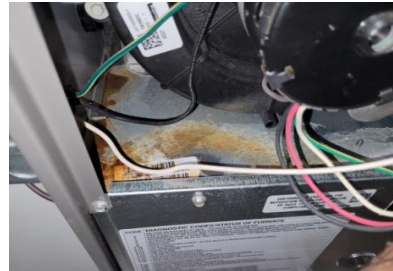
FORCED AIR FURNACE: [service annually](#)
[minor condensate leak/rust requires servicing](#)

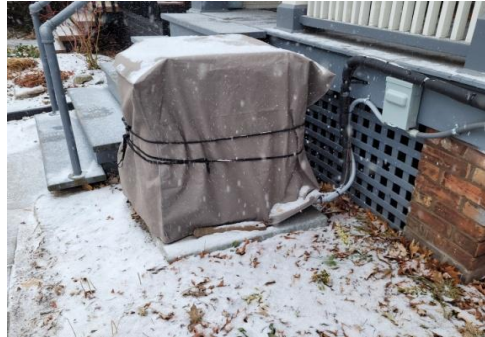
AIR CONDITIONER: not tested: should be serviced before using
