HOME INSPECTION REPORT

566 Indian Rd
Toronto

Prepared by: Bob Papadopoulos P.Eng., RHI *

Inspection Date: March 14 2023

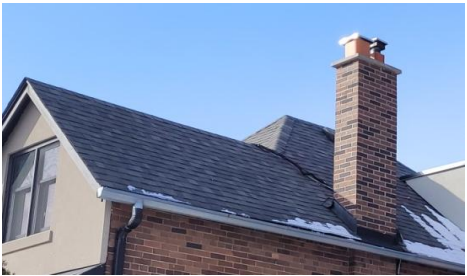
REFERENCE LINK		http://redbrickinspections.ca/docs/2_Roofing_Reference_Guide.pdf		
566 Indian Rd		ROOFING/Chimneys		March 14 2023
Description				
Roofing Material:	Location:	Leakage Probability:	Chimney(s) Type:	Location:
Asphalt Shingles:	Slope:	Low	Brick:	North
Not Determined	Flat:	Low new		
Asphalt Shingles:	Garage:	Medium		
Limitations				
Roof Inspected By:	Access Limited By:	Chimney Access Limited By:		
Binoculars	Height			
From Edge	Snow			
Observations/Recommendations				
Tree Branches: retain arbourist for annual monitoring/trimming				
Sloped Surface: overall surface in good repair				
Chimney(s): rebuilt and in good repair

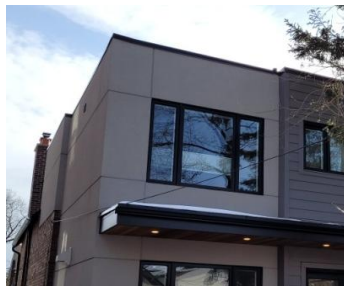
Flat Surface: could not access, newly built extension

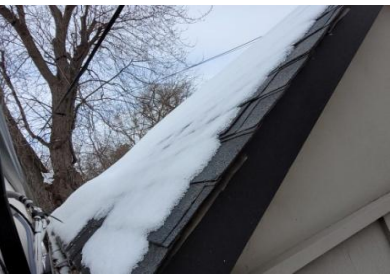
Garage: overall surface in good repair

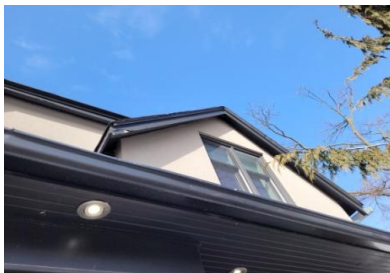
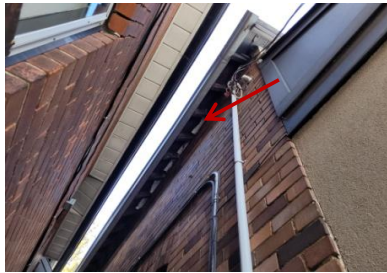
****Gutters/Downspouts:** requires maintenance/cleaning, some older gutters, recommend installing for garage

WALL SURFACES: overall in good repair, install caulking to stucco/brick seams
Soffit & Fascia: requires maintenance/cleaning, budget to cap with metal on south side gaps

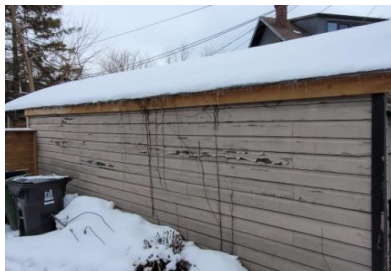
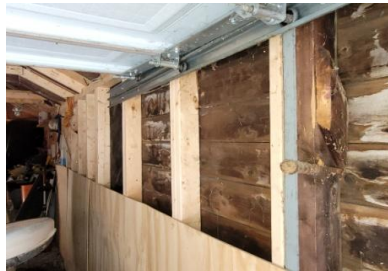
DETACHED GARAGE: older though some improvements to structure, typically ongoing repairs

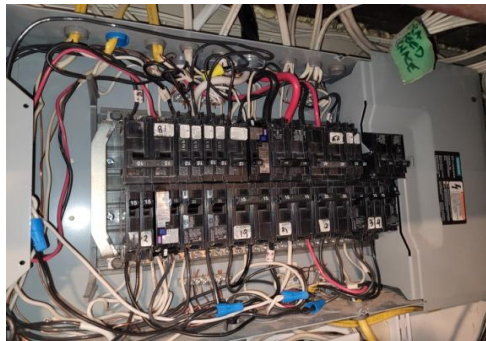
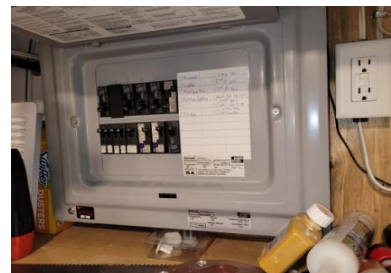
SERVICE ENTRANCE: overall in good repair
 SERVICE PANEL: overall in good repair
 Auxiliary Panel: overall in good repair, recent installation

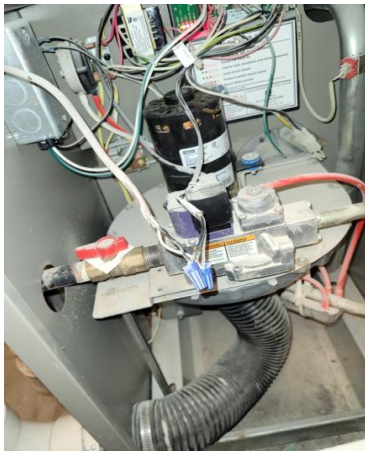
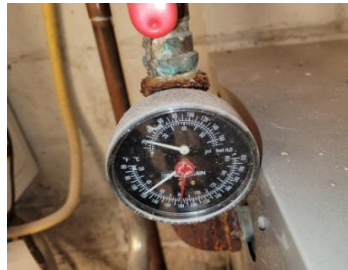
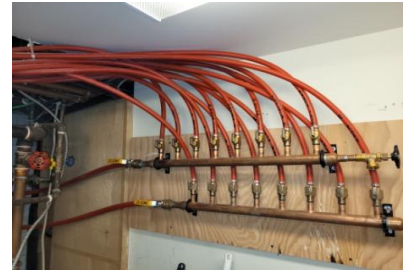
Comments: some components rusting- repair/replace as required

Piping: all piping/manifolds examined were in good repair

HOT WATER BOILER: service annually

recommend obtaining replacement parts/servicing contract

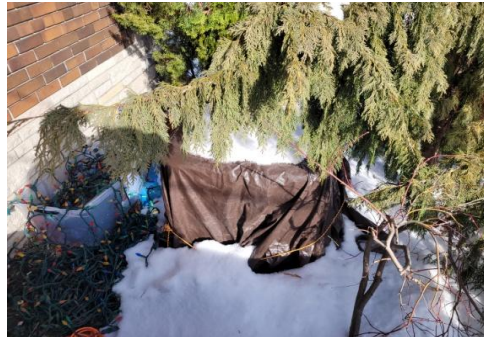
AIR CONDITIONER: [not tested: should be serviced before using](#)
[recommend obtaining replacement parts/servicing contract](#)

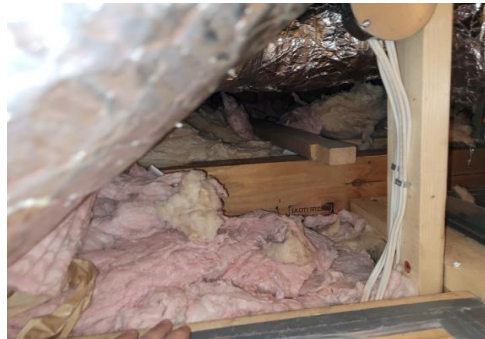
ROOF SPACE: uneven distribution of insulation - improve/add insulation

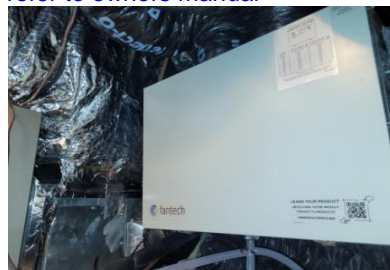
Heat Recover Ventilator: service annually
 refer to owners manual
