HOME INSPECTION REPORT

179 Indian Rd
Toronto

Prepared by: Bob Papadopoulos P.Eng., RHI *

Inspection Date: May 25 2023

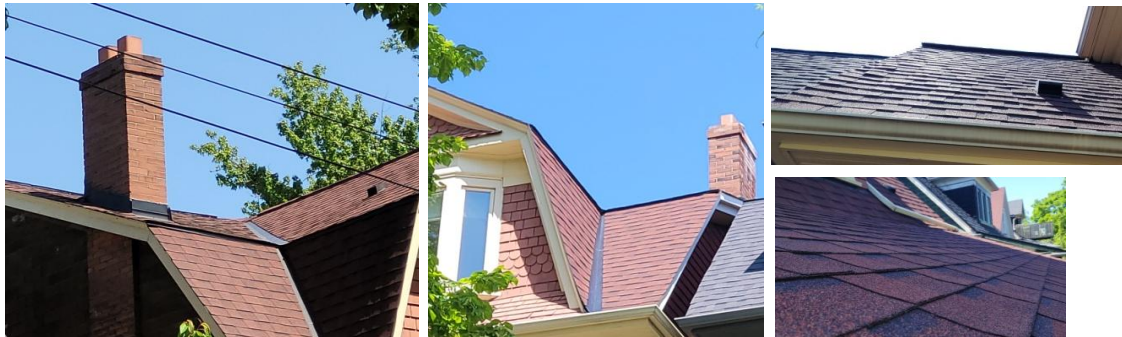
Sloped Surface: [overall surface in good repair, reported to be 10-yr-old asphalt shingles with a typical life expectancy of 20-yrs.](#)

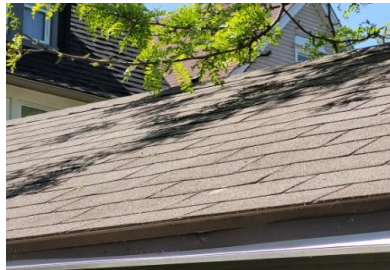
Porch(s): [overall surface in good repair](#)

Garage: [overall surface in good repair](#)

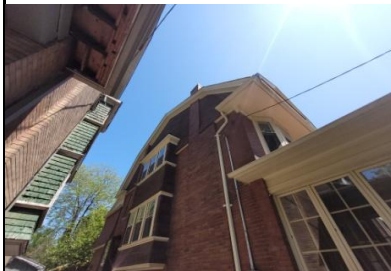
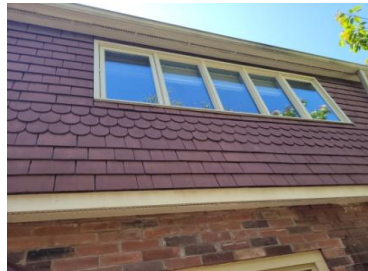
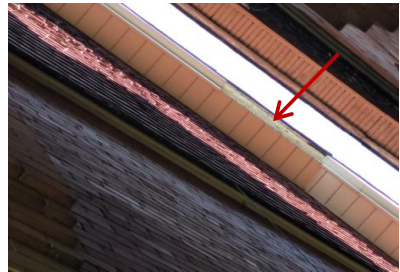
**Gutters/Downspouts: requires maintenance/cleaning
 **Walk(s): overall in good repair
 **Driveway(s): budget for repairs /re-surfacing
 WALL SURFACES:
 Brick: overall in good repair
 Wood Shingles: overall in good repair
 DOORS/WINDOWS: overall in good repair
 Soffit & Fascia: overall in good repair, budget for general maintenance/painting
 missing flashing on south side- minor

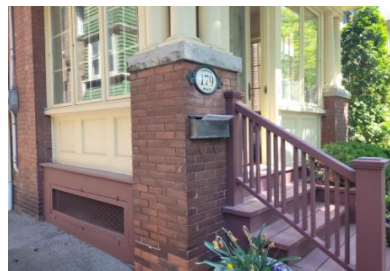
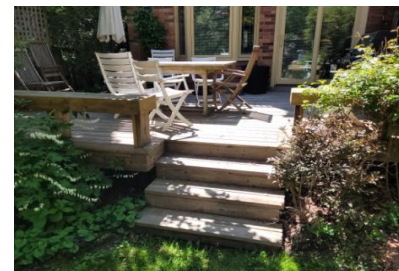
PORCH overall in good repair
 DECK lower and upper overall in good repair
 DETACHED GARAGE: older, typically ongoing repairs, wood plank floor over ground
 may become more cost effective to replace
 bottom perimeter prone to rot - repair as required, budget to repair perimeter

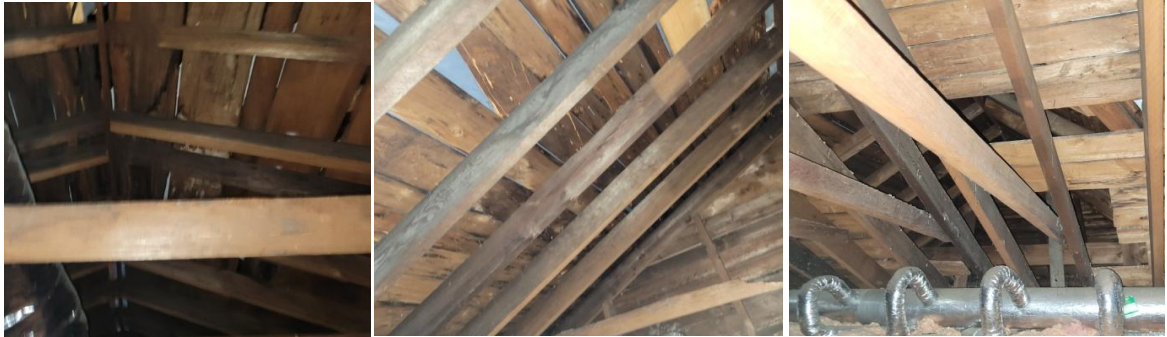
overall well built house

ROOF: overall in good repair

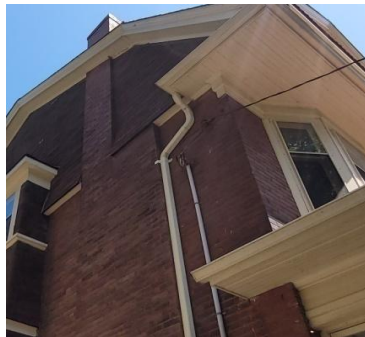
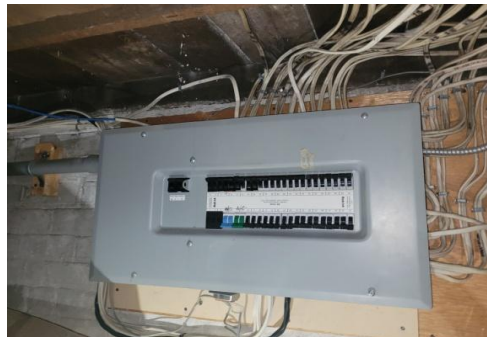
SERVICE ENTRANCE: **overall in good repair**

SERVICE PANEL: **overall in good repair**

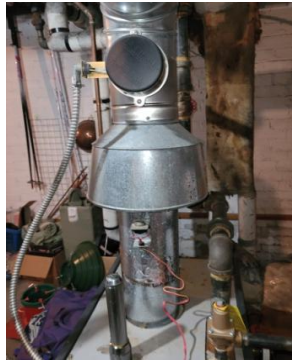
HOT WATER BOILER: service annually
continue servicing until replacement becomes necessary
annual CO test mandatory for this type of unit
reported that unit has been serviced annually
recommend obtaining replacement parts/servicing contract

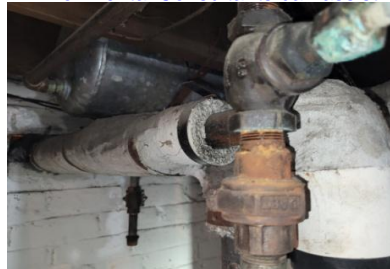
Piping: insulation on various heating pipes may contain asbestos
encapsulating the insulation is often the best approach
Environmental Consultants can assist if this is a concern

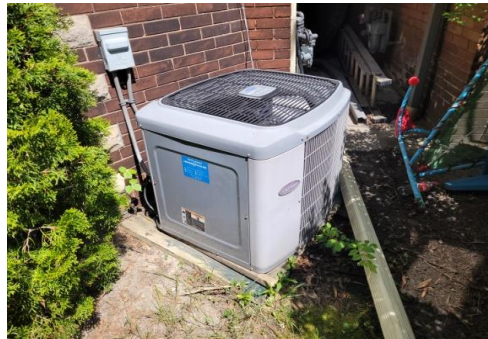
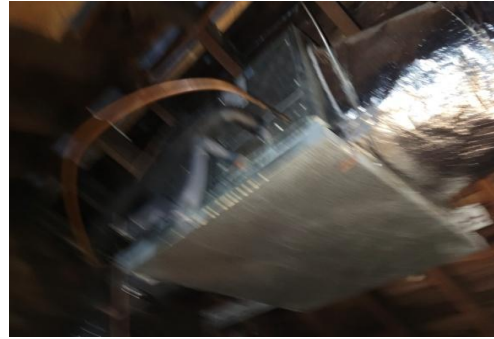
AIR CONDITIONER: old unit, continue servicing until replacement becomes necessary
consider replacing with new unit for improved efficiency

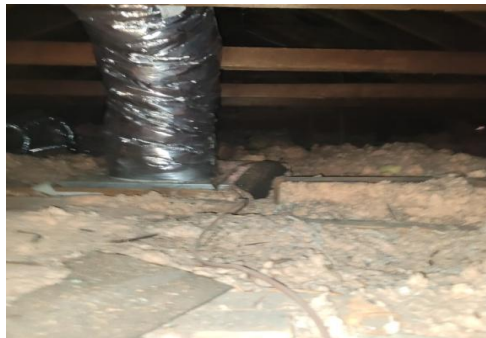
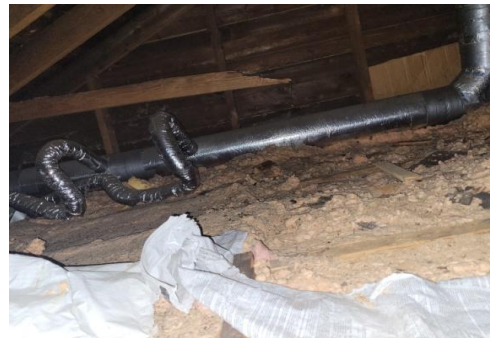
ROOF SPACE: recommend upgrading insulation to improve comfort and efficiency
recommend improving ventilation with soffit vents
Roof Access Hatch: insulate and weather-strip access hatch to roof space
