HOME INSPECTION REPORT

7 Cowan Ave
Toronto

Prepared by: Bob Papadopoulos P.Eng., RHI *

Inspection Date: April 18 2023

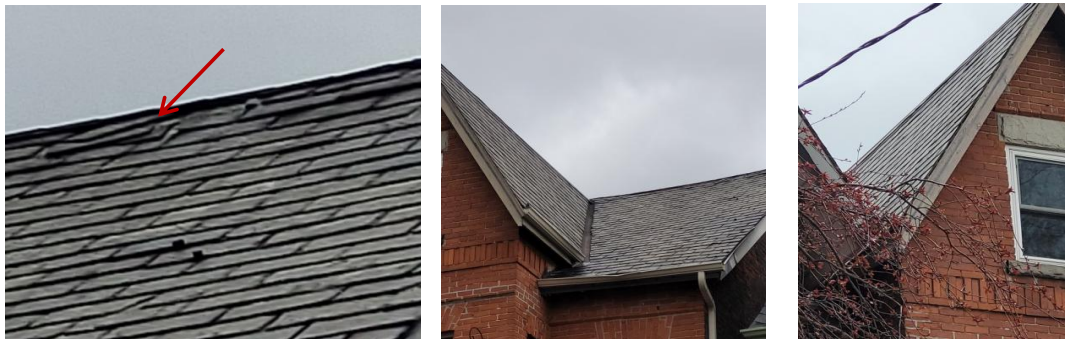
West Slope: overall in good repair, some loose shingles-repair, annual maintenance

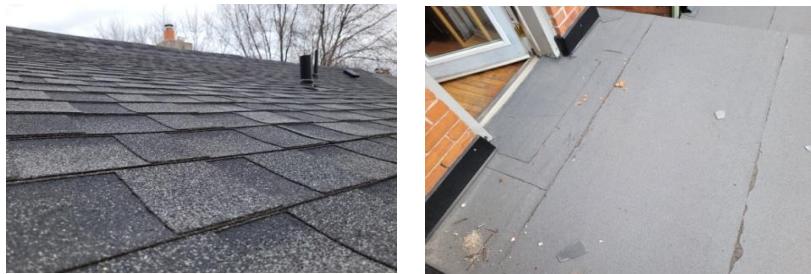
East Slope: overall surface in good repair
Porch(s): overall surface in good repair, door requires rail for safety

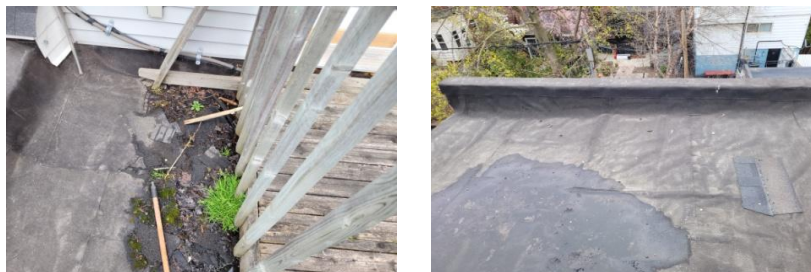
Flat Surface: older, pooling, requires cleaning, continue to maintain, budget to replace including old deck

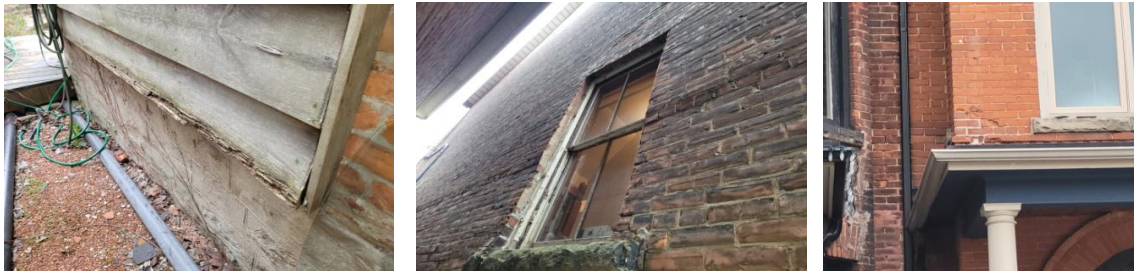
Soffit & Fascia: front: require general repairs and maintenance

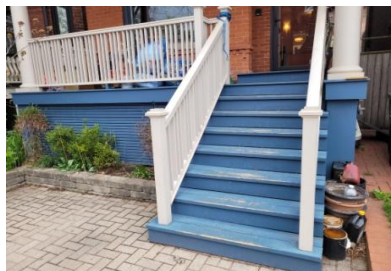
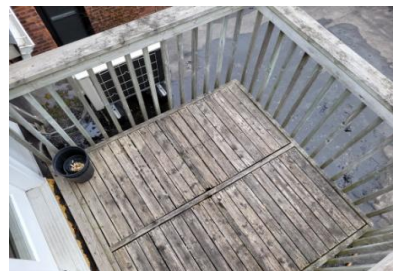
PORCH rebuilt/restored in good repair, paint as required

DECK old, budget to replace

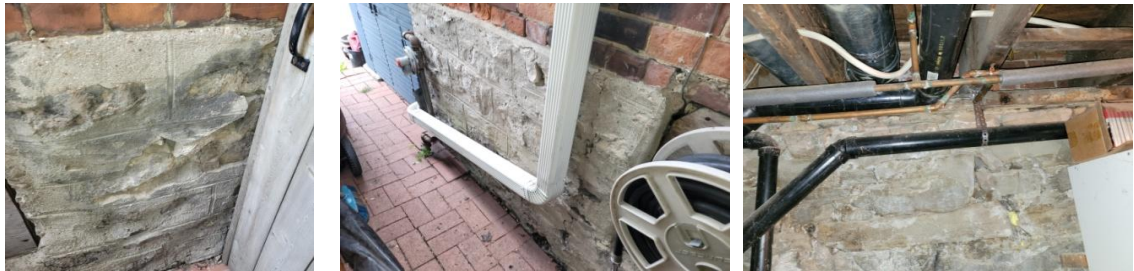
FOUNDATIONS: overall in good repair
older foundation typical to repair mortar as required

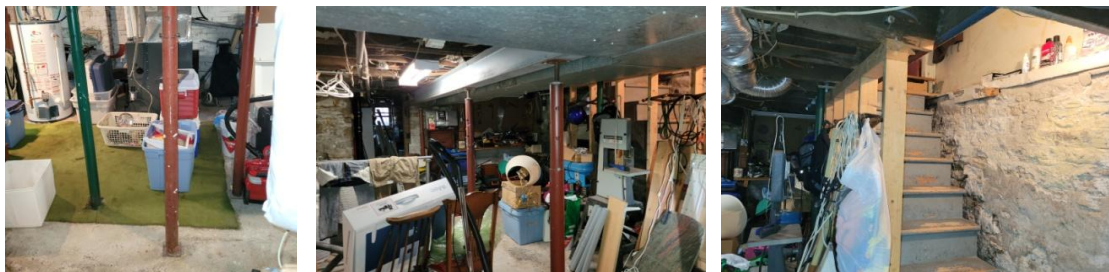
Stair Opening: minor sagging around stair areas though typical for older house
basement steps have been shored up with wood framing

FLOORS: main floor: shored up with steel beams and metal posts

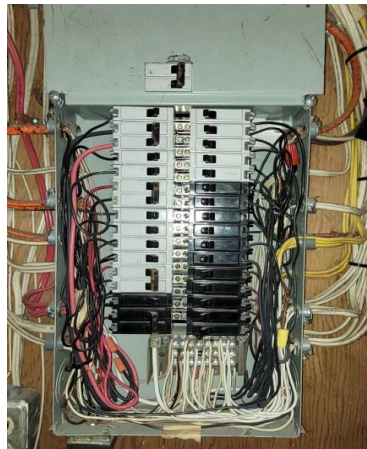
SERVICE ENTRANCE: overall in good repair
 SERVICE PANEL: crowded, double taps (two wires connect to one breaker), install larger panel if required/renovating

Note 1: All recommendations are safety issues - Treat them as high priority.

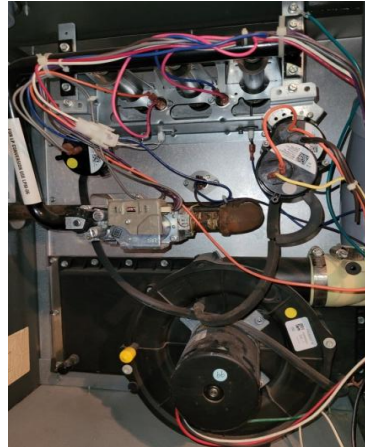
FORCED AIR FURNACE: [service annually](#)
[recommend obtaining replacement parts/servicing contract](#)
 Filter: [replace 1-per-3 months](#)

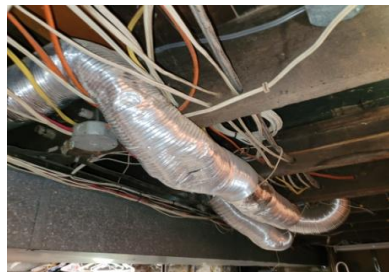
Ducts: [basement: some units \(flexible\) lower quality,](#)
[consider replacing, one unit disconnected rear of basement](#)

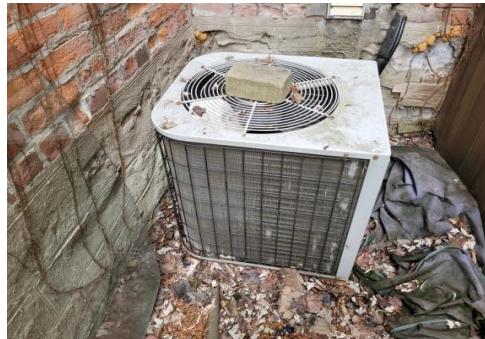
AIR CONDITIONER: old unit, continue servicing until replacement becomes necessary consider replacing with new unit for improved efficiency

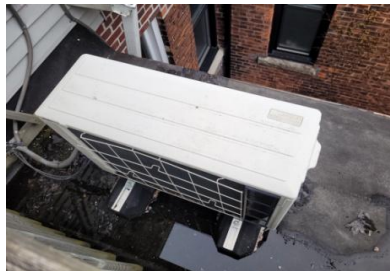
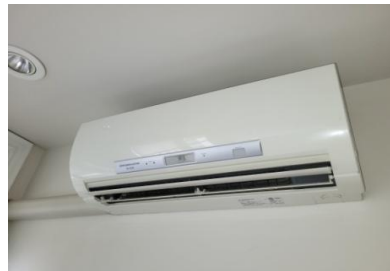
HEAT PUMP: 3rd level ductless: service annually

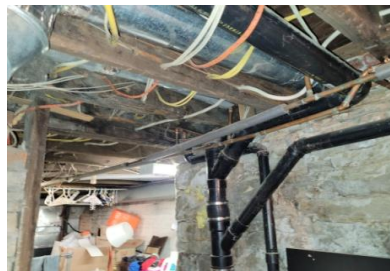
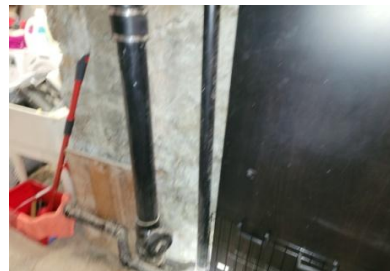
Basement Floor Drain: basement floor drain not found, further evaluation required
