HOME INSPECTION REPORT

87 Rushholme Rd

Toronto

Inspection Date: June 20 2023

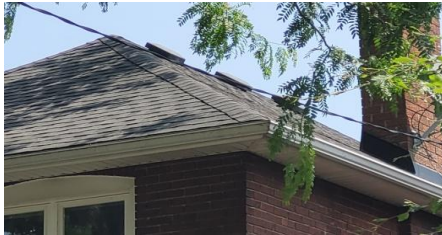
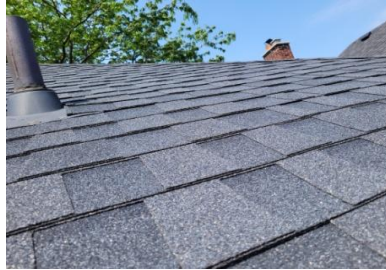
Sloped Surface: [overall surface in good repair](#)
 2nd Slope: [overall surface in good repair](#)

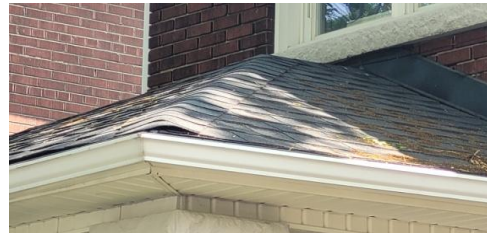
Porch(s): [overall surface in good repair](#)

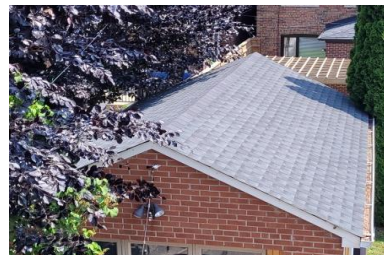
Garage: Studio: [overall surface in good repair](#)

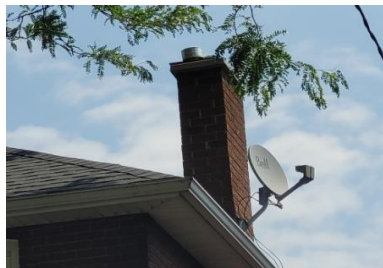
Chimney(s): [overall in good repair](#)

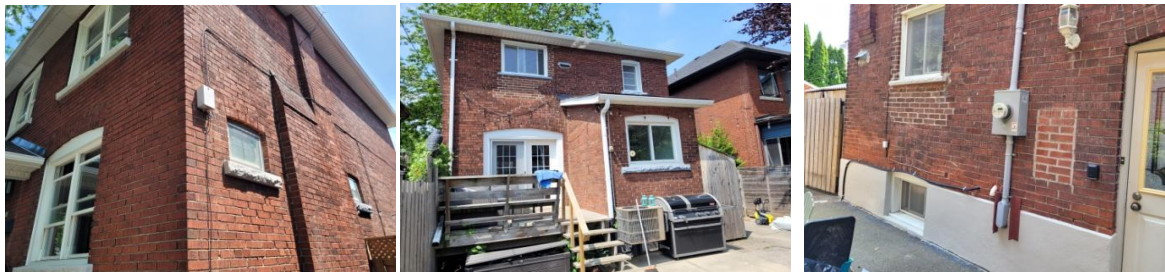
**Walk(s)/Driveway(s): continue to seal gaps along wall
 budget to re-surface driveway

WALL SURFACES: overall in good repair

DOORS/WINDOWS: overall in good repair

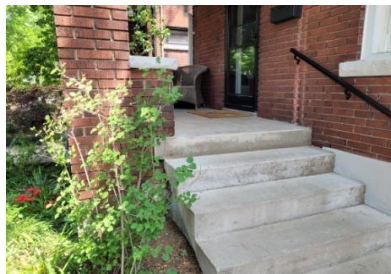
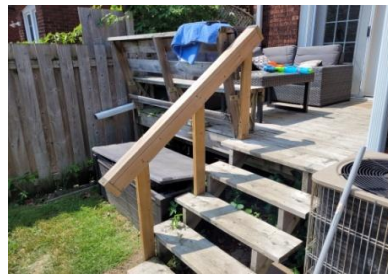
PORCH overall in good repair
 DECK overall in good repair

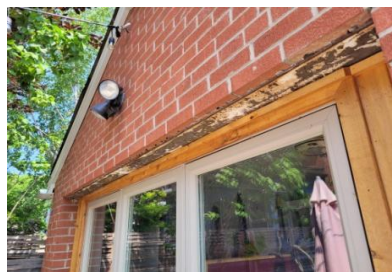
STRUCTURES overall well built detached Studio, wood components require general maintenance, paint metal lintel

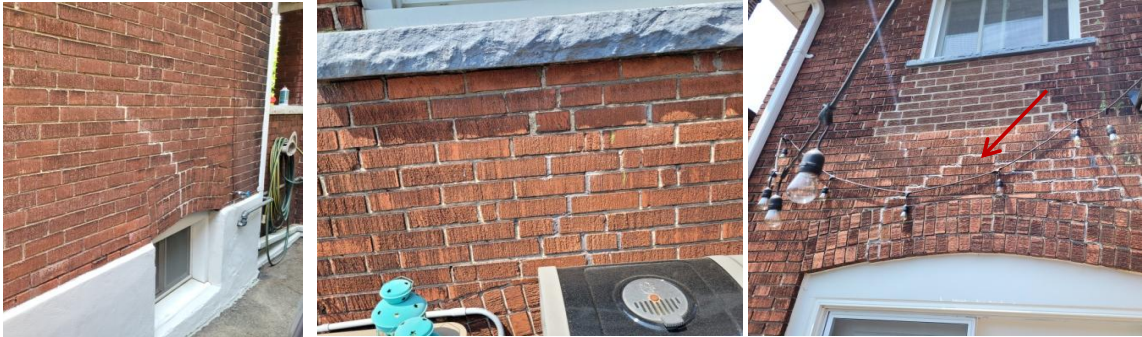
WALLS: typical settlement cracks and repairs
Masonry Arches: rear door: typical settlement cracks - repair with mortar

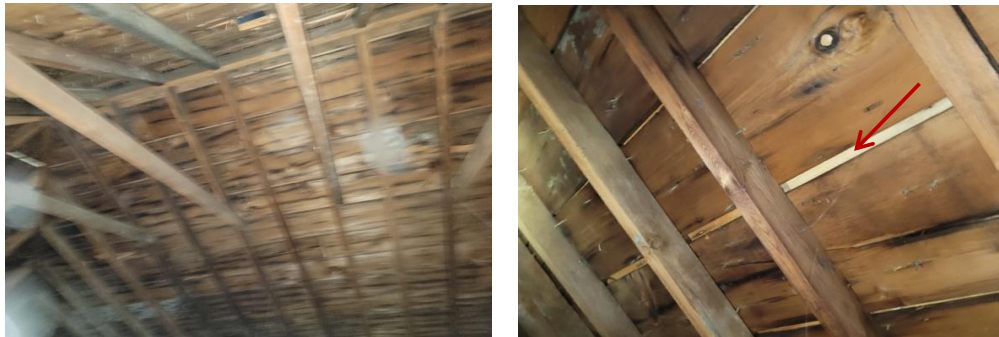
ROOF: overall in good repair
Roof Sheathing: new sheathing was installed over older planks which is above average

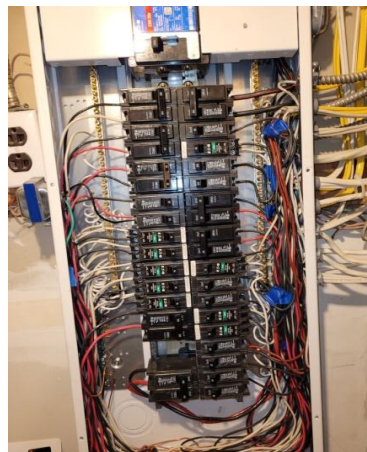
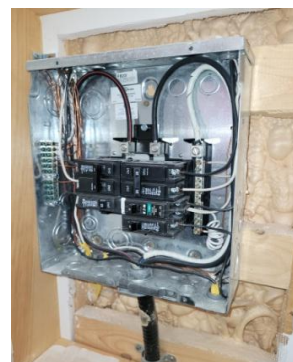
SERVICE ENTRANCE: overall in good repair

SERVICE PANEL: overall in good repair

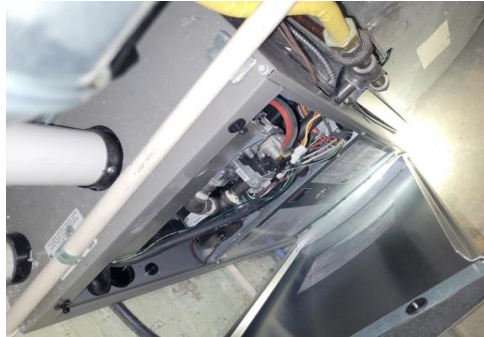
FORCED AIR FURNACE: [service annually](#)
Filter: [replace 1-per-3 months](#)

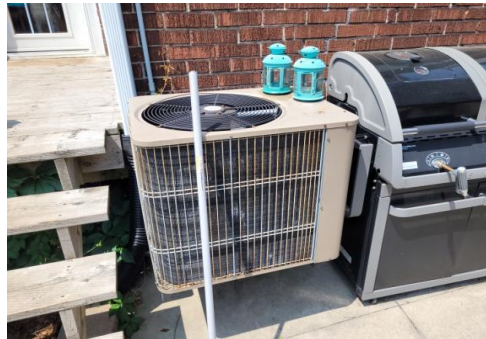
AIR CONDITIONER: **old unit, continue servicing until replacement becomes necessary**

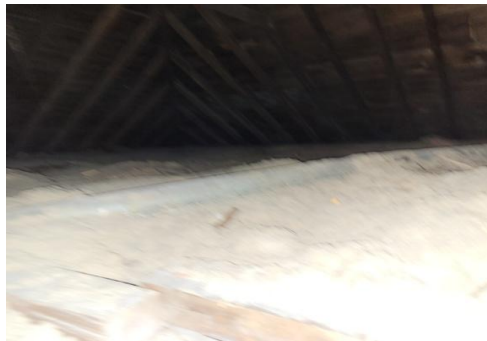
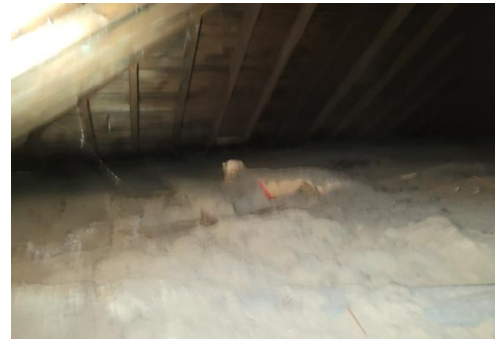
ROOF SPACE: recommend upgrading insulation to improve comfort and efficiency
recommend improving ventilation with soffit vents
insulate and weather-strip access hatch to roof space

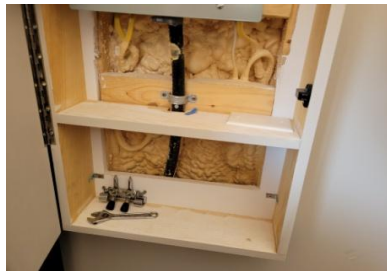
Comments: spray foam observed in walls of Detached Studio
