HOME INSPECTION REPORT

279 Margueretta St
Toronto

Prepared for: High Park Realty

Inspection Date: July 19 2023

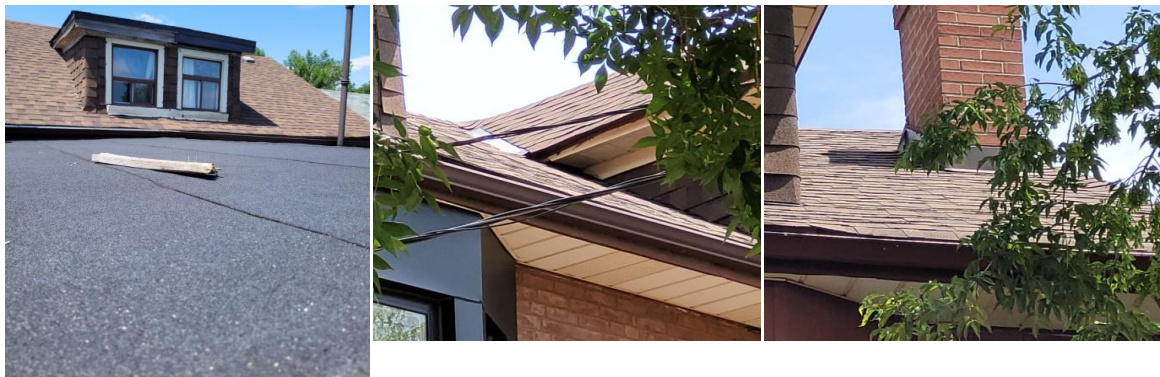
Sloped Surface: overall surface in good repair
 Flat Surface: overall surface in good repair
 Porch(s): overall surface in good repair

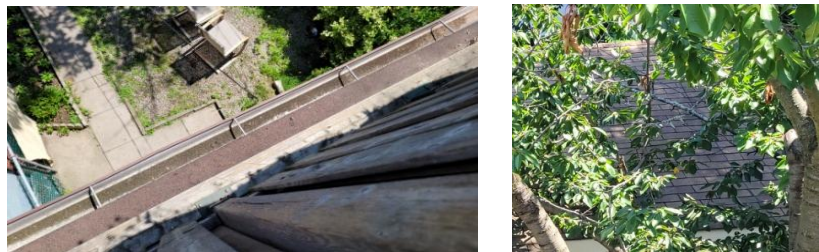
Garage: overall in good repair
 Deck: overall in good repair where visible

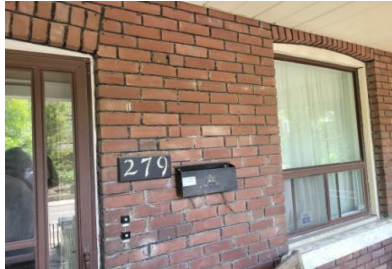
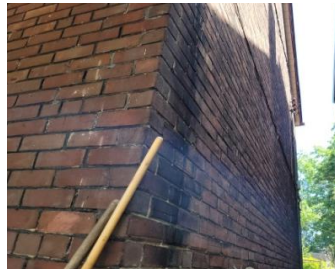
Soffit & Fascia: some requires general maintenance

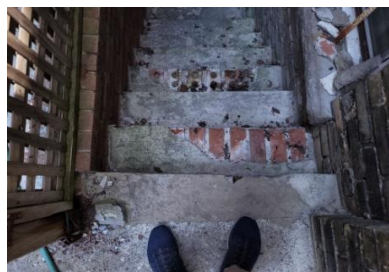
****BASEMENT WALKOUT:** requires hand rails, step repairs required, service drain

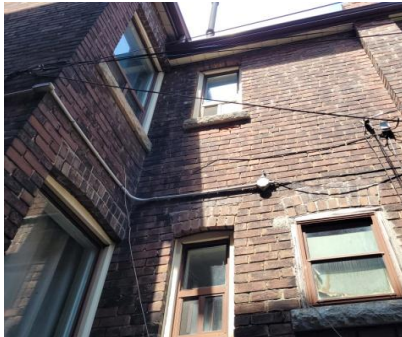
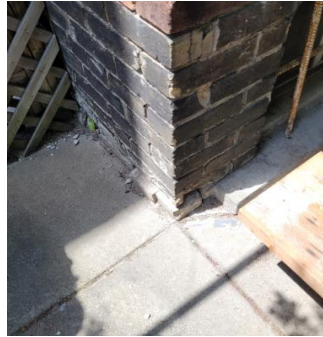
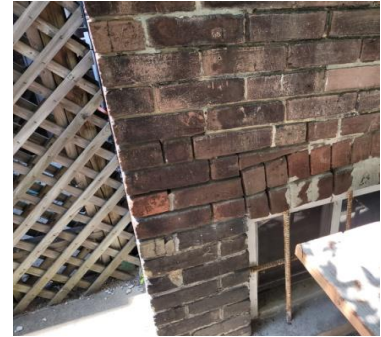
Masonry: overall in good repair, general repairs in some areas

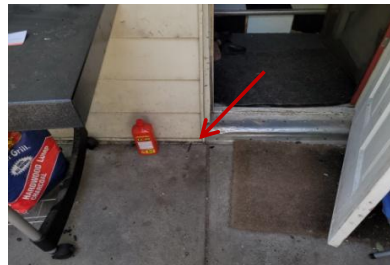
FLOORS: rear extension under steps, frame/sill near/below grade prone to moisture damage, presently no signs of damage though limited access, older wood post rot at base - replace

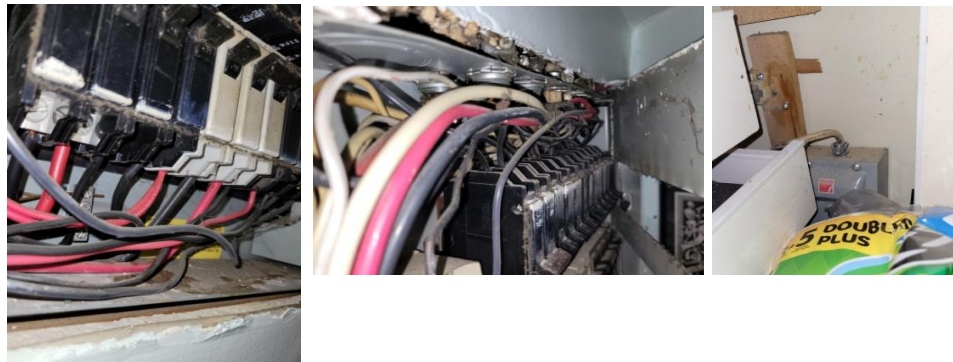
SERVICE PANEL: **crowded, install larger panel if required/when renovating**

Auxiliary Panel: **under kitchen sink**

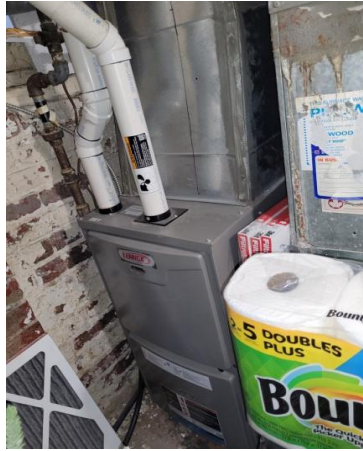
FORCED AIR FURNACE: [service annually](#)
[restricted access due to storage](#)
