HOME INSPECTION REPORT

14 Melbourne Ave

Toronto

Inspection Date: Aug 28 2023

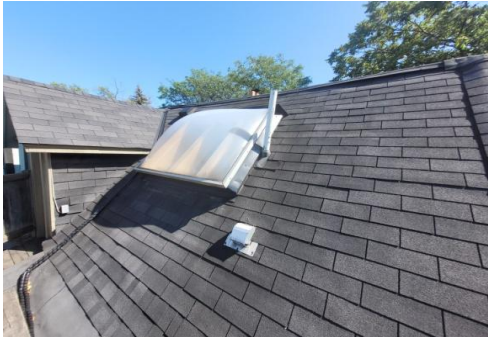
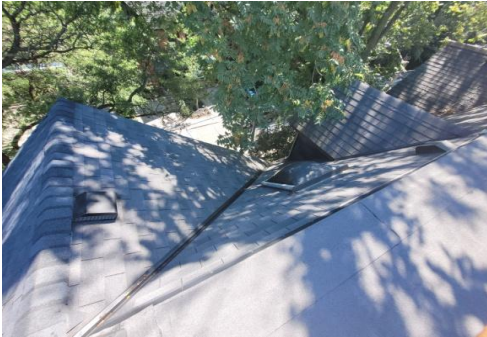
REFERENCE LINK		http://redbrickinspections.ca/docs/2_Roofing_Reference_Guide.pdf		
14 Melbourne Ave		ROOFING/Chimneys		Aug 28 2023
Description				
Roofing Material:	Location:	Leakage Probability:	Chimney(s) Type:	Location:
Asphalt Shingles:	Slope:	Medium	Brick:	Southeast
Modified Bitumen:	Upper Flat:	Low	Brick Abandoned:	North
Modified Bitumen:	Lower Flat:	Medium		
Limitations				
Roof Inspected By:	Access Limited By:	Chimney Access Limited By:		
Walking On	Deck			
Observations/Recommendations				
Tree Branches: retain arbourist for annual monitoring/trimming				
Sloped Surface: overall surface in good repair				
Skylight(s): older though overall in good repair

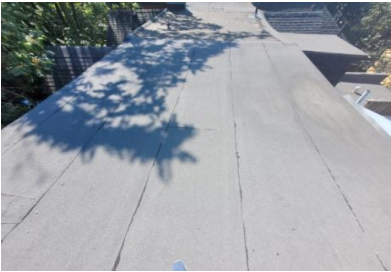
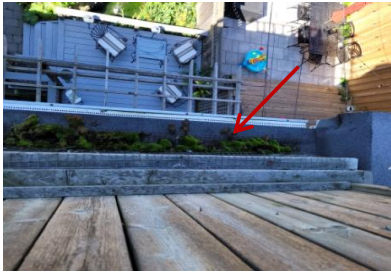
Upper Flat: overall in good repair				
Lower Flat: overall in good repair (deck), requires cleaning/maintenance

Chimney: overall in good repair				
install rain/screen cap to clay liner

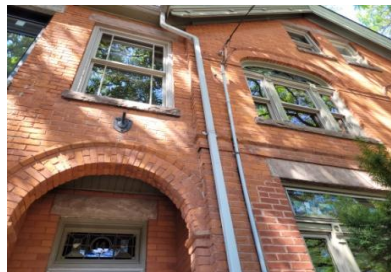
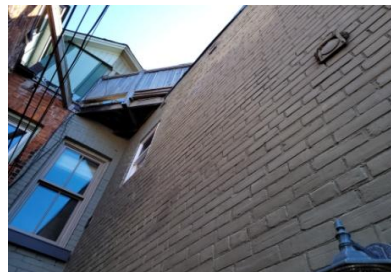
****Gutters/Downspouts:** requires maintenance/cleaning

Brick: overall in good repair

DOORS/WINDOWS: overall in good repair

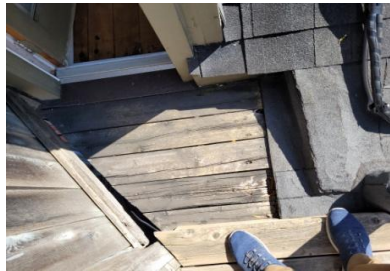
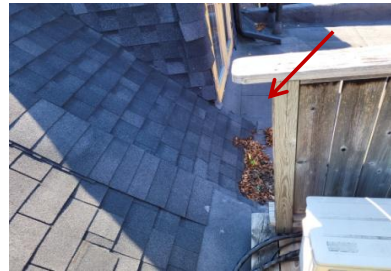
DECK upper deck: older, continue to monitor and repair, some floor boards at exit require replacement, extend railings at sloped roof for safety

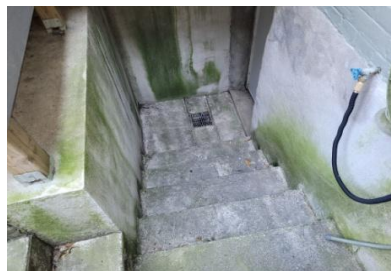
****BASEMENT WALKOUT:** overall in good repair, provide hand rails for safety

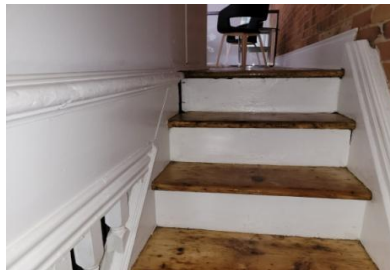
Stair Opening: minor sagging around stair areas though typical for older house

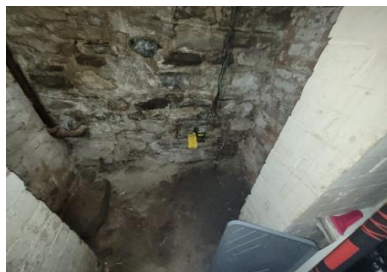
FOUNDATIONS: anticipate mortar repairs if renovating basement

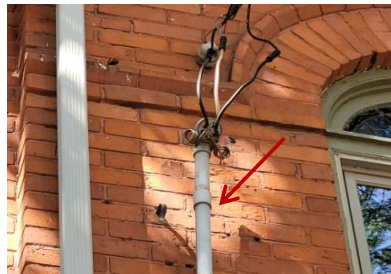
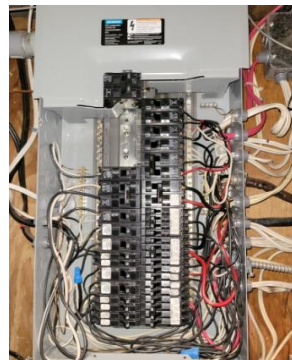
Mast: **loose, disconnected at top - contact utility to repair**

SERVICE PANEL: **overall in good repair**

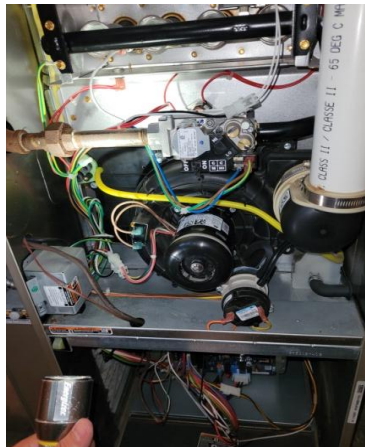
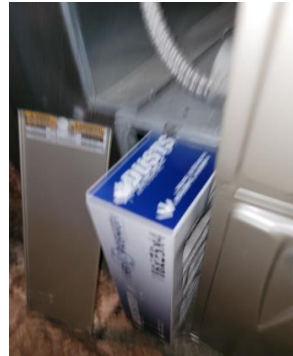
FORCED AIR FURNACE: [service annually](#)
[recommend obtaining replacement parts/servicing contract](#)
Filter: [replace 1-per-6 to 12 months](#)

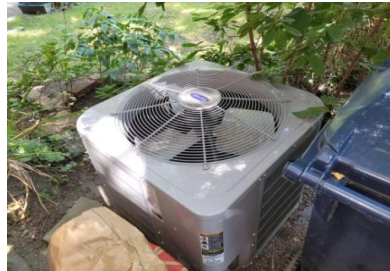
AIR CONDITIONER: [service annually](#)

Ductwork: [none in 2nd level washroom - provide if required](#)

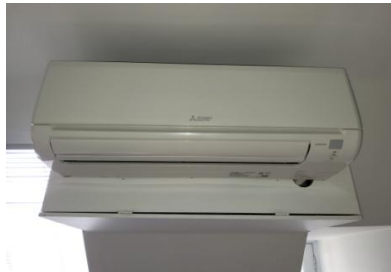
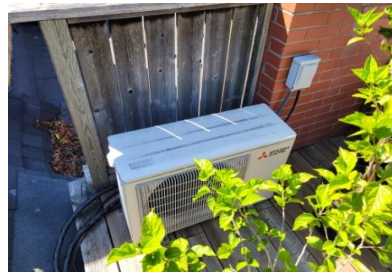
DUCTLESS HEAT PUMP: [3rd level, service annually](#)

[unit provides cooling and supplemental heating](#)
