# HOME INSPECTION REPORT

15 Fern Ave  
Toronto

Prepared by: Bob Papadopoulos P.Eng., RHI \*

Inspection Date: Aug 30 2023

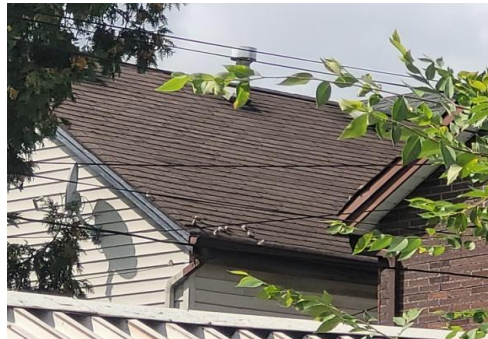
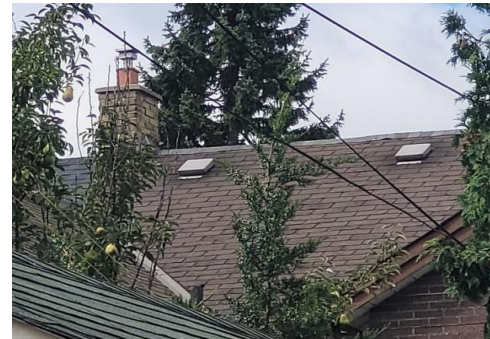
Sloped Surface: southeast shingles aging, budget to replace within 5 yrs.

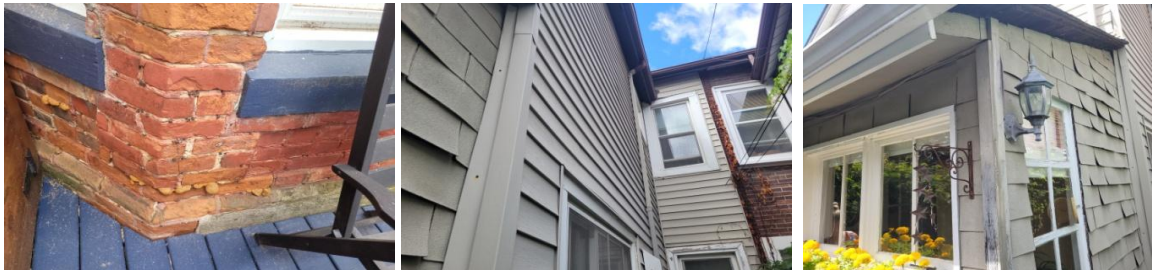
Asphalt Shingles: minor lifting - monitor, budget to replace with siding

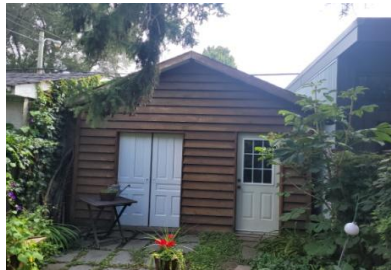
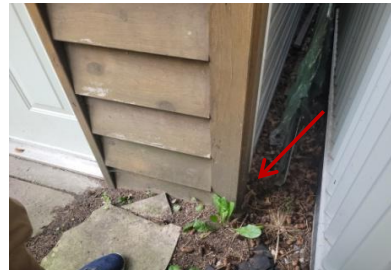
DETACHED GARAGE: overall well built, exterior wood component maintenance bottom perimeter near grade prone to rot - lower grade around perimeter to reduce risk, grade yard away from structure

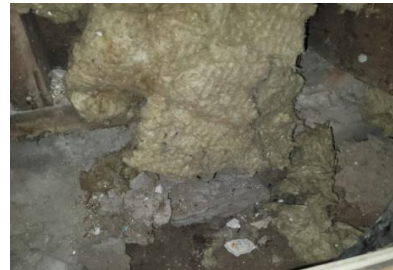
FOUNDATIONS: south part of basement (limited access due to drywall), appears minor spalling, anticipate repairs if renovating/lowering basement floor

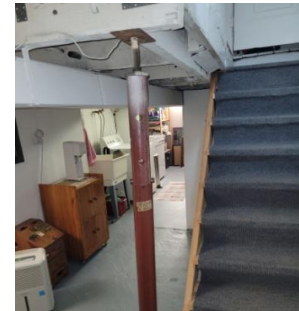
Stair Opening: basement: shored up with metal post, somewhat low quality installation, secure post top/bottom plate and monitor

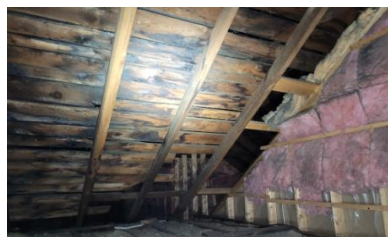
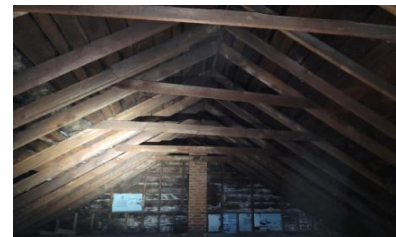
ROOF: overall in good repair, typical staining for older house

Party (Fire) Walls: recommend installing in roof space between attached neighbours

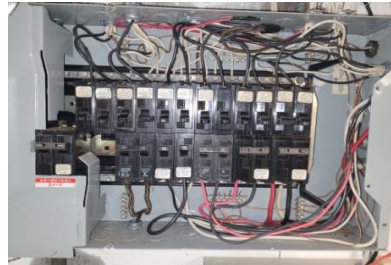
SERVICE PANEL: **overall in good repair**

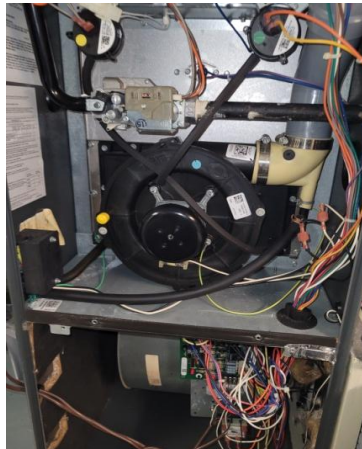
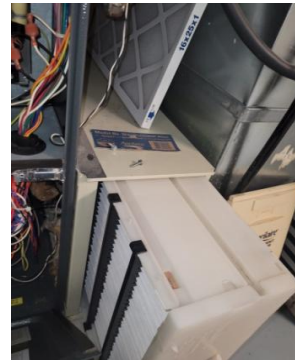
FORCED AIR FURNACE: [service annually](#)  
[recommend obtaining replacement parts/servicing contract](#)  
 Filter: [replace 1-per-6 months](#)

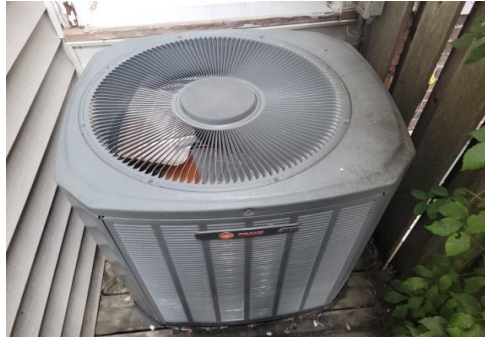
AIR CONDITIONER: aging unit, continue servicing until replacement becomes necessary

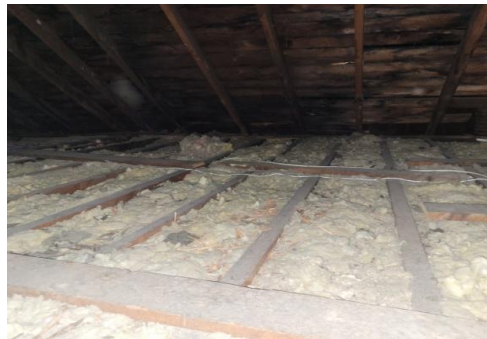
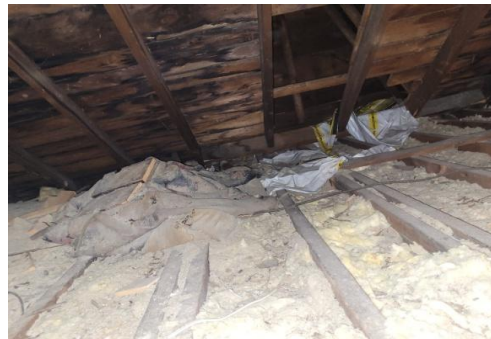
ROOF SPACE: recommend upgrading insulation to improve comfort and efficiency  
 recommend installing vapour barrier to minimize risk of heat loss which may contribute to ice dams at front of house  
 recommend improving ventilation with soffit vents

Roof Access Hatch: insulate and weather-strip access hatch to roof space

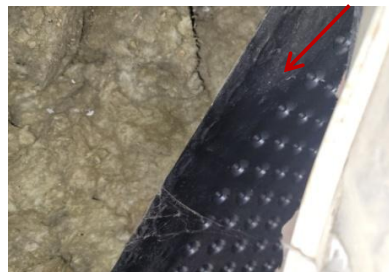
\*\*Basement Leakage: typical efflorescence, staining and dampness for older foundation  
 see steps below  
 recommend damp-proofing if renovating basement  
 rear basement foundation - appears some damp-proofing installed

1. gutters, downspouts, grading, driveways: ongoing maintenance and repair/see Exterior
2. cracks/form ties on foundation: monitor/repair as required
3. excavation/damp-proofing: monitor basement, consider step 3 as a last resort
