HOME INSPECTION REPORT

108 Cowan Ave
Toronto

Prepared by: Bob Papadopoulos P.Eng., RHI *

Inspection Date: Sept 19 2023

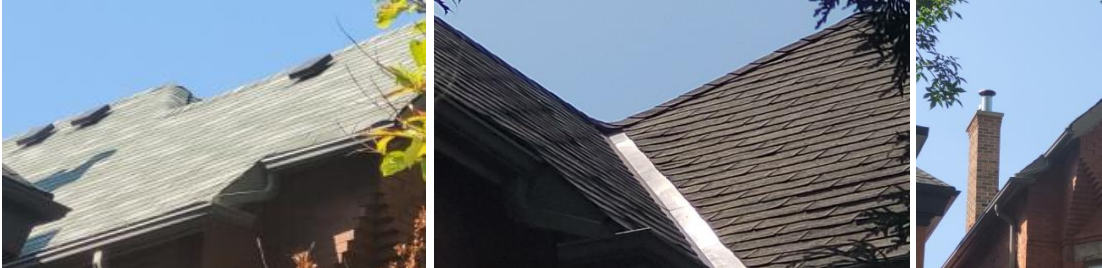
REFERENCE LINK		http://redbrickinspections.ca/docs/2_Roofing_Reference_Guide.pdf		
108 Cowan Ave		ROOFING/Chimneys		Sept 19 2023
Description				
Roofing Material:	Location:	Leakage Probability:		Chimney(s) Type: Location:
Asphalt Shingles:	Main Slope:	Low	front	
Asphalt Shingles:	Slope:	Low	rear	
Asphalt Shingles:	Garage:	Low		
Limitations				
Roof Inspected By:	Access Limited By:	Chimney Access Limited By:		
From Grade	Height			
Observations/Recommendations				
Tree Branches: retain arbourist for annual monitoring/trimming				
Comments: some surfaces aging though overall in good repair				
Main Slope: aging shingles, budget to replace within 5 yrs.				
Chimney: rebuilt and in good repair

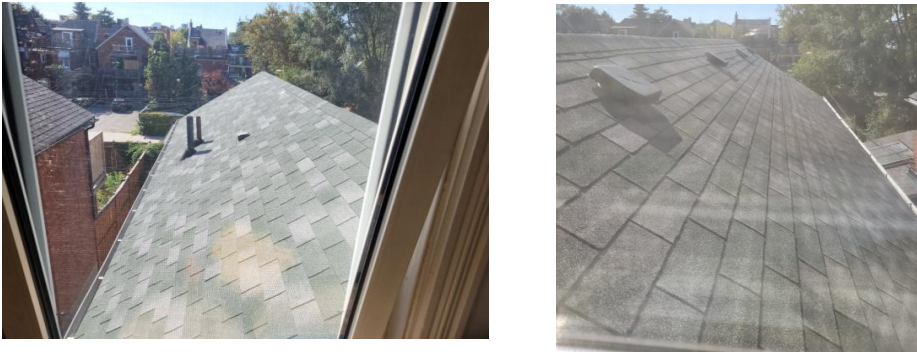
2nd Slope: south overall surface in good repair north side appears more aging surface, budget to replace within 5 yrs.

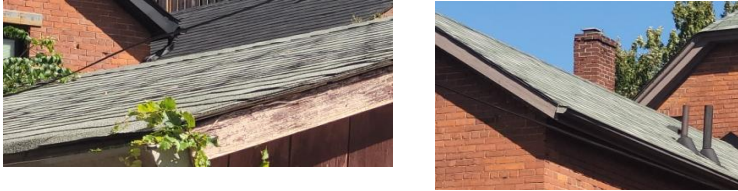
Garage: overall surface in good repair north side more aging surface, budget to replace within 5 yrs.

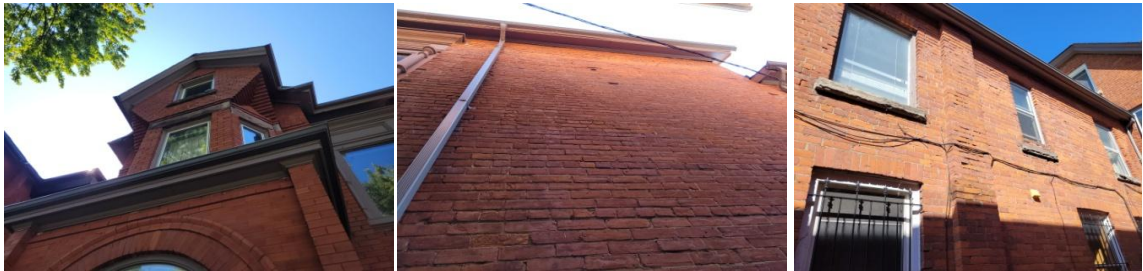
**** Downspouts:** extend 6-ft away from house
WALL SURFACES:
 Brick: overall in good repair, minor surface spalling typical for older house, replace bricks/mortar maintenance as required
 Soffit & Facia: overall in good repair
DOORS/WINDOWS: overall in good repair

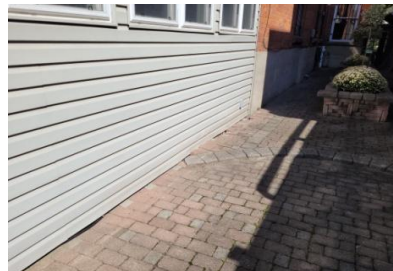
****Walk(s):** re-grade away fro house at rear south along extension, seal gap around crawl space

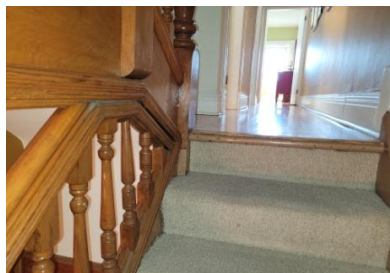
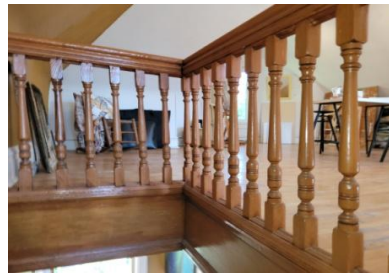
Stair Opening: minor sagging around stair areas though typical for older house

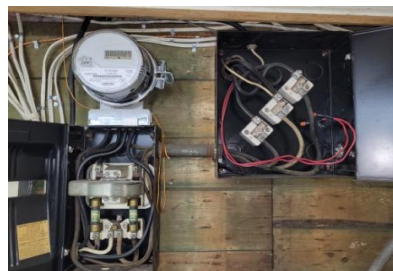
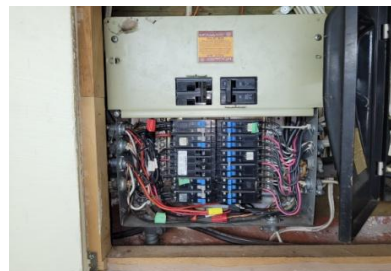
Mast: **older, recommend upgrading to 100 or 200 AMP**

Main Disconnect: **older 60 AMP service, recommend upgrading to 100 or 200 AMP**

SERVICE PANEL: **likely will require upgrading with above to larger panel**

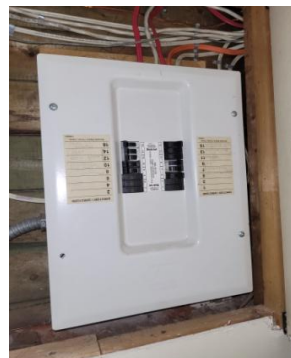
Auxiliary Panel: **overall in good repair**

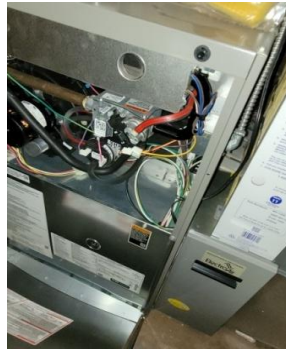
FORCED AIR FURNACE: [service annually](#)

Filter: [replace 1-per-6 to 12 months](#)
[recommend obtaining replacement parts/servicing contract](#)

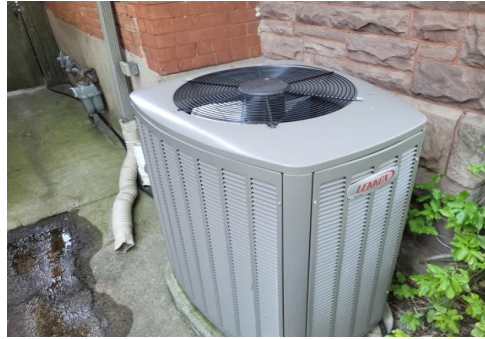
AIR CONDITIONER: [service annually](#)
