HOME INSPECTION REPORT

544 Indian Rd

Toronto

Inspection Date: Sept 12 2023

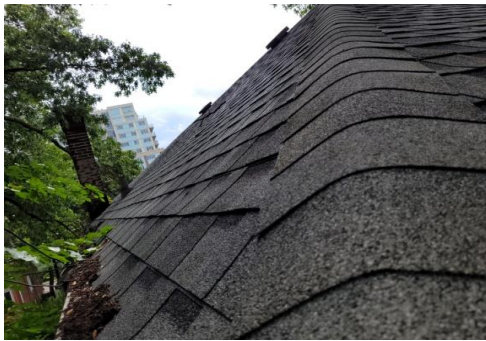
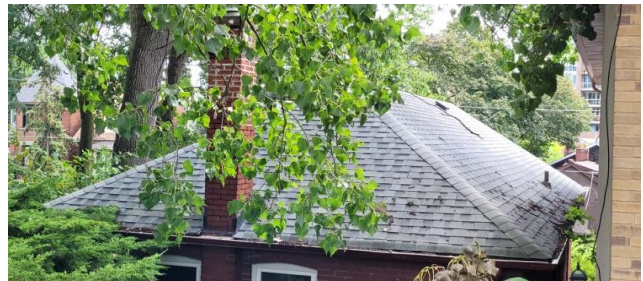
Sloped Surface: [overall surface in good repair](#)

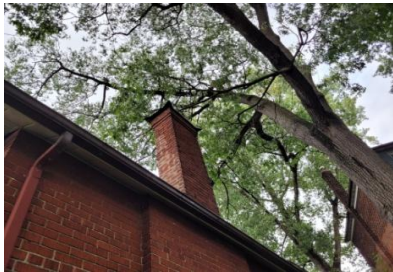
Chimney(s): [overall in good repair](#)

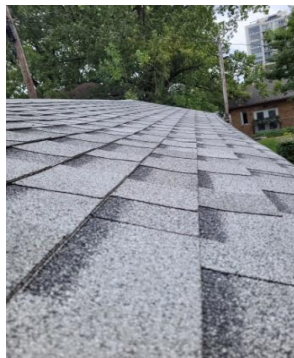
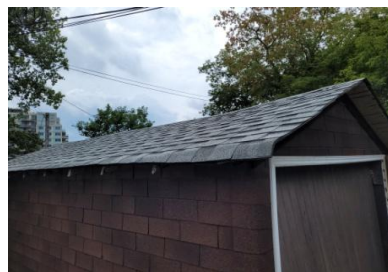
Garage: [overall surface in good repair, see Exterior Garage](#)

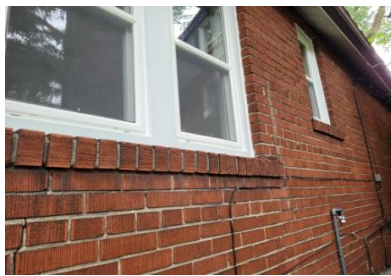
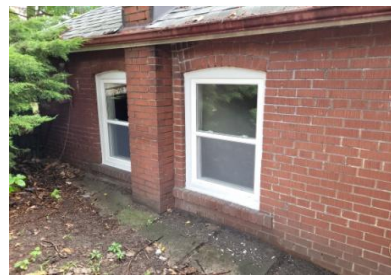
Brick: overall in good repair

DOORS/WINDOWS: overall in good repair

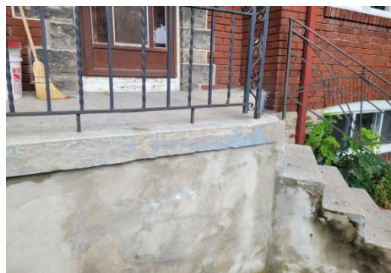
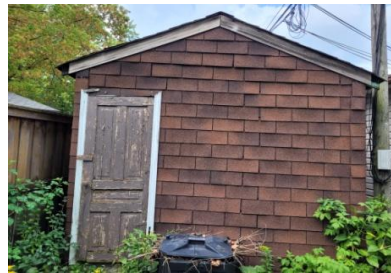
PORCH some settlement noted - monitor, budget to repair

DETACHED GARAGE: older, typically ongoing repairs

may become more cost effective to replace

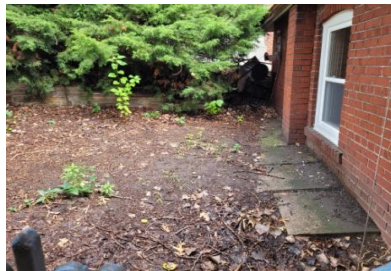
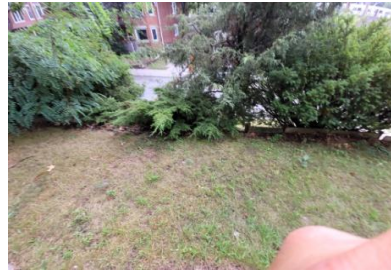
****Landscaping:** rear: budget to grade around house, front: budget to install retaining walls

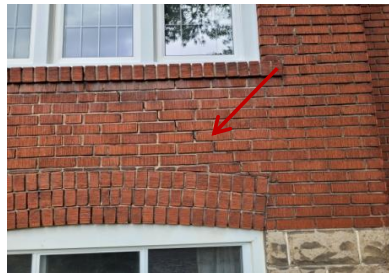
Masonry Arch: front: typical settlement cracks, repair and monitor

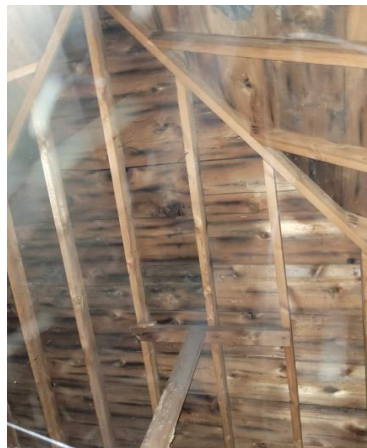
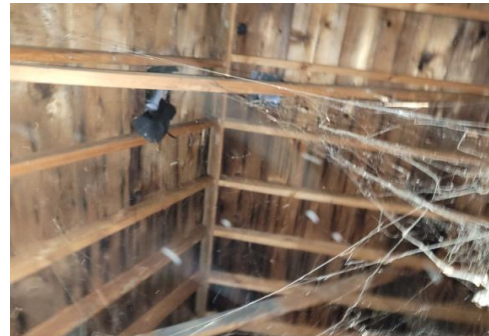
ROOF: overall in good repair

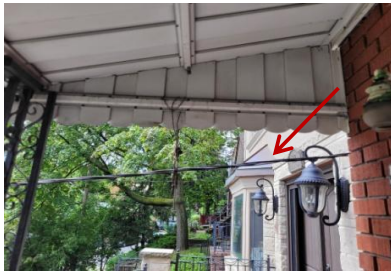
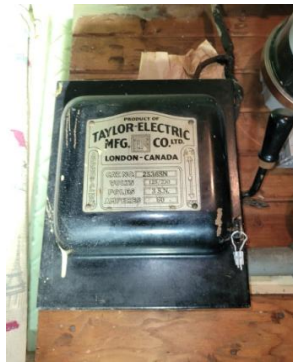
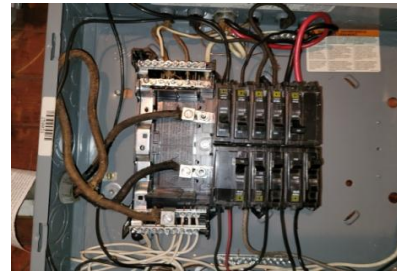
SERVICE ENTRANCE: **wires close to grade - contact utility to repair**
 Mast: **older mast: upgrade as required/renovating**
 Service Size: **upgrade to 100 amp service**
 SERVICE PANEL: **upgrade to larger panel**

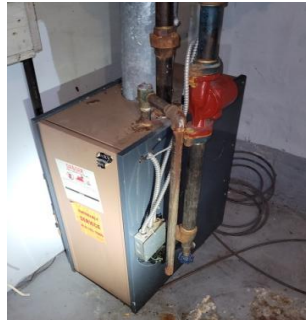
HOT WATER BOILER: [continue servicing until replacement becomes necessary](#)
[annual CO test mandatory for this type of unit](#)
[recommend upgrading to high efficiency unit](#)

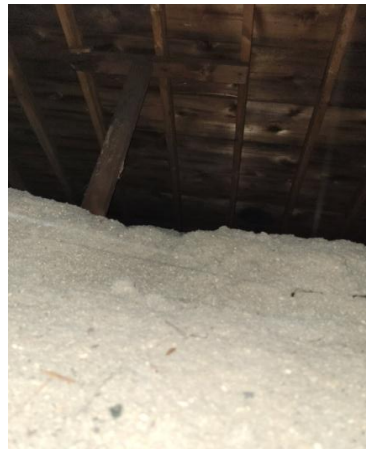
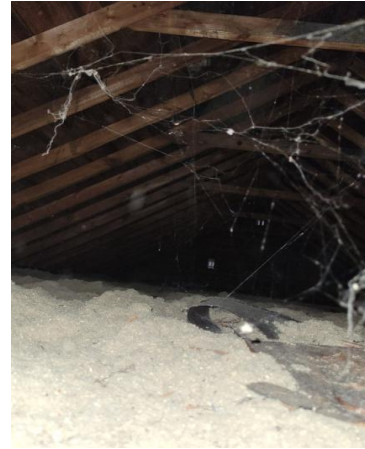
ROOF SPACE: overall insulation and ventilation is adequate
