HOME INSPECTION REPORT

11 Mountview Ave

Prepared by: Bob Papadopoulos P.Eng., RHI *

Inspection Date: Oct 25 2023

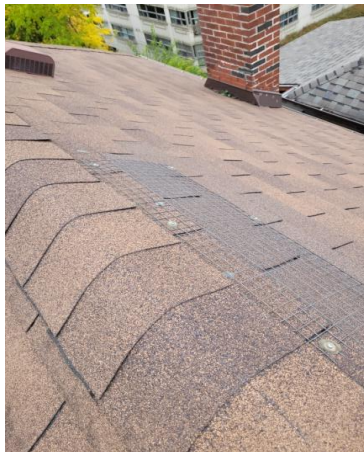
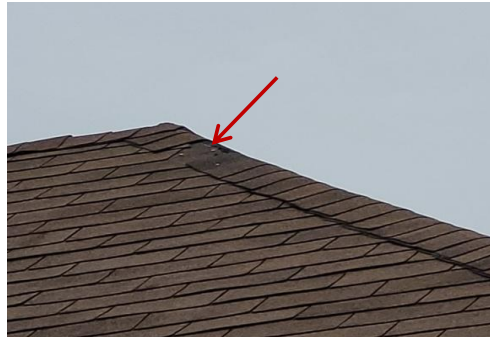
Sloped Surface: overall surface in good repair
requires minor repair at northwest hip

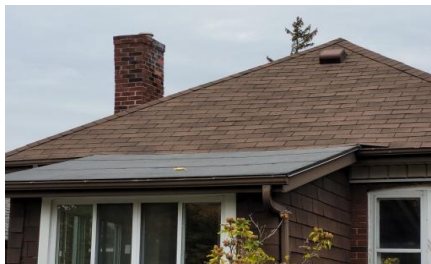
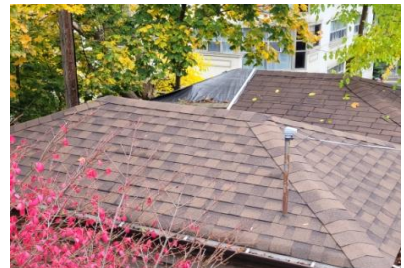
Porch(s): overall surface in good repair
Flat Surface: overall surface in good repair
Garage: overall surface in good repair

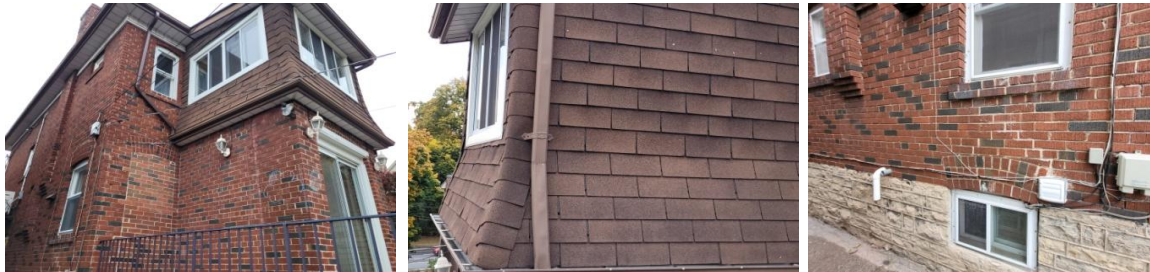
Asphalt Shingles: cupping/curling/aging, replace as required

DOORS/WINDOWS: older, service/upgrade as required

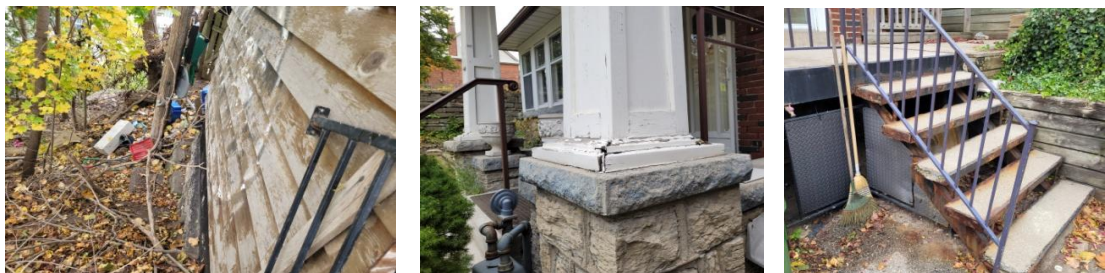
DETACHED GARAGE: older, typically ongoing repairs

PORCH column repairs required, railings required on south side for safety

DECK step maintenance

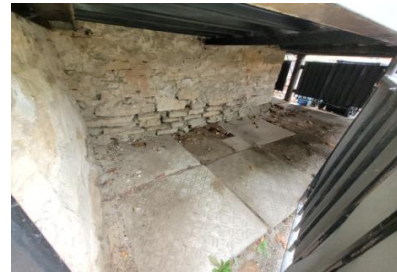
FOUNDATIONS: requires mortar repairs under deck

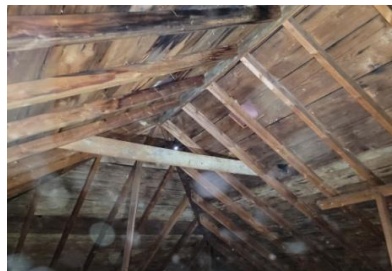
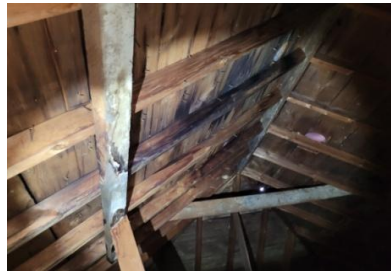
Roof Sheathing: staining at underside appears to be from prior leaking

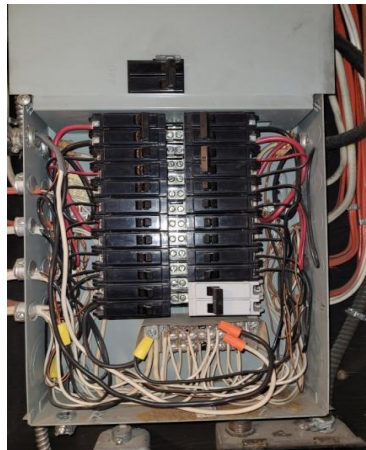
SERVICE PANEL: **crowded, double taps (two wires connect to one breaker), install sub-panel if required/renovating**

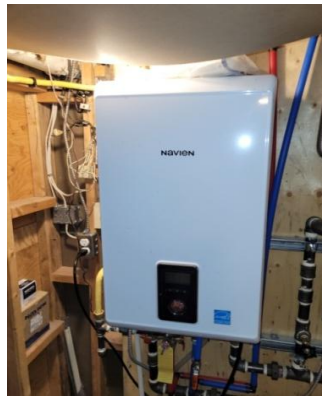
HOT WATER BOILER: [service annually](#)
COMBINATION SYSTEM: [provides house heating and domestic hot water](#)
[refer to warranty for repair/replacement parts](#)
Exhaust Pipes: [driveway: prone to damage - provide barrier](#)

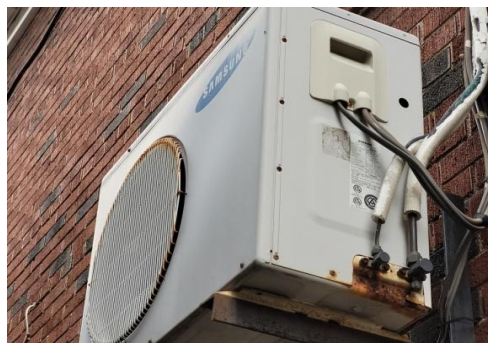
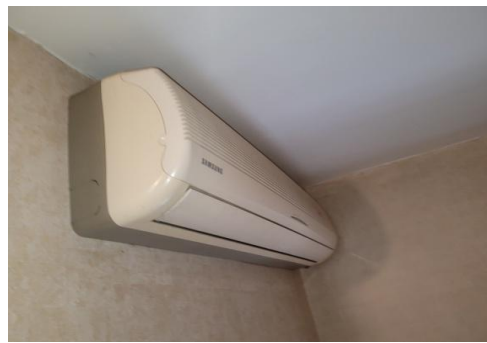
AIR CONDITIONER:
DUCTLESS A/C: reported old/inoperative, replace

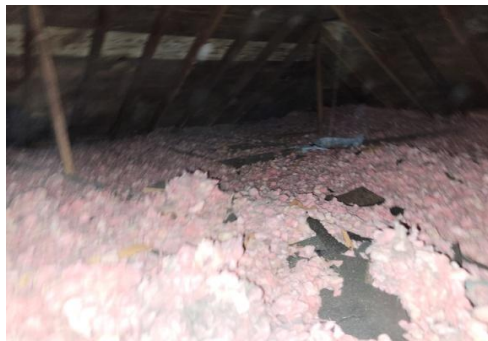
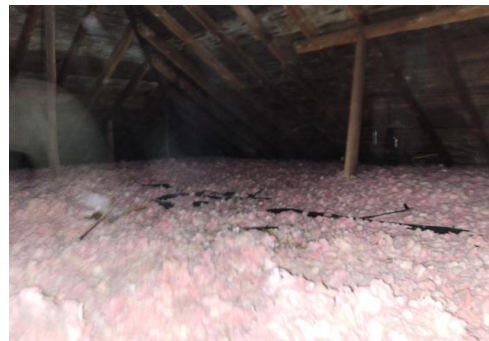
ROOF SPACE: recommend upgrading insulation to improve comfort and efficiency
 Roof Access Hatch: insulate and weather-strip access hatch to roof space
