# HOME INSPECTION REPORT

506 Riverside Dr  
Toronto

Prepared for: [High Park Realty](#)

Inspection Date: Oct 4 2023

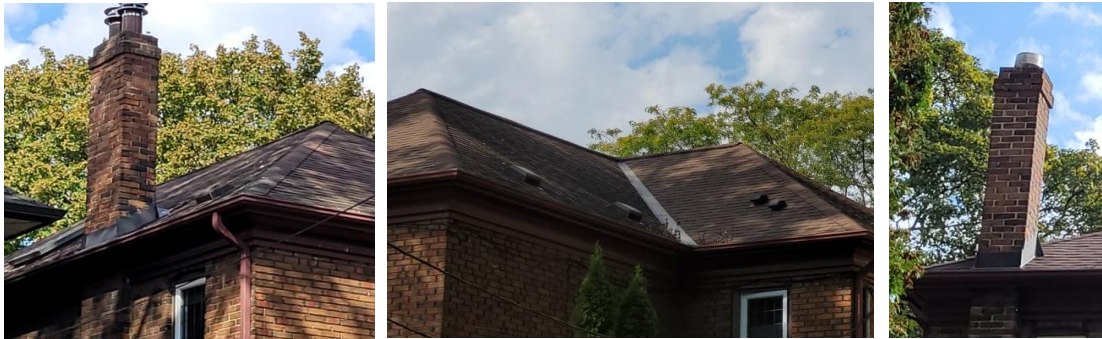
Sloped Surface: overall surface in good repair, aging on south side, budget to replace within 5 yrs.  
 Chimney(s): overall in good repair

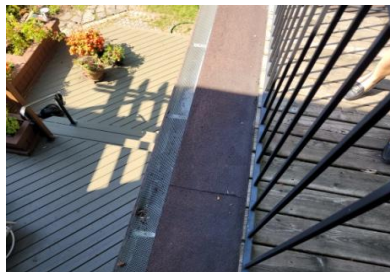
Flat Surface: overall in good repair, minor surface cracking, limited visibility due to deck

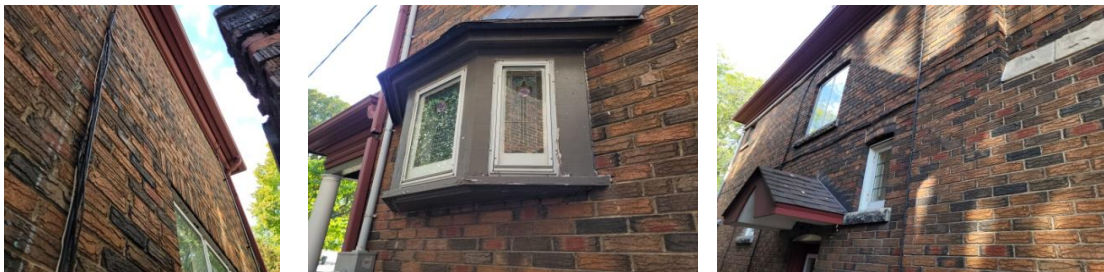
**\*\*Gutters/Downspouts:** requires maintenance/cleaning  
 Comments: retain arbourist for annual monitoring/trimming - see Retaining Wall below  
**WALL SURFACES:** overall in good repair  
 Soffit & Fascia: overall in good repair  
**DOORS/WINDOWS:** overall in good repair, maintain wood components as required

Note: Maintain Gutters & Downspouts annually. Extend Downspouts at least 6-feet away from the house

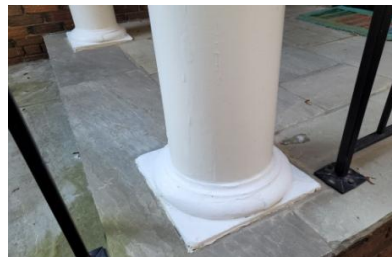
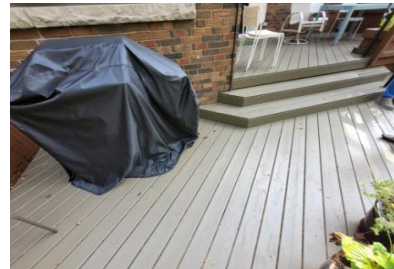
**PORCH** overall in good repair, wood base of columns - monitor/repair as required  
**DECK** overall in good repair, recently painted

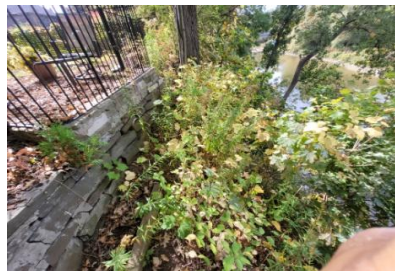
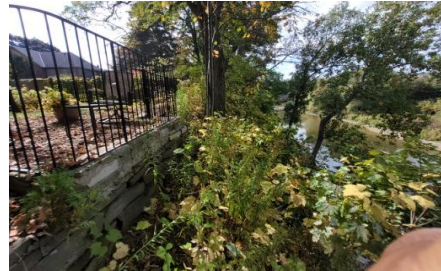
**RETAINING WALL:** ravine: minor movement - continue to monitor/repair as required,  
 cliff slope/flora appears stable though requires monitoring - retain specialist

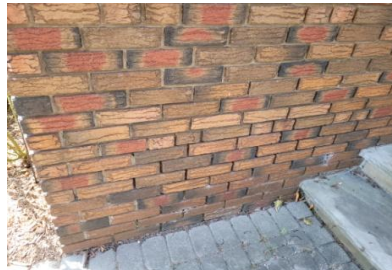
Masonry: general mortar repairs as required

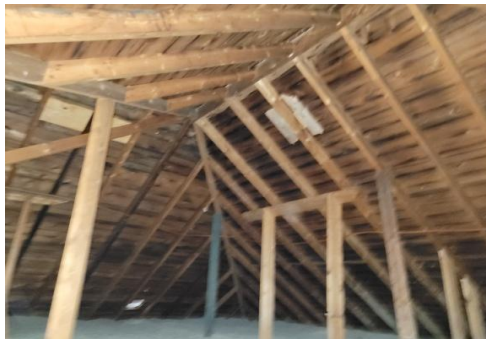
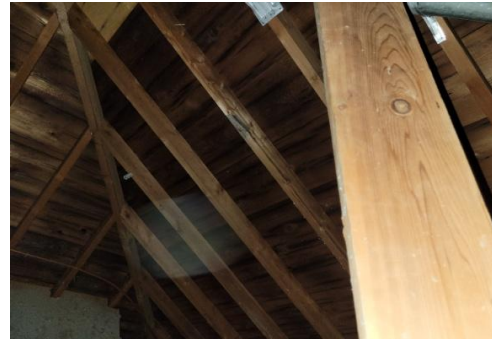
ROOF: overall in good repair, large space with 3rd level potential

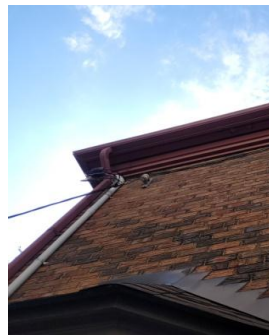
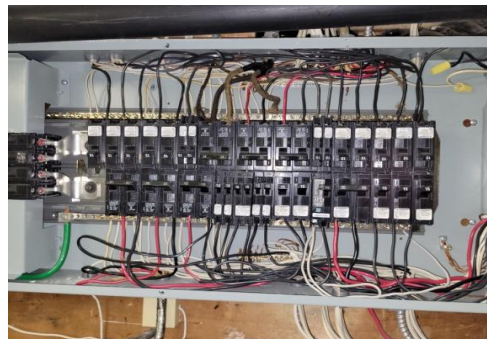
SERVICE ENTRANCE: **overall in good repair**

SERVICE PANEL: **overall in good repair**

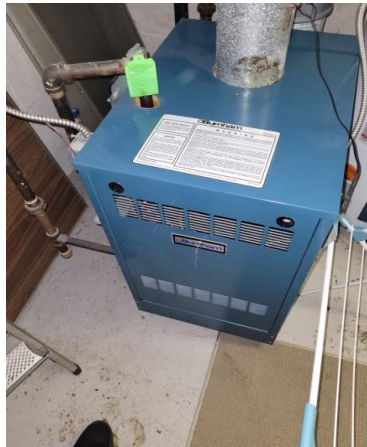
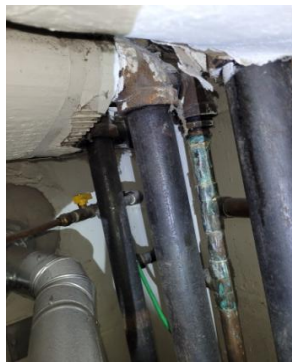
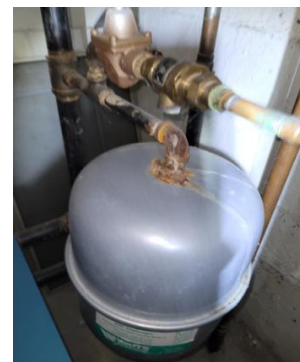
HOT WATER BOILER: [not tested: should be serviced before using](#)  
[continue servicing until replacement becomes necessary](#)  
[annual CO test mandatory for this type of unit](#)  
[some corroded connections - service repair](#)

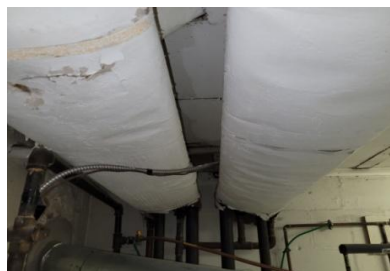
Piping: [insulation on heating pipes may contain asbestos](#)  
[encapsulating the insulation is often the best approach](#)  
[Environmental Consultants can assist if this is a concern](#)

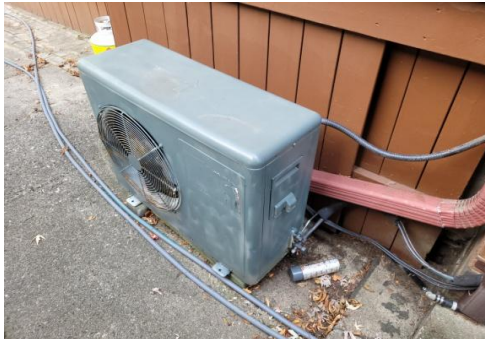
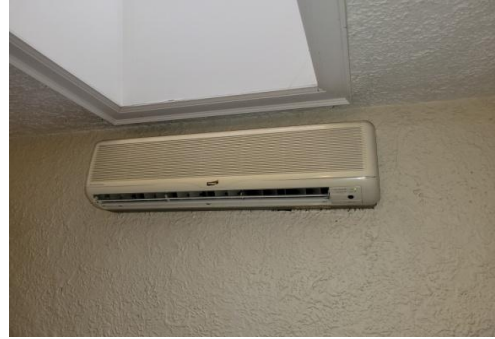
DUCTLESS A/C: old unit, continue servicing until replacement becomes necessary  
presently cooling adequately

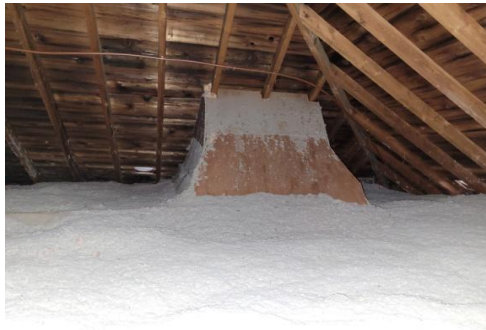
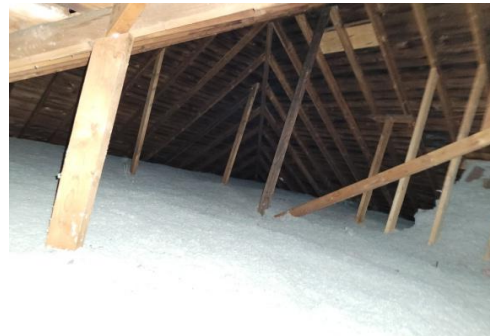
ROOF SPACE: insulation and ventilation is adequate

insulation has been improved which will improve comfort and efficiency

Roof Access Hatch: insulate and weather-strip access hatch to roof space
