# HOME INSPECTION REPORT

2475B Dundas St W  
Toronto

Inspection Date: Dec 19 2023

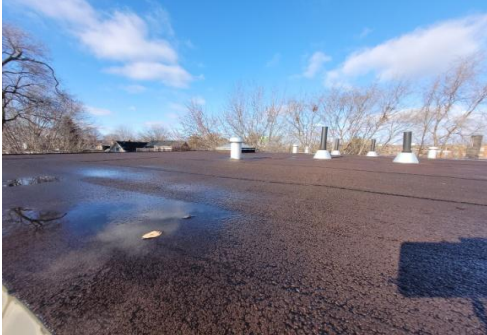
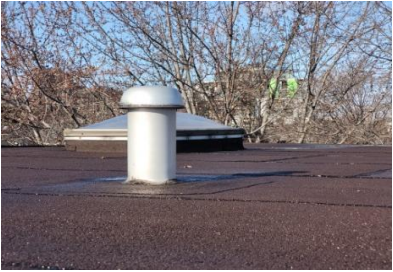
REFERENCE LINK		<a href="http://redbrickinspections.ca/docs/2_Roofing_Reference_Guide.pdf">http://redbrickinspections.ca/docs/2_Roofing_Reference_Guide.pdf</a>		
2475B Dundas St W		<b>ROOFING/Chimneys</b>		Dec 19 2023
Description				
Roofing Material:	Location:	Leakage Probability:	Chimney(s) Type:	Location:
Modified Bitumen:	Flat:	Medium		
Asphalt Shingles:	Slope:	Medium		
Not Determined	2nd Flat:			
Limitations				
Roof Inspected By:	Access Limited By:	Chimney Access Limited By:		
From Edge From Grade	Deck			
Observations/Recommendations				
<p>Flat Surface: <a href="#">minor surface cracking/worn surface, minor pooling, budget to replace within 5-yr</a>            Skylight: <a href="#">overall in good repair</a></p>

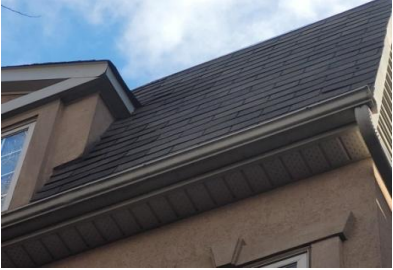
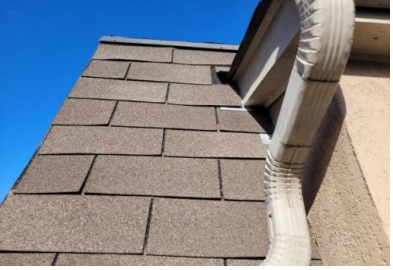
<p>Sloped Surface: <a href="#">front and rear dormers, aging surface, budget to replace within 5 yrs.</a></p>

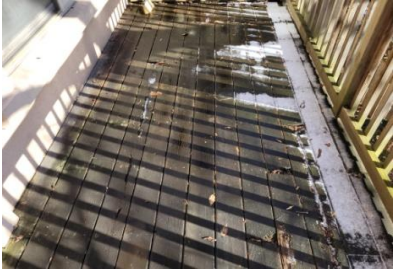
<p>2nd Flat: <a href="#">lower deck: not visible, further evaluation - replace when repairing deck</a></p>

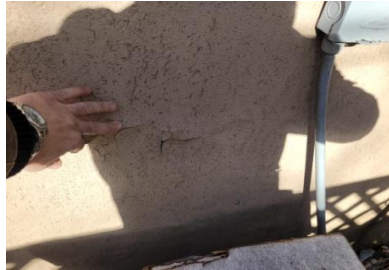
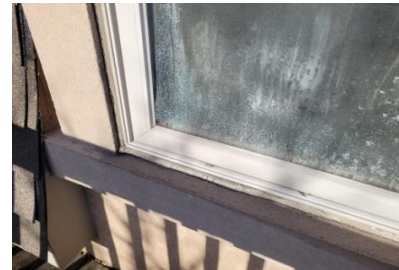
**DOORS/WINDOWS:** caulking repairs required, to reduce risk of moisture penetration into wall system that can lead to mould/frame damage in the long term  
also see Interior Doors/Windows

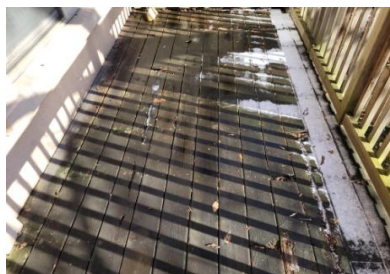
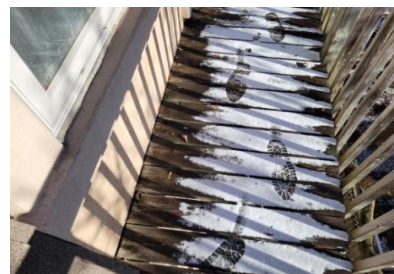
**DECK(s):** older, various repairs required to floorboards/railings, monitor joists/beams

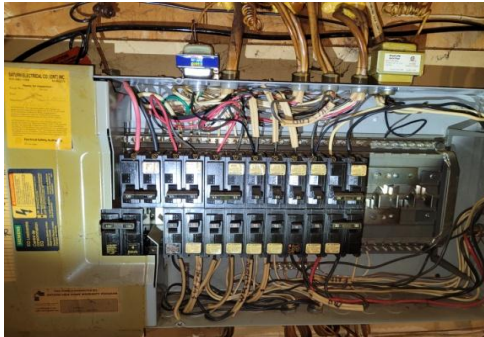
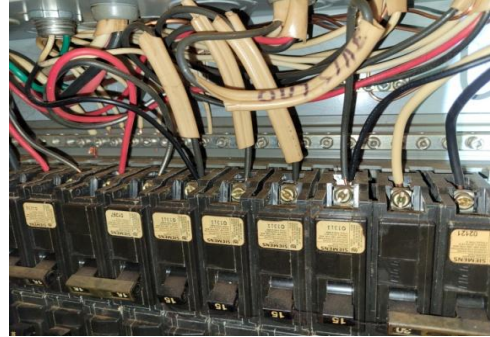
SERVICE PANEL: **overall in good repair**  
**double taps (two wires connect to one breaker), install additional breakers**

Note 1: All recommendations are safety issues - Treat them as high priority.

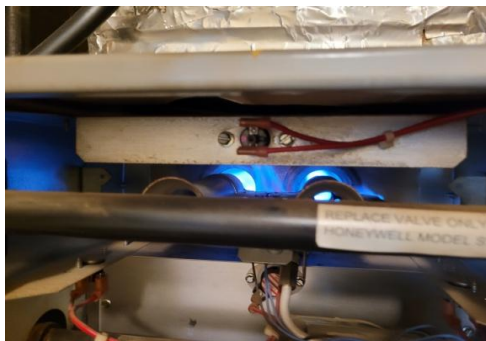
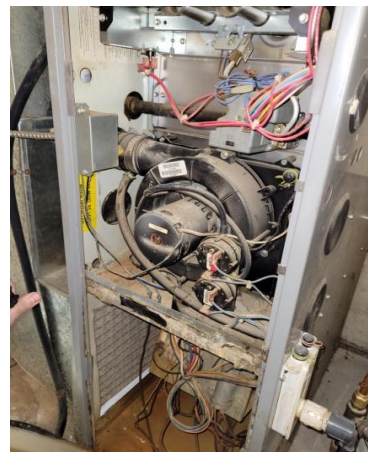
FORCED AIR FURNACE: requires servicing, burner further evaluation-erratic flame,  
might be more cost effective to replace

Filter: replace 1-per-3 months

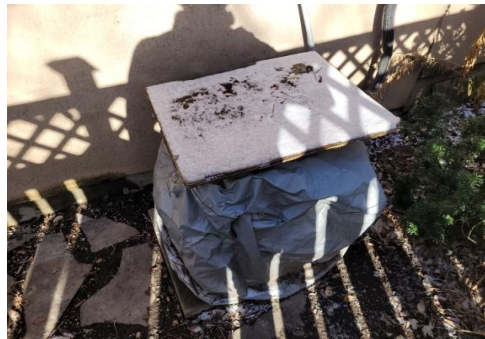
AIR CONDITIONER: not tested: should be serviced before using  
aging unit, continue servicing until replacement becomes necessary

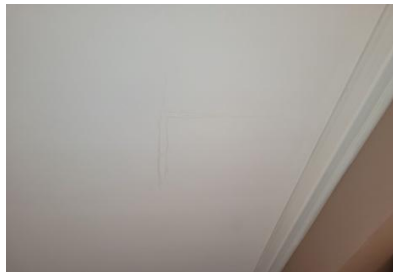
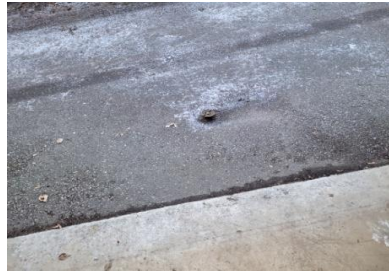
**Comments:** staining on ceiling under 3rd level washroom, test dry with moisture meter, continue to monitor

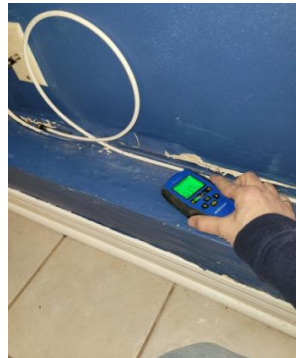
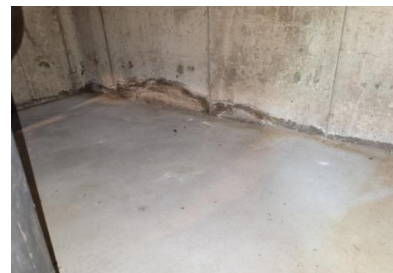
Comments: [main level perimeter: typical efflorescence, staining from rising damp](#)
