HOME INSPECTION REPORT

13 Delaney Crescent
Toronto

Inspection Date: [Feb 13 2024](#)

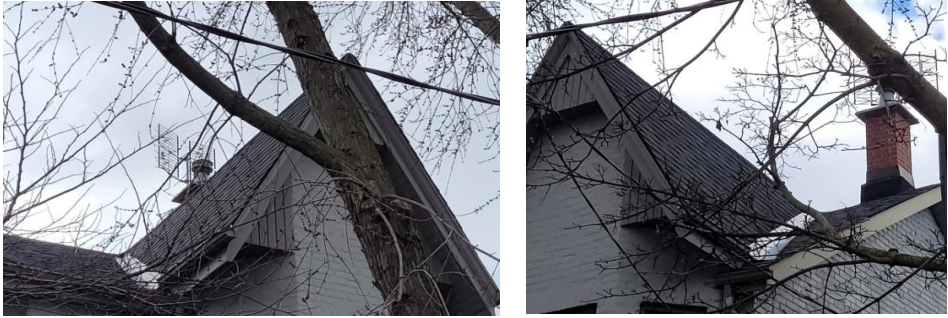
REFERENCE LINK		http://redbrickinspections.ca/docs/2_Roofing_Reference_Guide.pdf		
13 Delaney Crescent		ROOFING/Chimneys		Feb 13 2024
Description				
Roofing Material: Asphalt Shingles:	Location: Slope:	Leakage Probability: Low	Chimney(s) Type: Brick:	Location: West
Limitations				
Roof Inspected By: From Grade	Access Limited By: Height Tree	Chimney Access Limited By: Height		
Observations/Recommendations				
<p>Sloped Surface: reported the roof surfaces are approximately 7-yrs-old with a typical life expectancy of over 20-yrs.</p> <p>Chimney: rebuilt and in good repair</p>

<p>Flat Surface: reported the roof surfaces are approximately 7-yrs-old with a typical life expectancy of over 20-yrs.</p>				
<p>Tree Branches: contact Toronto hydro for annual monitoring/trimming</p>				
<p>Note: Recommend Annual Maintenance Contract for Roof Surface, Flashing Details and Chimney(s)</p>

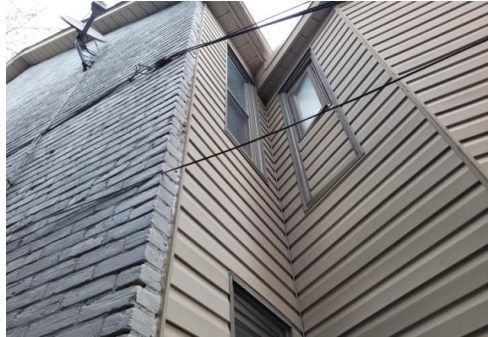
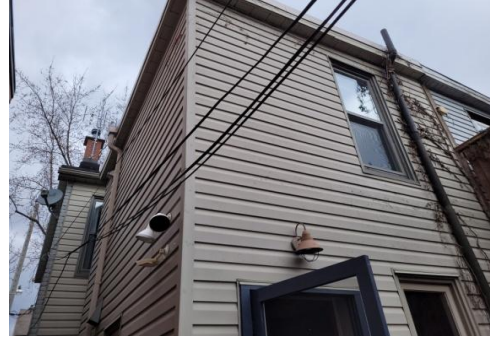
WALL SURFACES: overall in good repair

DOORS/WINDOWS: overall in good repair

** Downspouts: extend 6-ft away from house

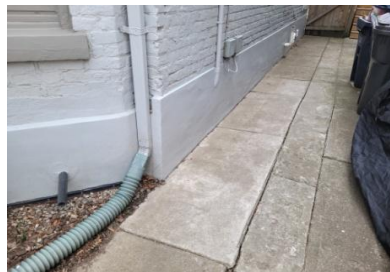
**Walk(s): uneven, somewhat slopes towards house, repair and budget to replace seal gaps along foundation wall

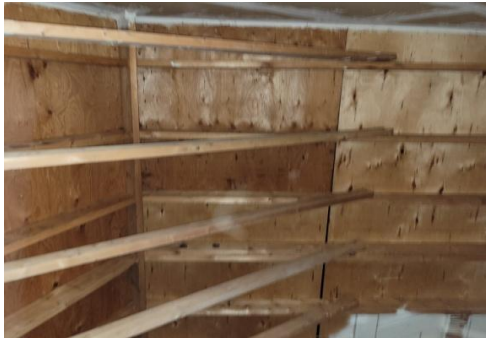
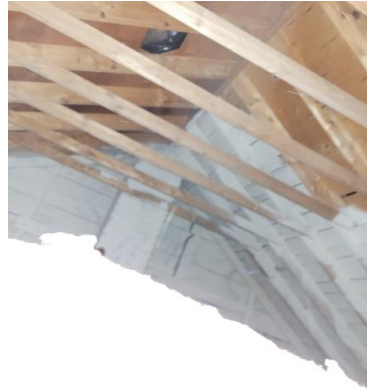
overall in good repair

ROOF: rebuilt, overall in good repair,

Party (Fire) Walls: installed on east side between neighbour

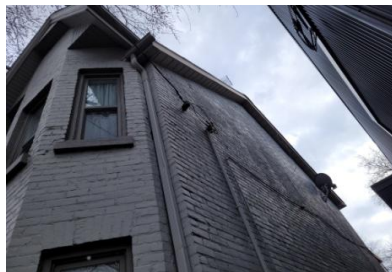
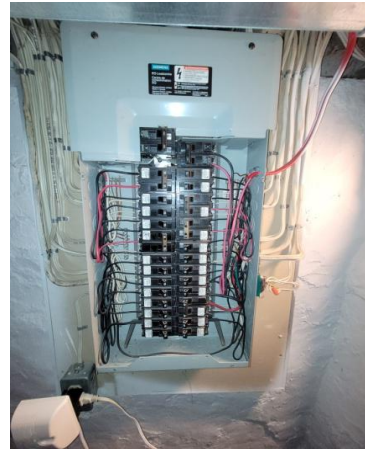
SERVICE ENTRANCE: **overall in good repair**

SERVICE PANEL: **overall in good repair**

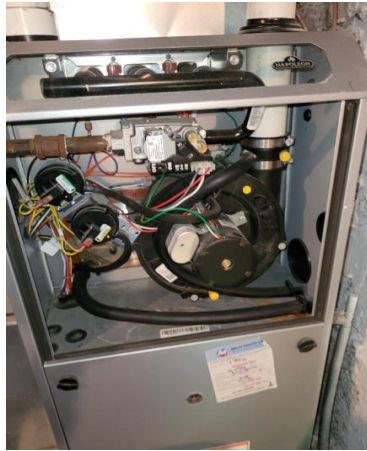
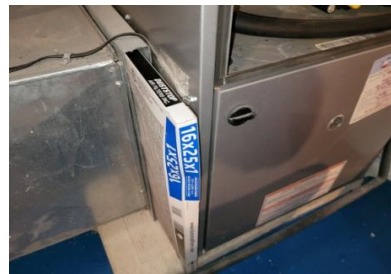
FORCED AIR FURNACE: [service annually](#)
Filter: [replace 1-per-3 months](#)

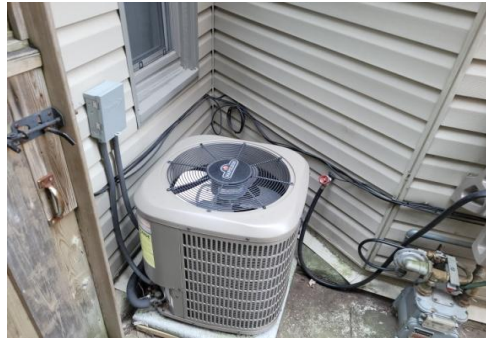
AIR CONDITIONER: not tested: should be serviced before using

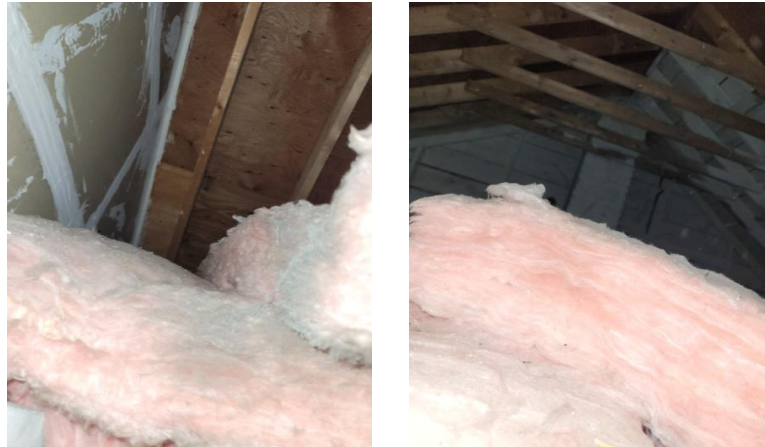
ROOF SPACE: insulation and ventilation is adequate
 Roof Access Hatch: insulate and weather-strip access hatch to roof space

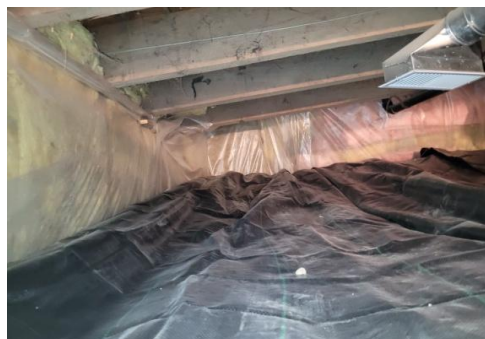
Crawlspace Walls: insulation is adequate

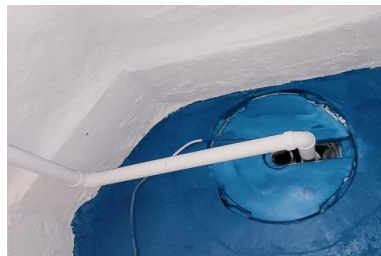
**Basement Leakage: presently no leaking observed,
 north foundation damp-proofed to minimize leaking risk
 service sump pump annually
 recommend back up battery for sump pump

1. gutters, downspouts, grading, driveways: ongoing maintenance and repair/see Exterior
2. cracks/form ties on foundation: monitor/repair as required
3. excavation/damp-proofing: monitor basement, consider step 3 as a last resort
