# HOME INSPECTION REPORT

151 Cowan Ave

Prepared by: Bob Papadopoulos P.Eng., RHI \*

Inspection Date: [Feb 6 2024](#)

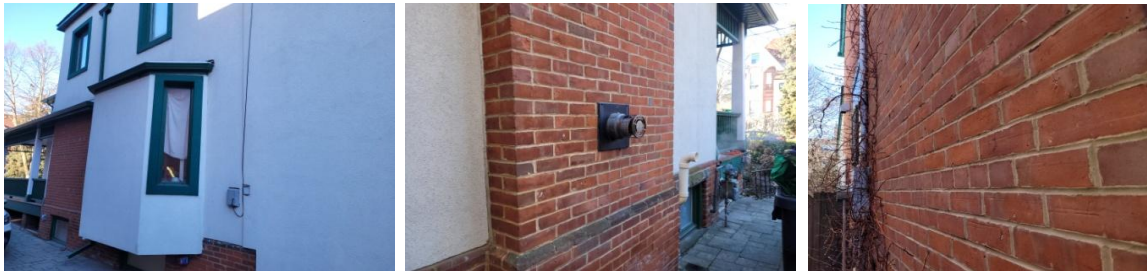
\*\*Walk(s)/Driveway(s): overall in good repair  
DETACHED GARAGE: newer well built  
WALL SURFACES: overall in good repair  
Soffit & Fascia: overall in good repair  
DOORS/WINDOWS: overall in good repair

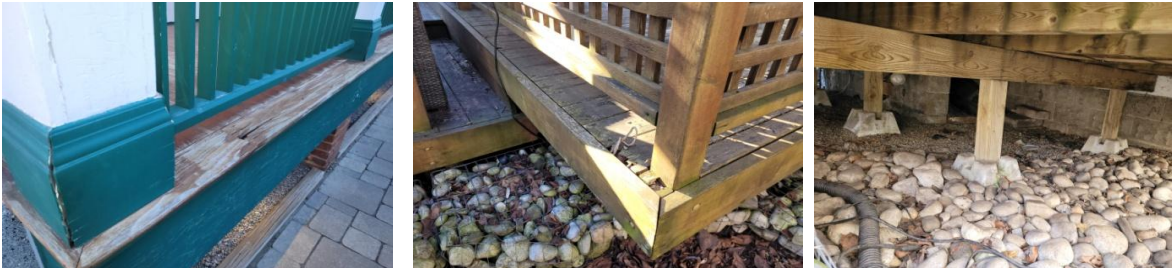
PORCH floor boards in some areas require repairs/replacement, resurfaced steps  
DECK floor boards in some areas require repairs/replacement  
supports for columns prone to settlement/heaving - presently none- monitor

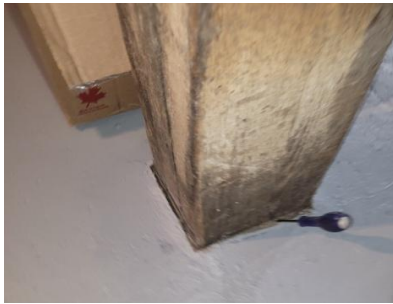
Wood Beam: older units, minor splitting/dry rot is typical for older house, no signs of distress

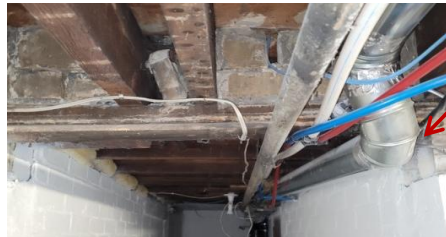
Wood Beam: rear basement hall: timber has been notched though older condition and no signs of distress, monitor, budget to replace with metal lintel or if renovating

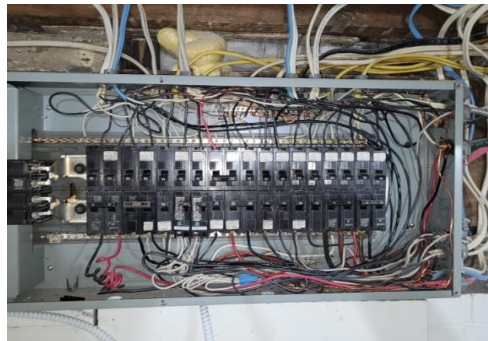
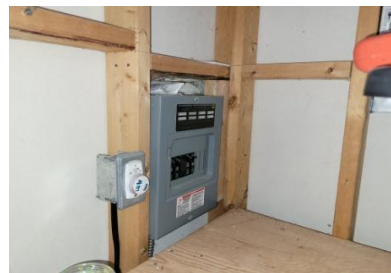
one double tap breaker (two wires connect to one breaker) - not critical

Auxiliary Panel: in garage: cover not removed do to shelf/storage

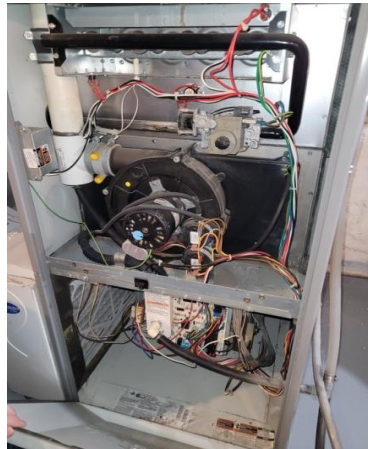
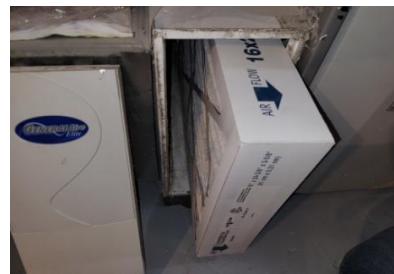
FORCED AIR FURNACE: [service annually](#)  
[recommend obtaining replacement parts/servicing contract](#)  
Filter: [replace 1-per-6 to 12 months](#)

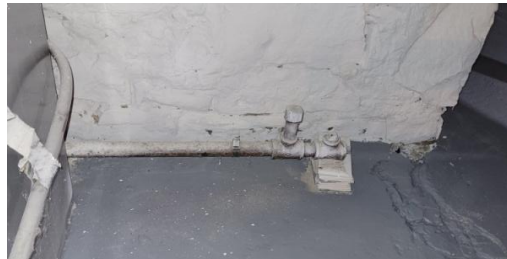
Gas Piping: [basement - abandoned - remove if required by contractor](#)

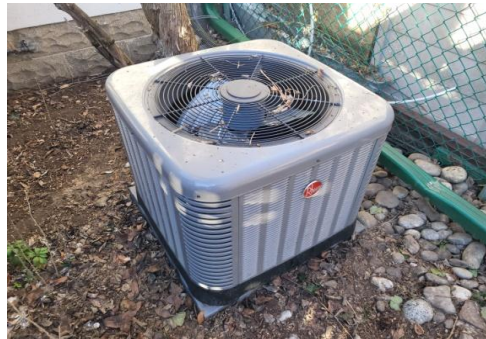
AIR CONDITIONER: [not tested: should be serviced before using](#)

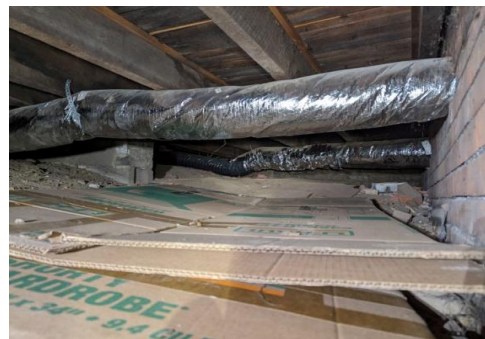
**East Main CrawlSpace**

CrawlSpace Floor: budget to spray foam floors to improve comfort/efficiency

CrawlSpace Walls: budget to spray foam floors to improve comfort/efficiency

Comments: recommend installing moisture barrier over open ground

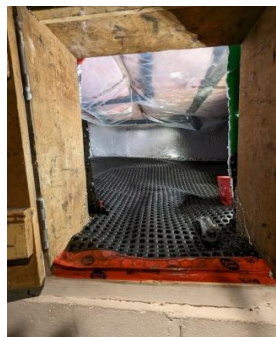
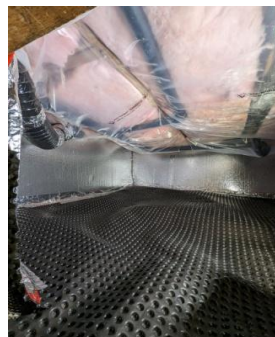
**Southeast crawlspace**

overall in good repair, floor/wall insulated and moisture barrier installed on ground
