HOME INSPECTION REPORT

36 Pearson Ave

Prepared by: Bob Papadopoulos P.Eng., RHI *

Inspection Date: Jan 30 2024

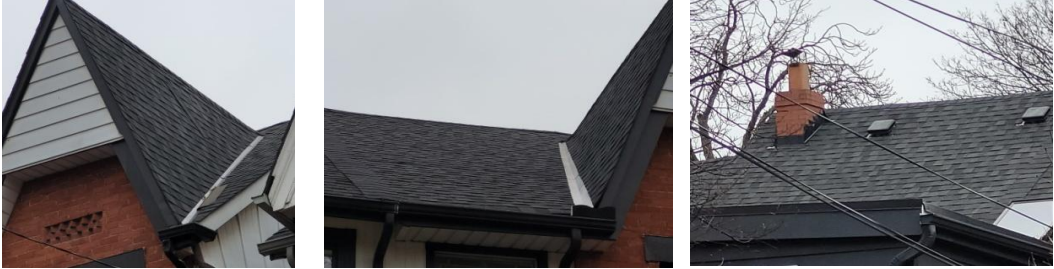
REFERENCE LINK	http://redbrickinspections.ca/docs/2_Roofing_Reference_Guide.pdf			
36 Pearson Ave	ROOFING/Chimneys			Jan 30 2024
Description				
Roofing Material:	Location:	Leakage Probability:	Chimney(s) Type:	Location:
Asphalt Shingles:	Slope:	Low	Brick Abandoned:	East
Not Determined	Flat:	Low		
Asphalt Shingles:	Garage:	Medium		
Limitations				
Roof Inspected By:	Access Limited By:	Chimney Access Limited By:		
From Grade	Height			
Observations/Recommendations				
<p>Sloped Surface: overall surface in good repair, some loose shingles on east side require maintenance</p>

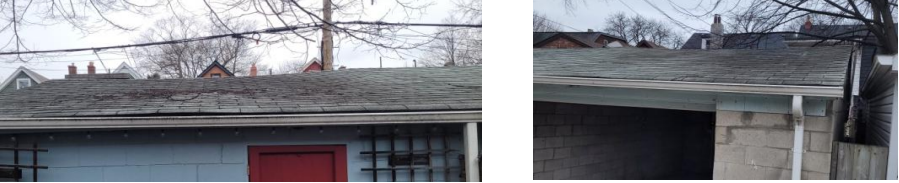
<p>Main Flat: not accessible due to height, reported to be approx. 11-yrs old typical life expectancy is over 20-yrs</p>				
<p>Garage: aging but overall in good repair</p>

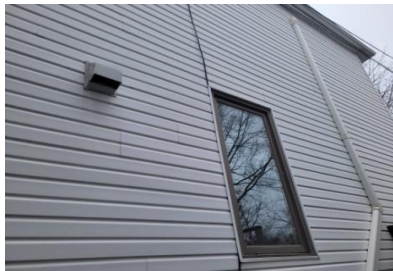
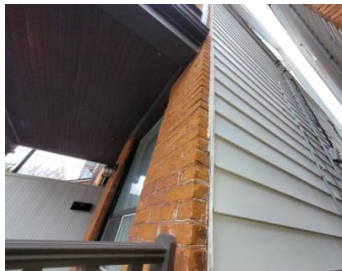
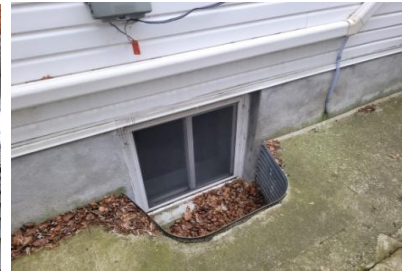
DOORS/WINDOWS: overall in good repair, various wood components require maintenance

**Window Well: recommend window well cover

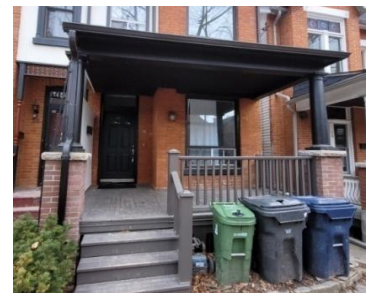
PORCH overall in good repair, roof-minor slope does not appear critical, columns flooring/railings/steps have been replaced

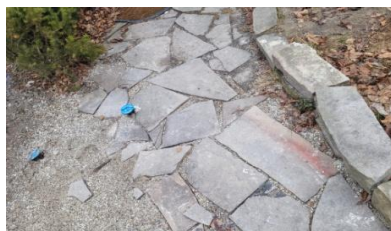
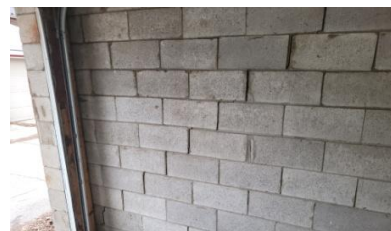
DETACHED GARAGE: some wall settlement noted- likely older, repair mortar and continue to monitor floor settlement/cracks

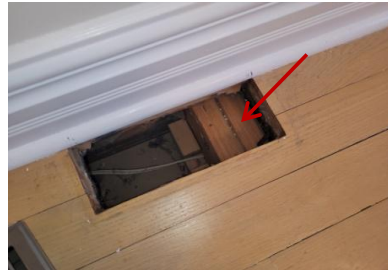
FLOORS: access through vent shows new engineering joists installed (likely during renovation)

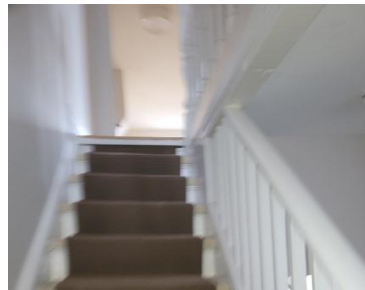
FLOORS:
Stair Opening: minor sagging around stair areas though typical for older house

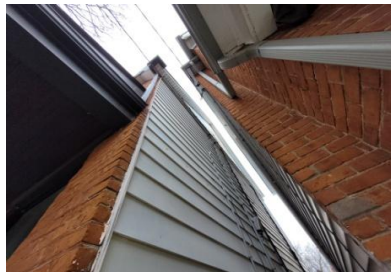
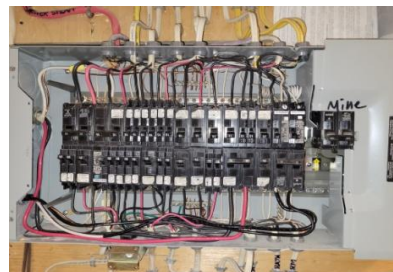
SERVICE ENTRANCE: **overall in good repair**

SERVICE PANEL: **overall in good repair**

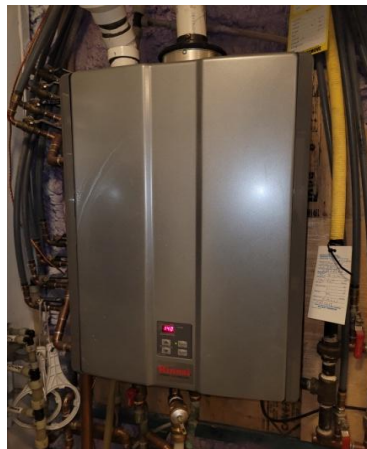
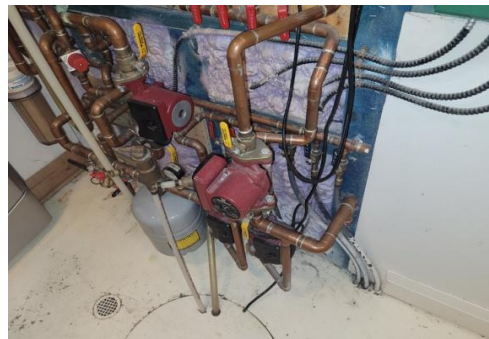
Radiator(s): new units installed

Hot Water Radiant Heat: basement floor and washrooms

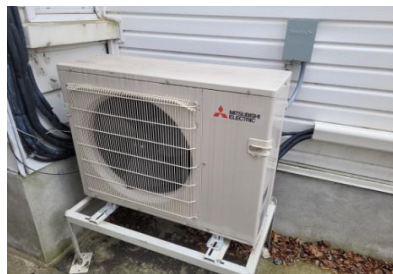
4 units

HEAT PUMP: multi split zoned for 4 ductless wall mounted units
 unit provides cooling and supplemental heating
 service annually
 tested in heating mode

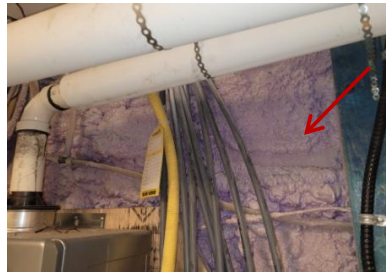
Basement Walls: [spray foam insulation installed which is above average](#)

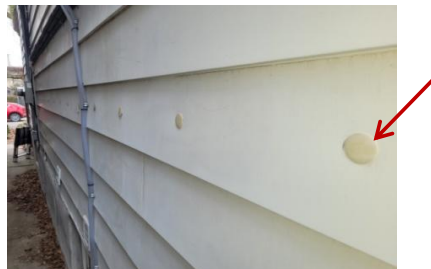
Wood Frame Walls: [spray foam insulation installed which is above average](#)

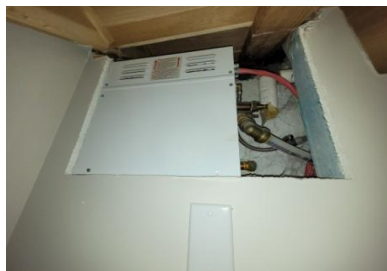
Washroom Shower: [steam generator tested functional, unit in closet - should have drip pan](#)
