HOME INSPECTION REPORT

96 Roncesvalles

Toronto

Inspection Date: Feb 15 2024

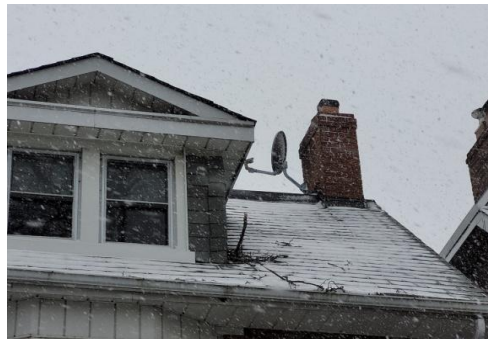
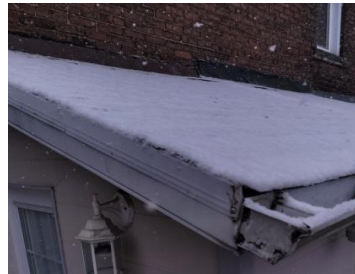
Sloped Surface: [overall surface in good repair](#)
 2nd Slope: [not visible due to snow](#)

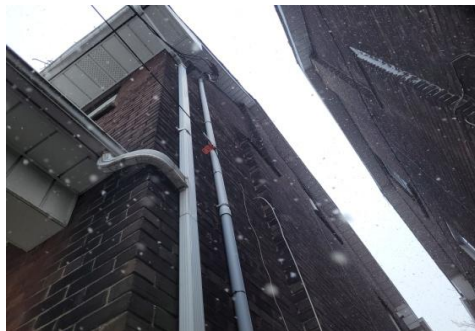
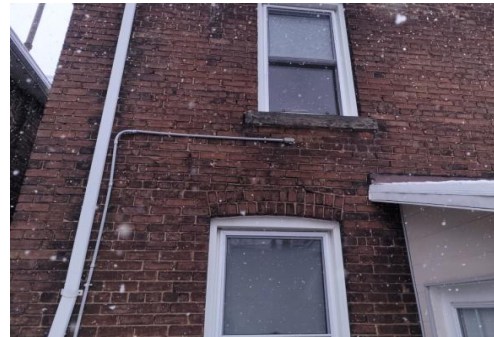
Brick: [overall in good repair, typical surface spalling for older house](#)

Soffit & Facia: [overall in good repair](#)

DOORS/WINDOWS: [overall in good repair](#)

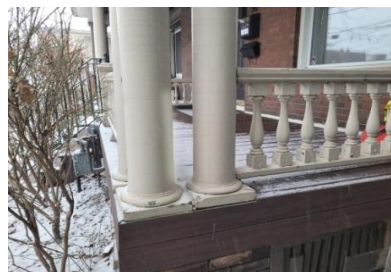
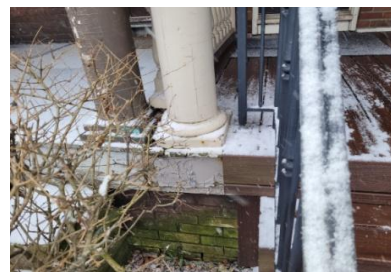
DECK [overall in good repair](#)

PORCH [column repairs required, wood component maintenance, floor is composite material in good repair](#)

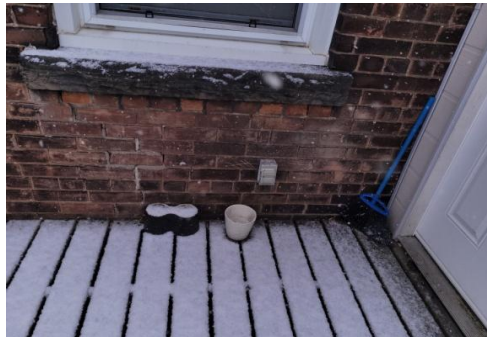
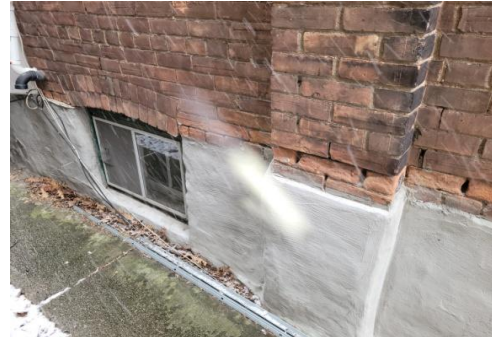
Masonry: minor, typical settlement cracks, repair mortar as required
replace bricks as required

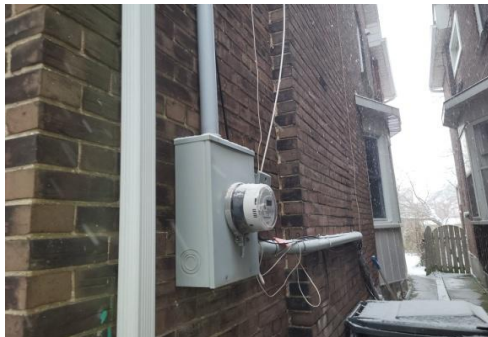
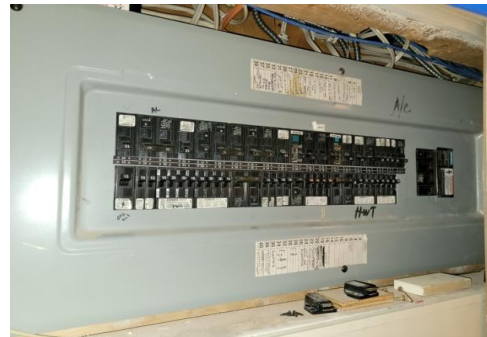
SERVICE ENTRANCE: overall in good repair
 SERVICE PANEL: overall in good repair
 cover not removed due to cabinet

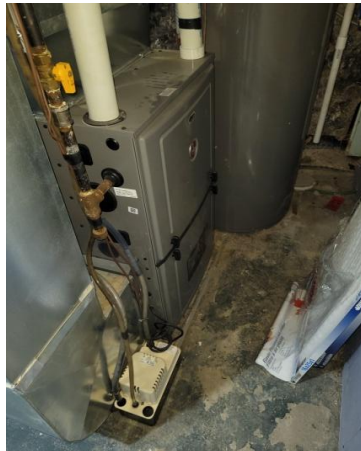
FORCED AIR FURNACE: [service annually](#)

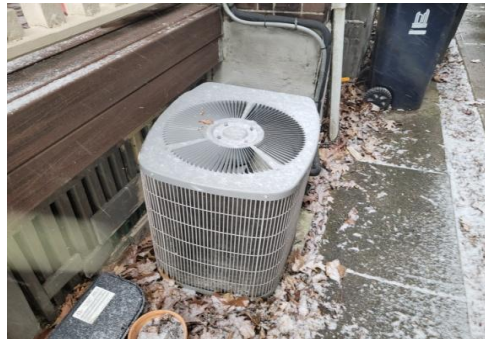
AIR CONDITIONER: not tested: should be serviced before using
