# HOME INSPECTION REPORT

139 Dunn Ave  
Toronto

Prepared by: Bob Papadopoulos P.Eng., RHI \*

Inspection Date: [March 12 2024](#)

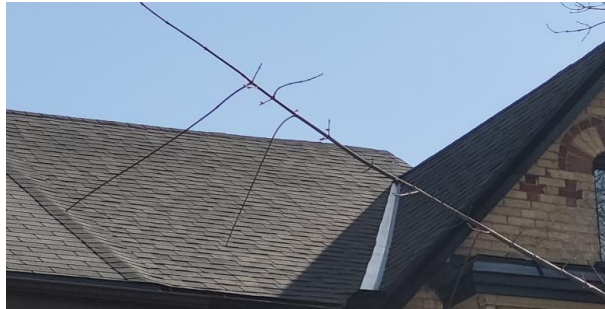
West Slope: overall surface in good repair reported to be approx. 4-yrs old, typical life expectancy of over 20-yrs.

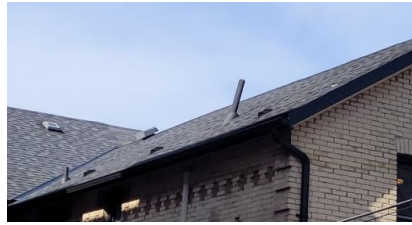
East Slope: as above, old leak staining under chimney

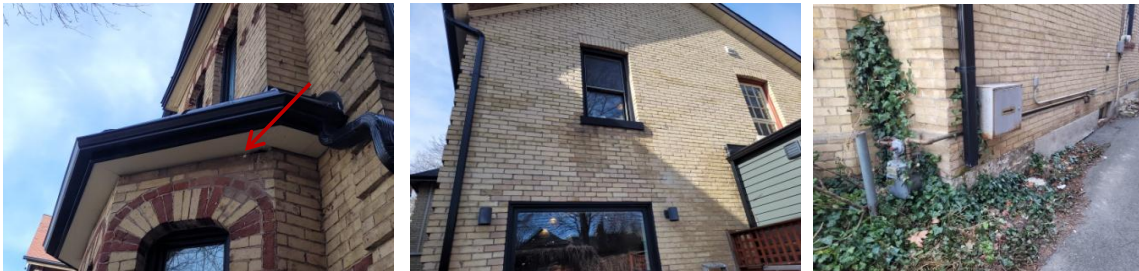
**\*\*Walk(s):** seal gaps along foundation wall

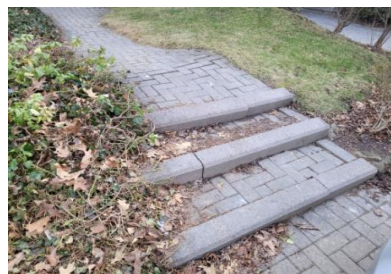
**\*\*Walk(s):** uneven, settlement, trip hazard - repair

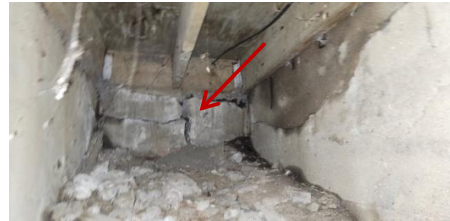
overall older well built house  
 FOUNDATIONS: basement abandoned walkout- small portion of foundation requires further evaluation/repair  
 appears to be minor  
 also see Interior Basement

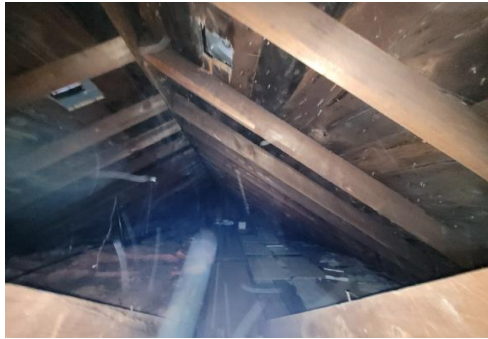
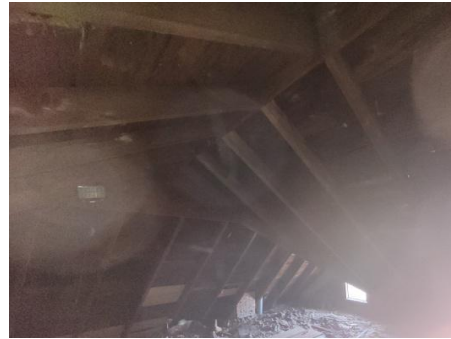
ROOF: overall in good repair, 3rd level potential  
 Party (Fire) Walls: recommend installing on north side betwixt neighbour

**STRUCTURE** Overall older well built house. Reported rear crawlspace joists have been reinforced. Recommend installing a fire wall in the roof spaces between the attached neighbour.

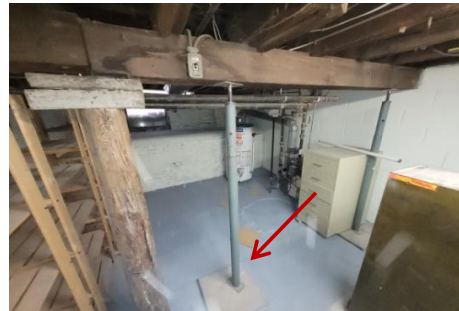
FLOORS: basement: wood beam has been 'shored-up', somewhat suspect support should be monitored and installed properly if intent is to use basement as a living space  
 crawlspace: reported floor joists were reinforced ('sistered') with new joists

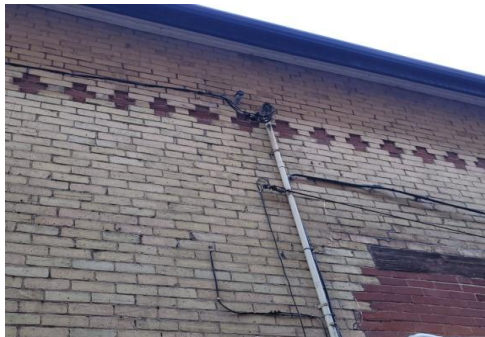
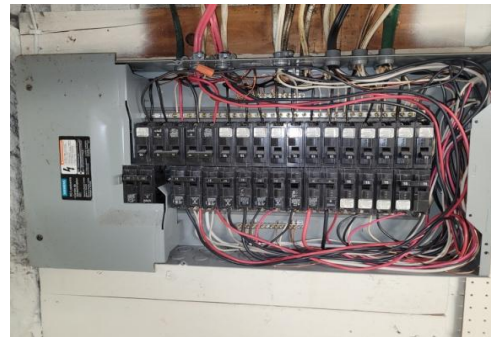
SERVICE ENTRANCE: **older, can be upgraded if renovating**

SERVICE PANEL: **overall in good repair**

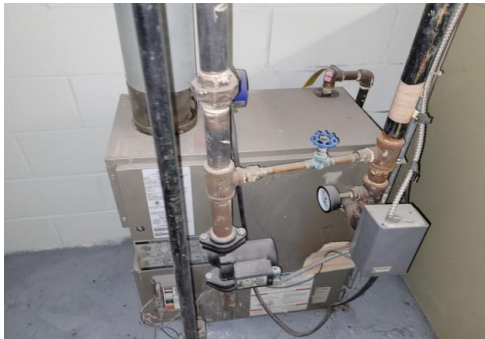
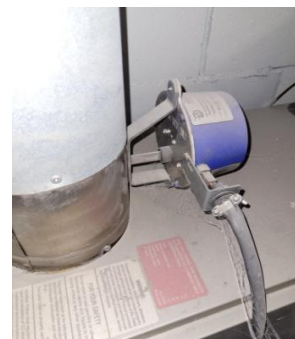
HOT WATER BOILER: [service annually, auto damper requires repair](#)  
[annual CO test mandatory for this type of unit](#)  
[recommend obtaining replacement parts/servicing contract](#)

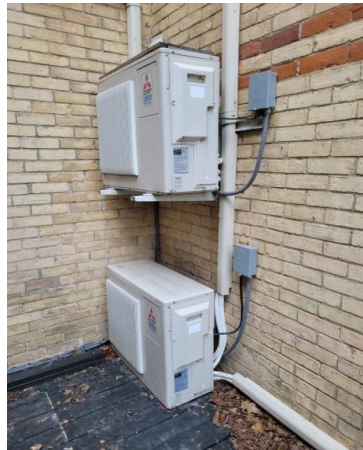
DUCTLESS HEAT PUMP: [two units- four zones, service annually](#)

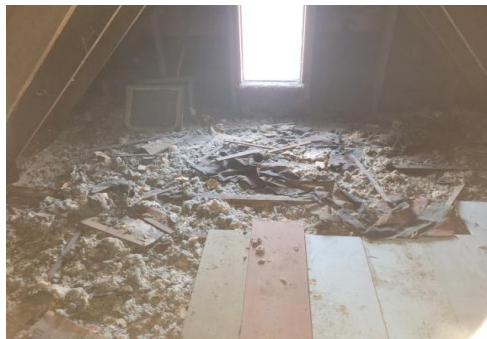
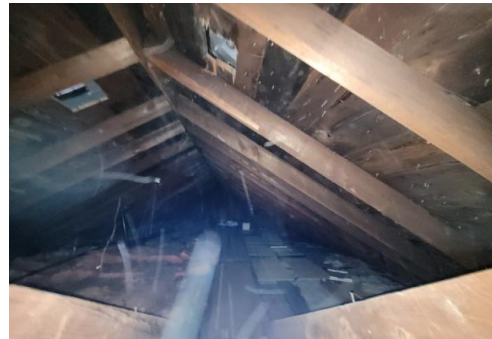
ROOF SPACE: east and west areas: old insulation, damaged/soiled, debris, etc.  
 overall budget to remove and install new insulation and vapour barrier,  
 Comments: if intent is to make roof space into 3rd level in short term then  
 install insulation (consider spray foam) on rafters

**INSULATION/  
VENTILATION** Recommend additional insulation in the roof space to improve comfort and efficiency. It was reported the rear crawl space floor was insulated with spray foam.

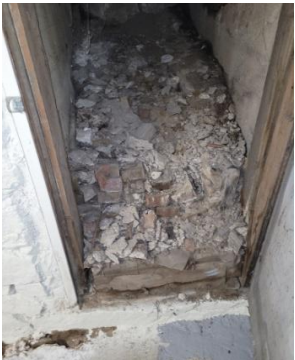
\*\*Basement Leakage: typical efflorescence, staining and dampness for older foundation  
    abandoned walkout- consider installing retaining wall in door opening

1. gutters, downspouts, grading, driveways: ongoing maintenance and repair/see Exterior
2. cracks/form ties on foundation: monitor/repair as required
3. excavation/damp-proofing: monitor basement, consider step 3 as a last resort
