# HOME INSPECTION REPORT

70 Thirty Ninth St  
Toronto

Prepared by: Bob Papadopoulos P.Eng., RHI \*

Inspection Date: Feb 21 2024

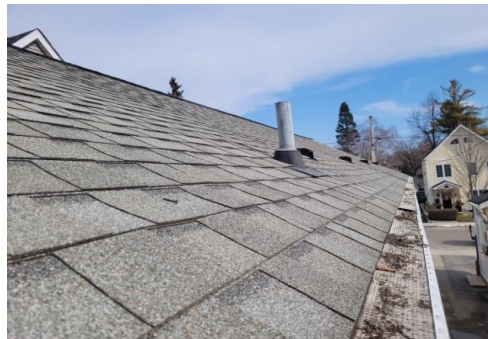
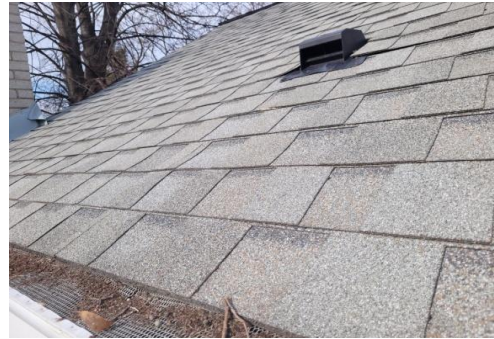
Main Slope: overall surface in good repair

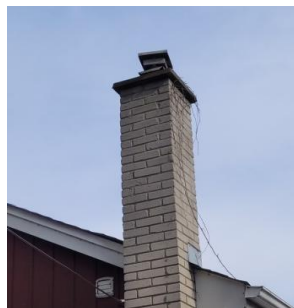
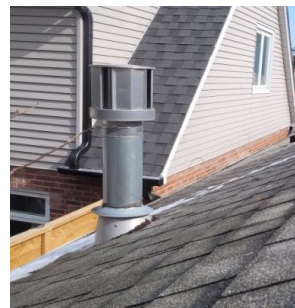
Chimney(s):  
Brick: can be removed  
Metal: in good repair

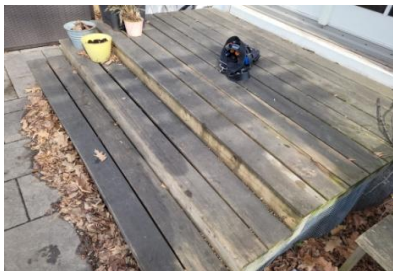
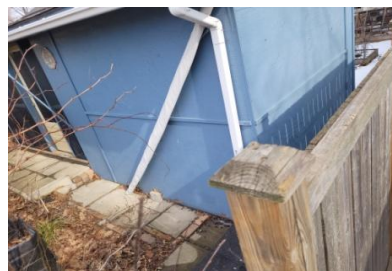
DECK [power wash/maintenance, provide hand railings for safety](#)

STRUCTURES [shed: overall in good repair, supported by floating footings on gravel- monitor](#)

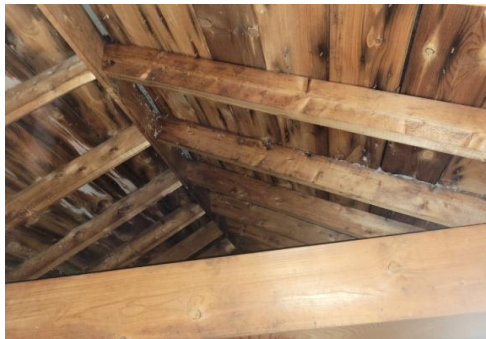
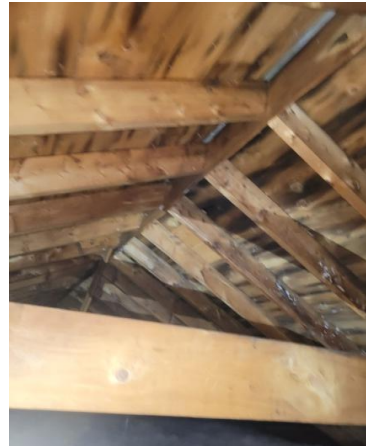
ROOF: overall in good repair

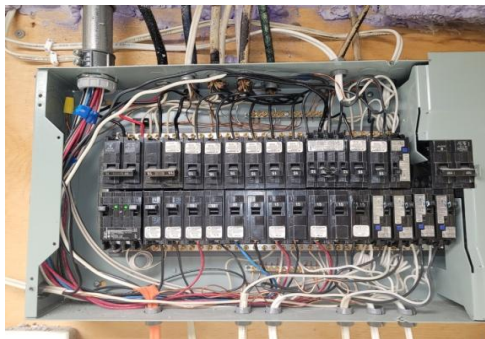
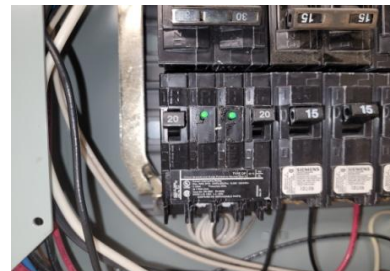
**Limitations****Main Disconnect Cover Not Removed****Observations/Recommendations**SERVICE ENTRANCE: **overall in good repair**SERVICE PANEL: **overall in good repair, includes a surge protector device**

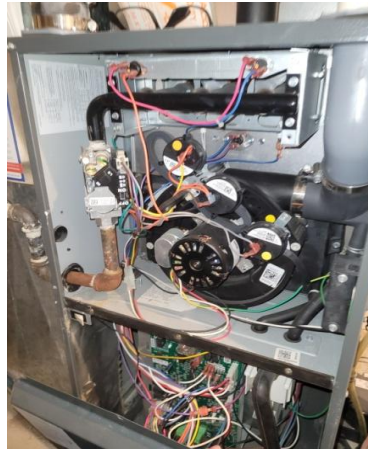
FORCED AIR FURNACE: [service annually](#)  
[replace 1-per-3 months](#)

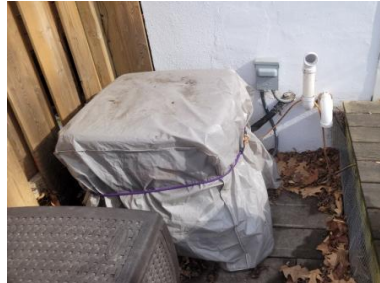
AIR CONDITIONER: not tested: should be serviced before using

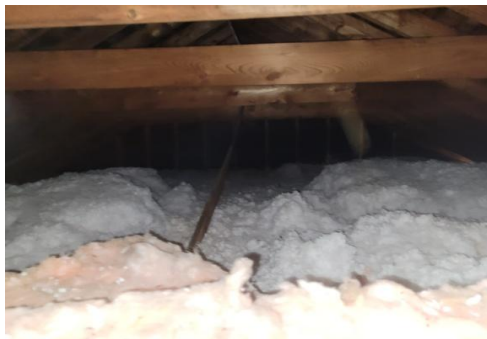
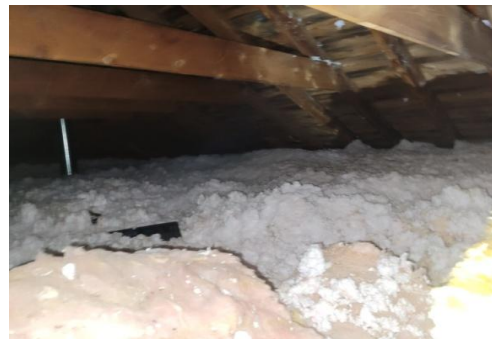
ROOF SPACE: insulation and ventilation is adequate  
 some areas uneven distribution of insulation - improve/add insulation

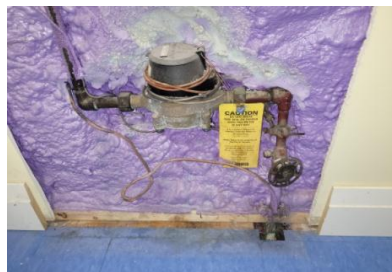
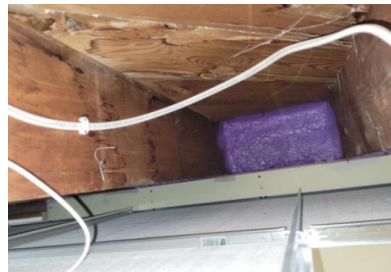
Basement Walls: spray foam insulation installed which is above average
