# HOME INSPECTION REPORT

110 Marion St  
Toronto

Prepared by: Bob Papadopoulos P.Eng., RHI \*

Inspection Date: July 19 2023

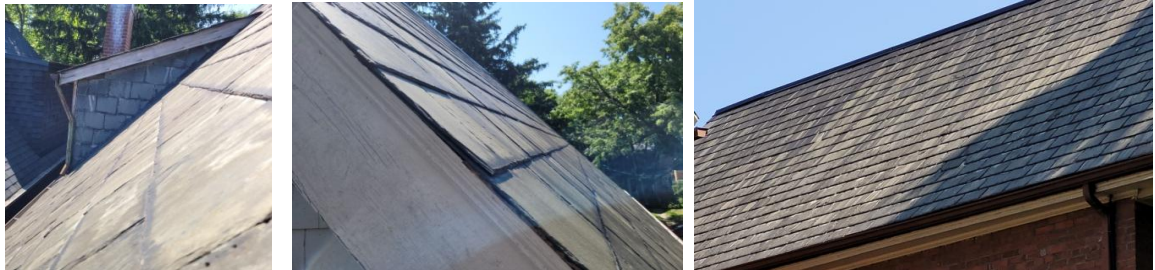
Sloped Surface: slate in good repair, service annually, replace as required

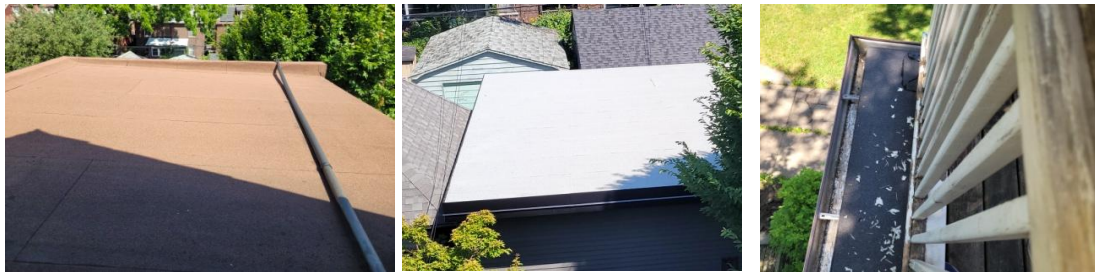
Flat Surface: overall surface in good repair  
 Garage: overall surface in good repair  
 Deck: front deck: overall surface in good repair where visible

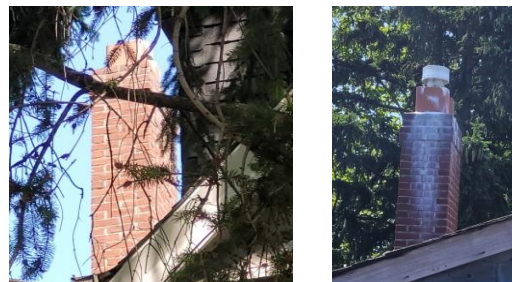
Chimney: overall in good repair  
 install rain/screen cap to clay liner

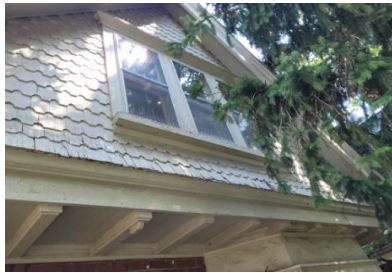
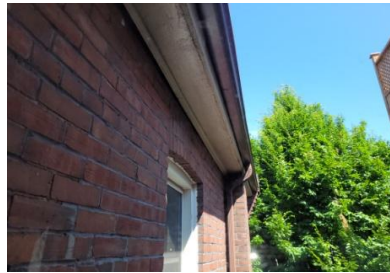
Soffit & Facia: requires general repairs and maintenance

Wood Shingles: various requires general repairs and maintenance

**DOORS/WINDOWS:** various requires general repairs and maintenance

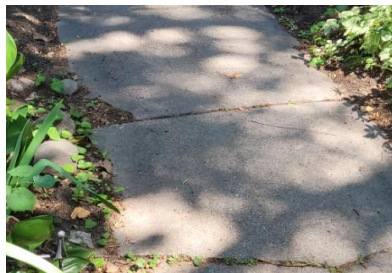
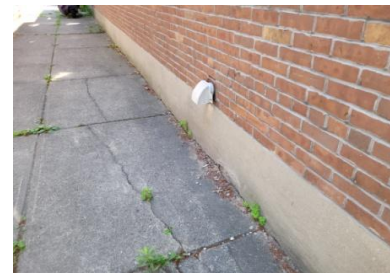
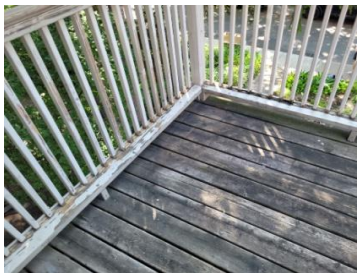
**\*\*Walk(s):** minor settlement/cracks, budget to repair/replace

**\*\*Walk(s)/Driveway(s):** seal gaps along foundation wall

**DECK** requires general repairs and maintenance

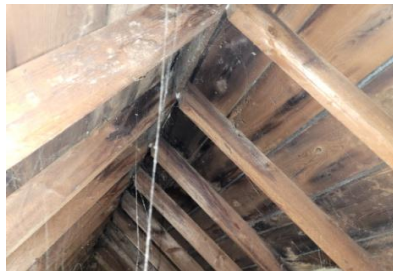
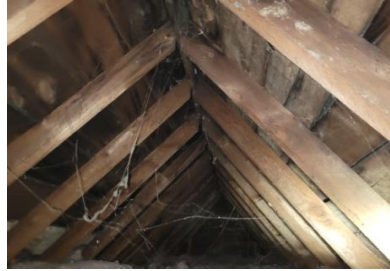
### ROOF: overall in good repair

typical staining for older house

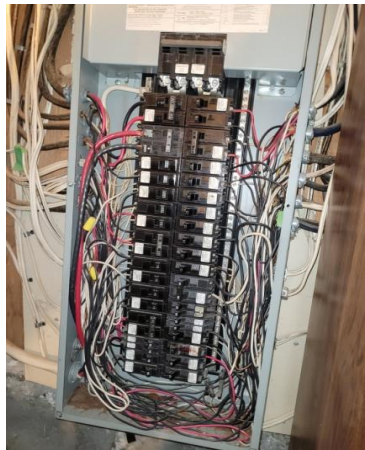
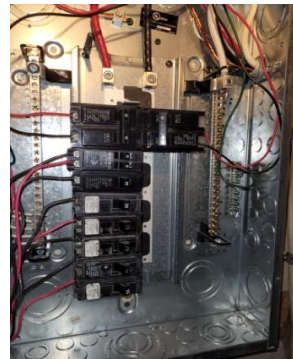
SERVICE PANEL: crowded, double taps (two wires connect to one breaker), overall in good repair

Auxiliary Panel: overall in good repair

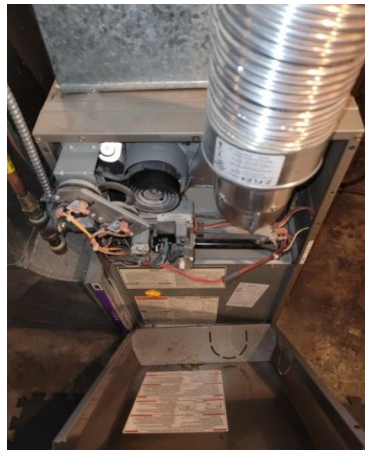
FORCED AIR FURNACE: [continue servicing until replacement \(to high efficiency\) becomes necessary](#)

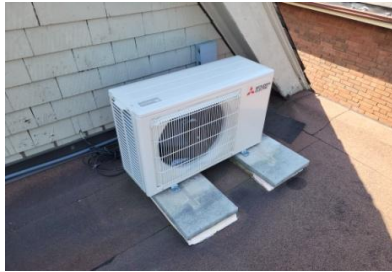
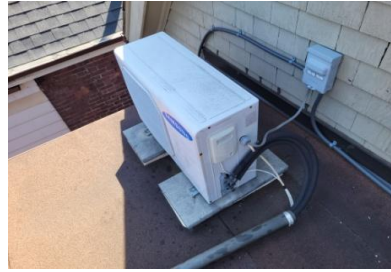
HEAT PUMP: one aging unit, continue servicing until replacement becomes necessary  
 service both annually  
 one unit servicing 3rd level front bedroom  
 one unit servicing 2nd level rear bedroom/washroom (aging unit)

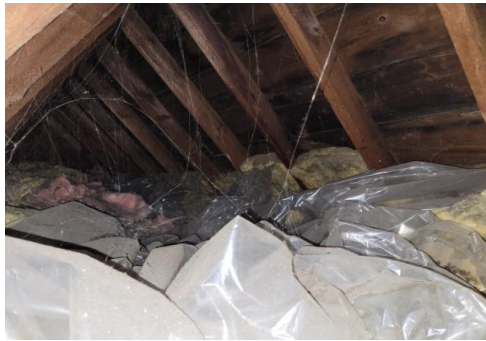
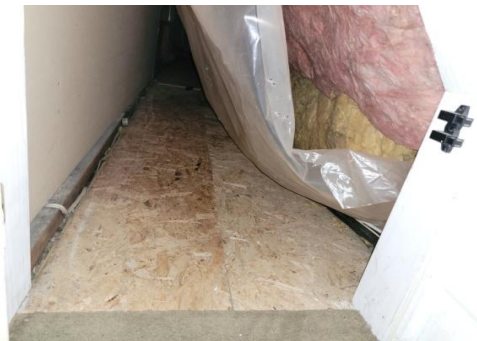
- ROOF SPACE: [uneven distribution of insulation - improve/add insulation](#)
- Roof Access Hatch: [insulate and weather-strip access hatch to roof space](#)
- Knee Wall Hatch: [insulate and weather-strip access hatch to knee wall space](#)
- Knee Walls: [loose vapour barrier - minor repair](#)

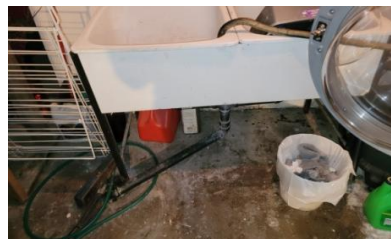
Laundry Tub: [drains directly in to basement floor drain - poor arrangement - repair](#)
