HOME INSPECTION REPORT

17 Indian Road Cres

Toronto

Inspection Date: [March 27 2024](#)

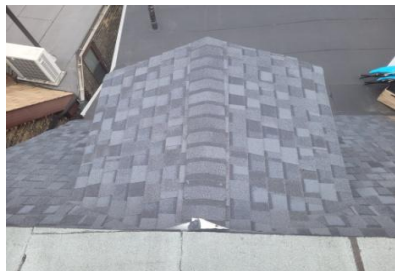
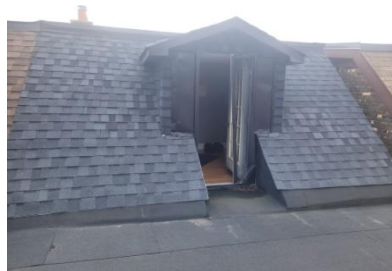
Sloped Surface: [overall surface in good repair](#)
 Porch(s): [mostly not visible due to deck, overall surface in good repair where visible rear extension shingles in good repair](#)

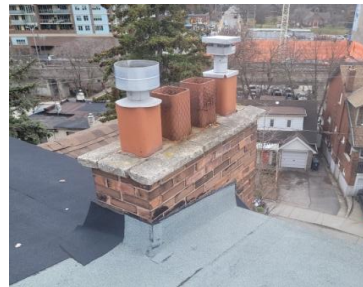
Chimney: [overall in good repair](#)
[install rain/screen cap to clay liner](#)

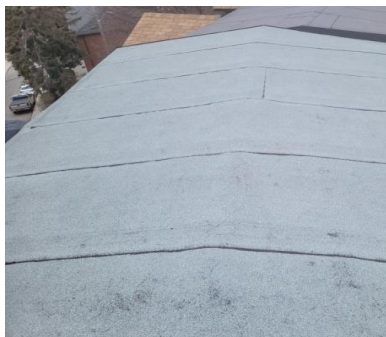
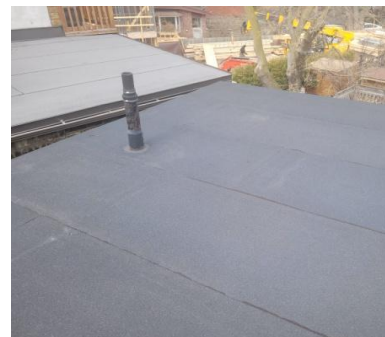
Upper Flat: [overall surface in good repair](#)
 Lower Flat: [overall surface in good repair, unsafe access - requires rail at door, extend plumbing stack above upper roof line](#)

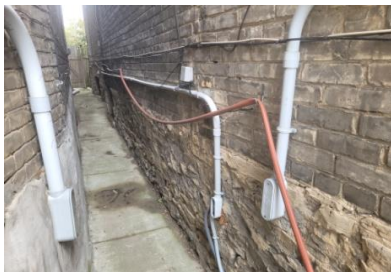
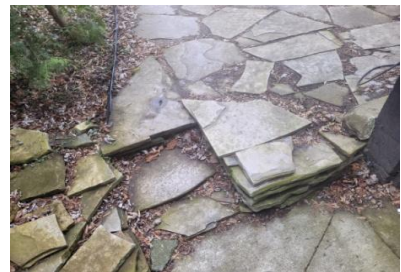
**Walk(s): loose at rear corner - repair, seal gaps/cracks along wall

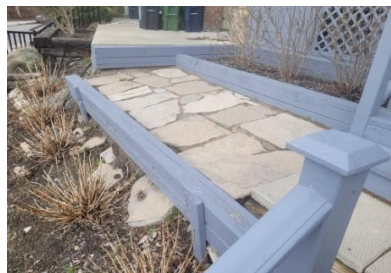
**Landscaping: retaining wall/walkway movement - repair, also consider safety rails

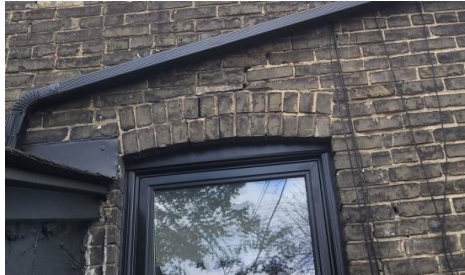
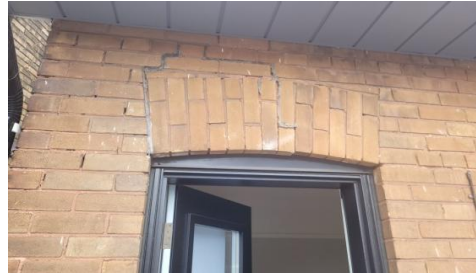
Masonry Arches: cracks above arch typical, repair mortar

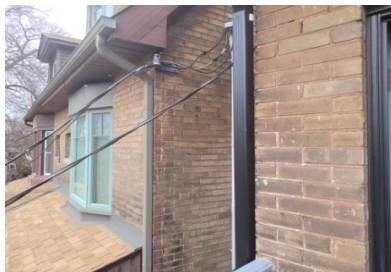
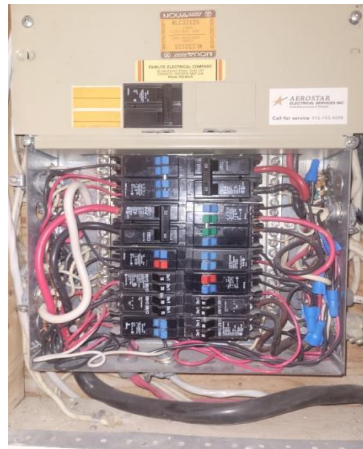
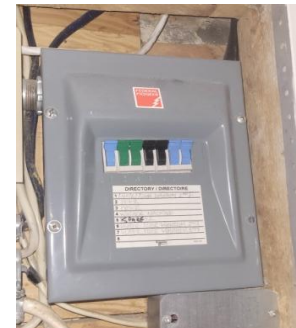
SERVICE ENTRANCE: overall in good repair, clearance from wires- safety concern

SERVICE PANEL: crowded, overall in good repair

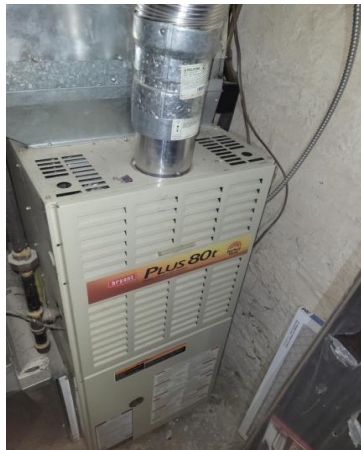
FORCED AIR FURNACE: [aging, continue servicing until replacement becomes necessary](#)

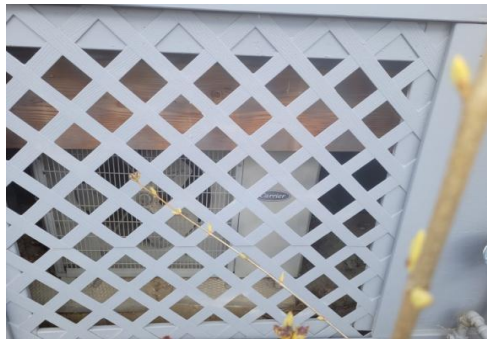
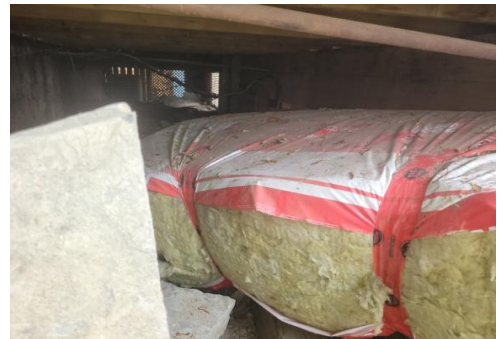
AIR CONDITIONER: [under porch, could not access](#)
[not tested: should be serviced before using](#)

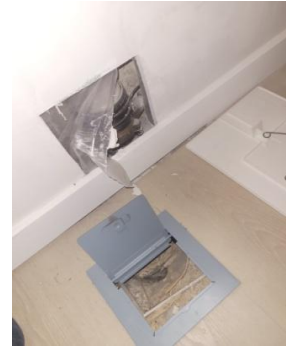
WATERMAIN: somewhat difficult to access valve in floor
