HOME INSPECTION REPORT

15 Cowan Ave
Toronto

Prepared by: Bob Papadopoulos P.Eng., RHI *

Inspection Date: [Aug 27 2024](#)

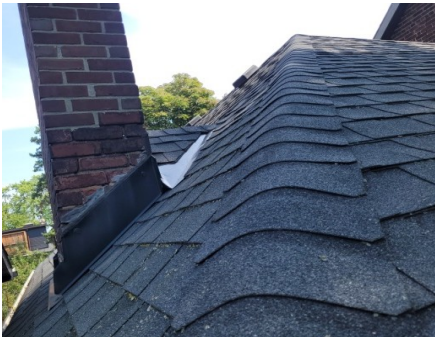
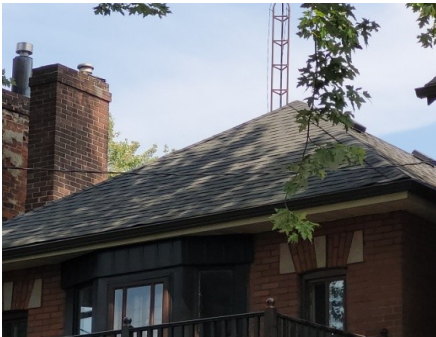
REFERENCE LINK	http://redbrickinspections.ca/docs/2_Roofing_Reference_Guide.pdf			
15 Cowan Ave	ROOFING/Chimneys			Aug 27 2024
Description				
Roofing Material:	Location:	Leakage Probability:	Chimney(s) Type:	Location:
Asphalt Shingles:	Slope:	Low	Brick:	North
Asphalt Shingles:	2nd Slope:	Low		
Asphalt Shingles:	Porch(s):	Medium		
Limitations				
Roof Inspected By:	Access Limited By:	Chimney Access Limited By:		
From Edge	Height	Height		
From Grade	Deck			
Observations/Recommendations				
Tree Branches: retain arbourist for annual monitoring/trimming				
Sloped Surface: overall surface in good repair

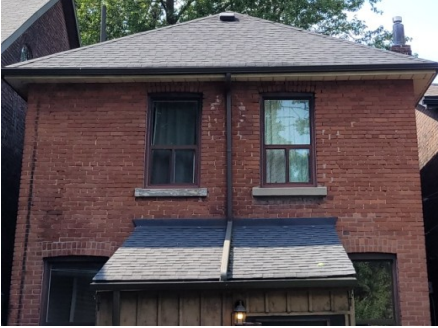
2nd Slope: overall surface in good repair

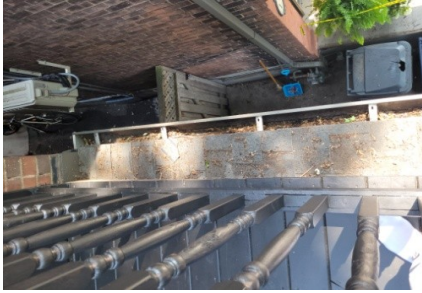
Porch(s): upper porch -asphalt shingles used for flat roof - more prone to leaking - monitor

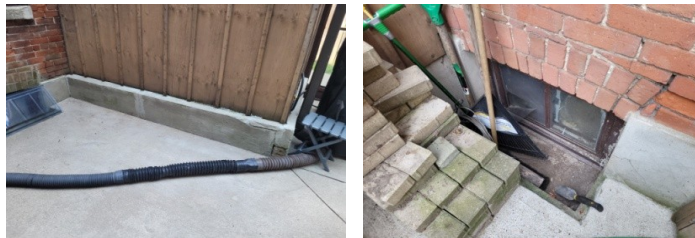
**Gutters/Downspouts: requires maintenance/cleaning
extend 6-ft away from house

**Window wells: no drains- more prone to leaking- provide cover to north unit

**Walk(s): seal gaps along wall

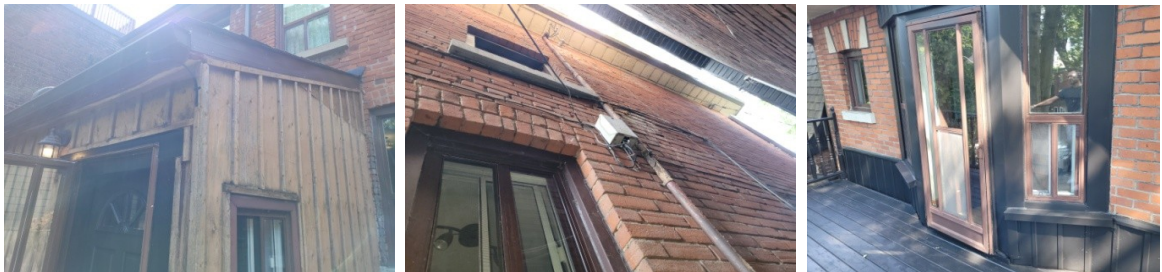
WALL SURFACES:

Brick: overall in good repair

Wood siding: overall in good repair, paint as required

DOORS/WINDOWS: overall in good repair

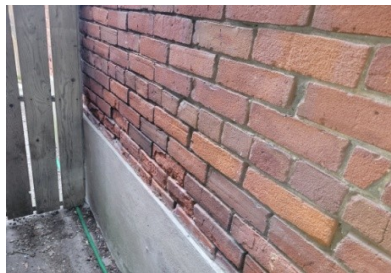
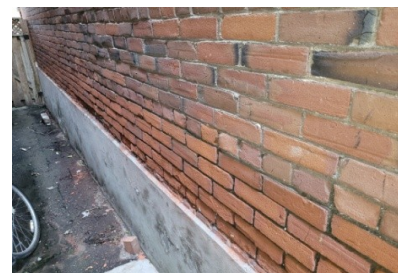
Masonry: typical surface/mortar spalling - repair as required

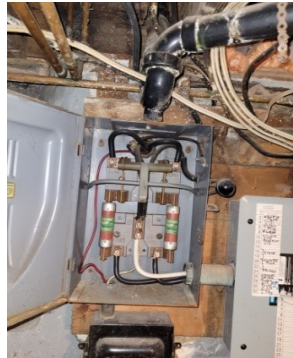
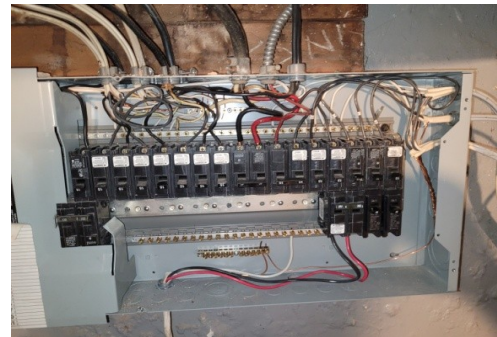
Mast: **older , upgrade if renovating**

Main Disconnect: **older , can be removed when upgrading mast**

SERVICE PANEL: **overall in good repair**

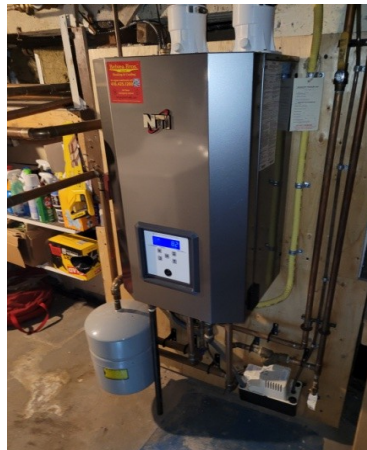
HOT WATER BOILER: [service annually](#)
 COMBINATION SYSTEM: [provides house heating and domestic hot water](#)

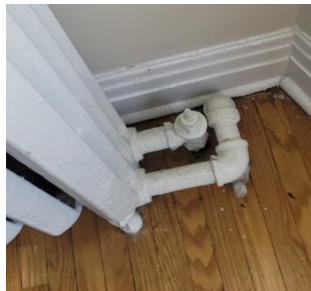
Radiator(s): [monitor/repair valves as required](#)
[some valves presently missing handles](#)
[no heating source observed in basement](#)
