HOME INSPECTION REPORT

58 Springhurst Ave
Toronto

Prepared by: Bob Papadopoulos P.Eng., RHI *

Inspection Date: [Aug 8 2024](#)

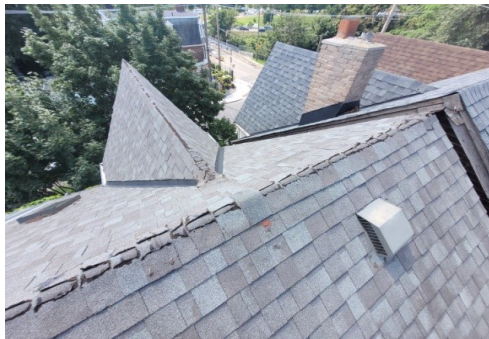
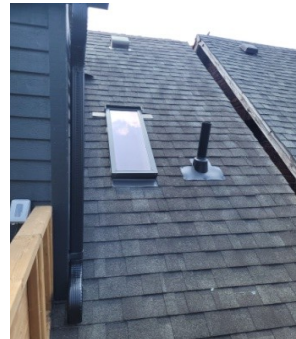
Sloped Surface: [overall surface in good repair, skylights in good repair](#)
[ridges shingles to be replaced](#)

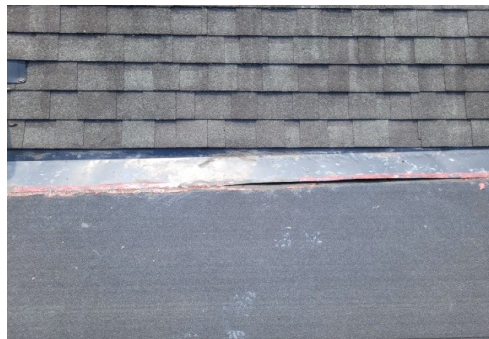
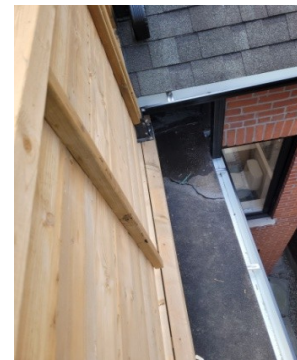
Upper Flat: [overall surface in good repair](#)
 Lower Flat: [overall in good repair where visible](#)

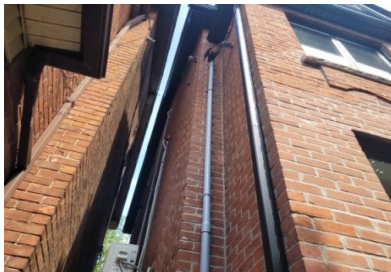
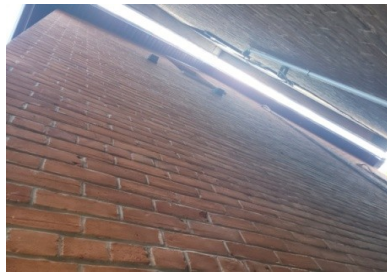
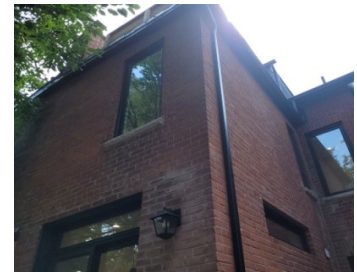
WALL SURFACES: west central: missing vent cap - provide
Brick: restored, overall in good repair
Wood siding: newer, overall in good repair
DOORS/WINDOWS: newly installed

**Gutters/Downspouts: newly installed
Soffit & Fascia: newly installed

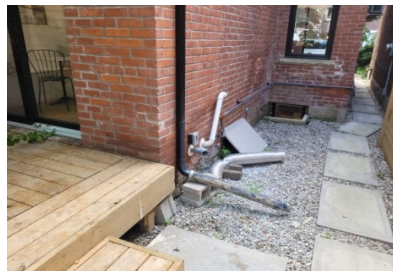
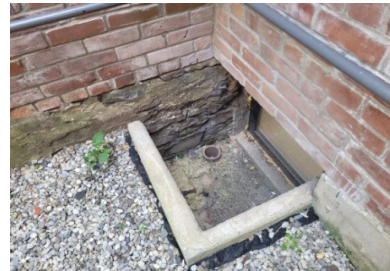
**Window wells: provide proper window well covers
**Grading: monitor grading around window wells- re-grade away from house if water pooling

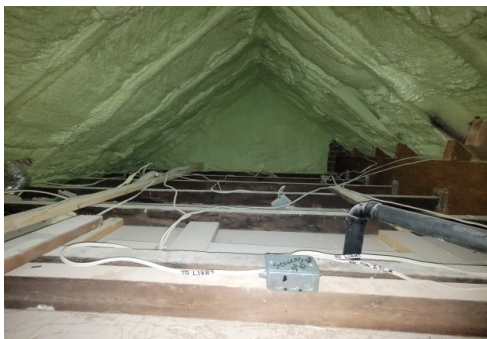
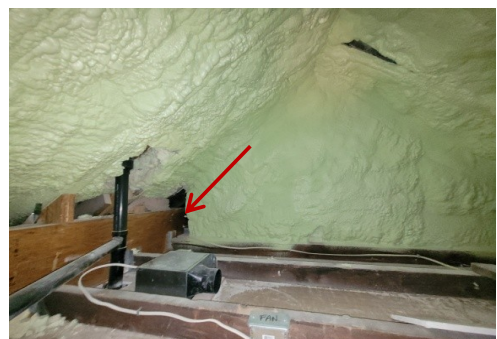
Party (Fire) Walls: installed in slope roof space and spray foamed- some gaps should be sealed

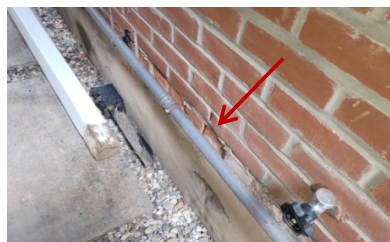
Masonry: bricks/mortar restored, west lower side: minor surface spalling

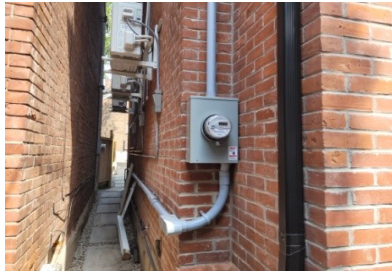
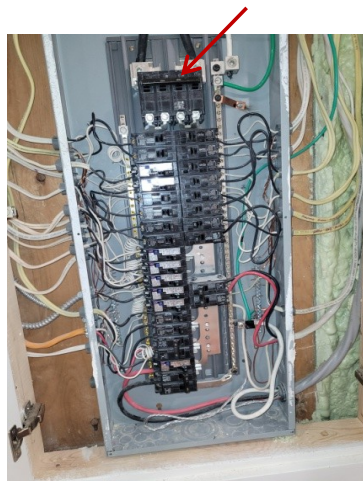
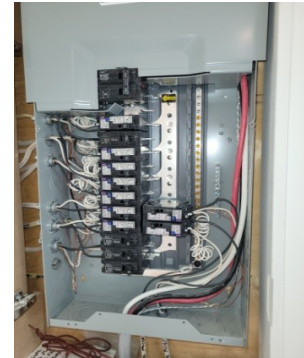
- SERVICE ENTRANCE: newly installed
- SERVICE PANEL: newly installed, one breaker tripping- further evaluation
- Main Disconnect: missing cover inside of panel
- Auxiliary Panel: newly installed

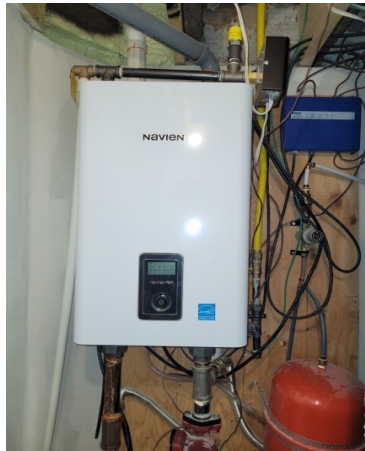
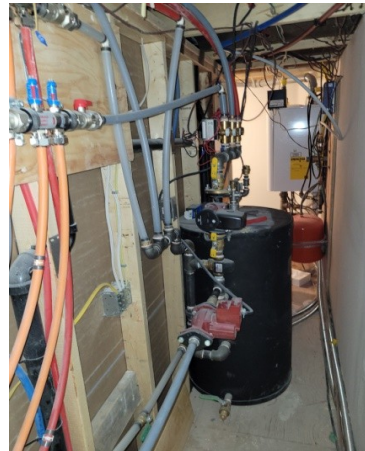
Hot Water Radiant Heat: basement/1st/2nd radiant floor heating and 3rd level radiator heating

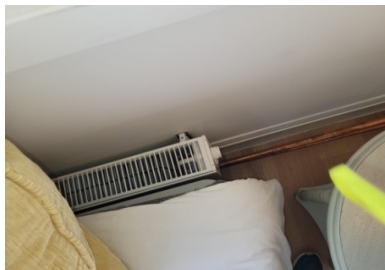
Radiator(s): 3rd level south bedroom: exposed pipes prone to damage: should be boxed in ideally

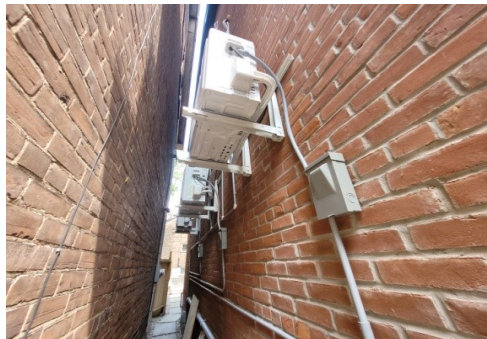
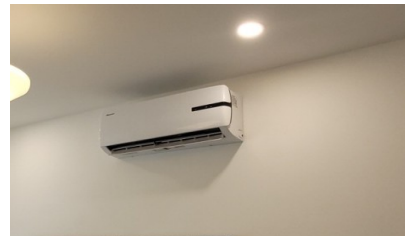
DUCTLESS A/C: **three units:**
1st/2nd and 3rd level
service annually

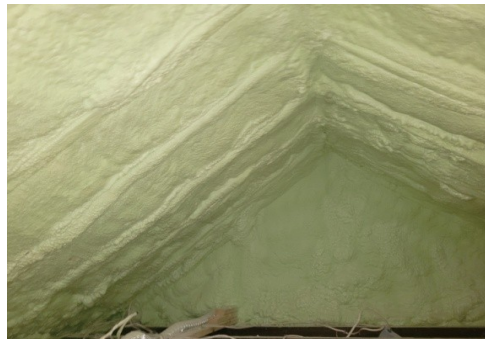
ROOF SPACE: spray foam insulation installed which is above average

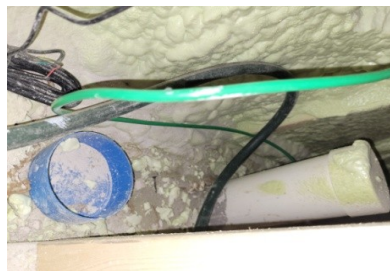
WALLS: spray foam insulation installed which is above average
