# HOME INSPECTION REPORT

8 Marksbury Rd  
Aurora

Prepared by: Bob Papadopoulos P.Eng., RHI \*

Inspection Date: [July 31 2024](#)

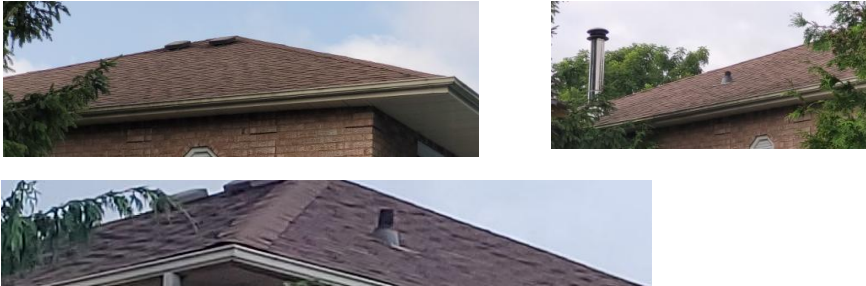
REFERENCE LINK		<a href="http://redbrickinspections.ca/docs/2_Roofing_Reference_Guide.pdf">http://redbrickinspections.ca/docs/2_Roofing_Reference_Guide.pdf</a>		
8 Marksbury Rd		<b>ROOFING/Chimneys</b>		July 31 2024
Description				
Roofing Material:	Location:	Leakage Probability:	Chimney(s) Type:	Location:
Asphalt Shingles:	Slope:	Low	Metal:	West
Asphalt Shingles:	Garage:	Low	Metal:	East
Limitations				
Roof Inspected By:	Access Limited By:	Chimney Access Limited By:		
From Grade	Height Tree	Height		
Observations/Recommendations				
Tree Branches: <a href="#">retain arbourist for annual monitoring/trimming</a>				
Sloped Surface: <a href="#">overall surface in good repair</a>

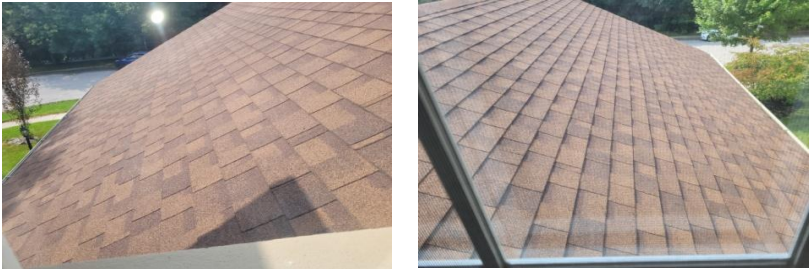
Garage: <a href="#">overall surface in good repair</a>

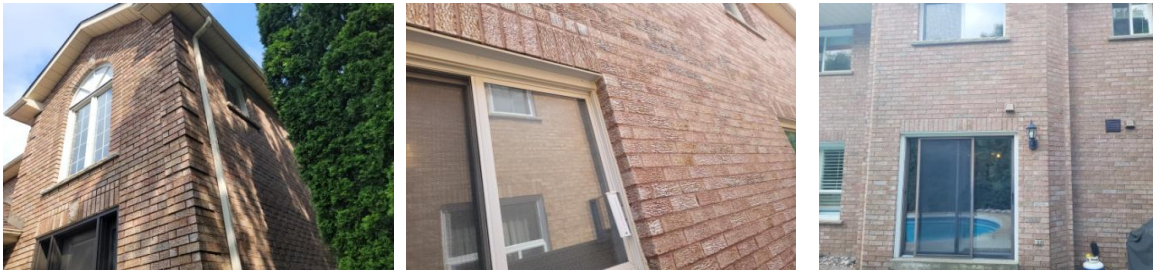
WALL SURFACES: overall in good repair  
DOORS/WINDOWS: overall in good repair, see Interior  
newer front door

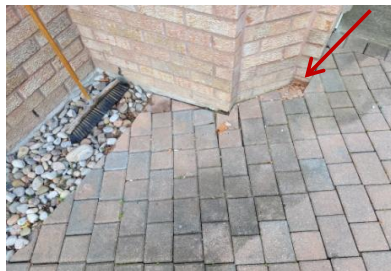
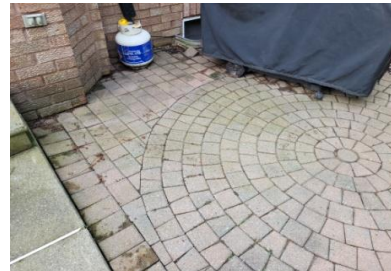
\*\*Patio(s): settlement towards house, re-grade and slope away from house  
lower grade below brick to avoid brick damage

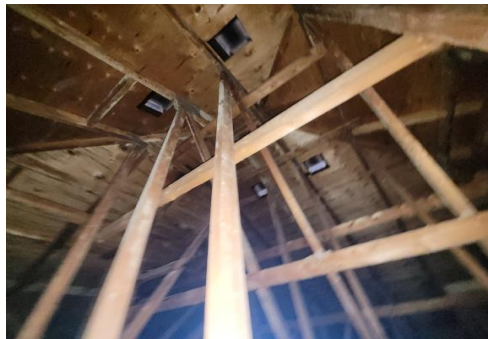
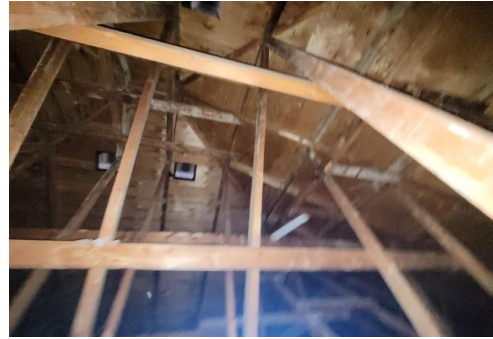
ROOF: overall in good repair

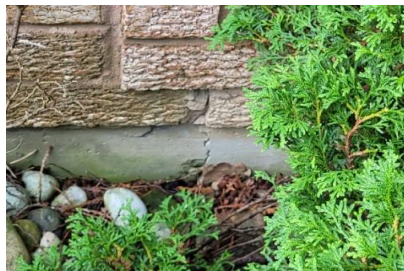
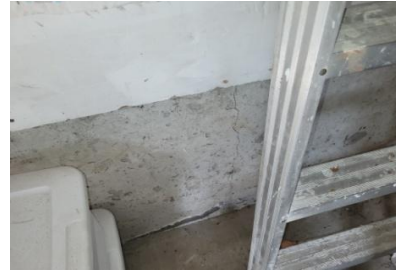
FOUNDATIONS: typical shrinkage/settlement cracks

1. gutters, downspouts, grading, driveways: ongoing maintenance and repair/see Exterior
2. cracks/form ties on foundation: monitor/repair as required
3. excavation/damp-proofing: monitor basement, consider step 3 as a last resort

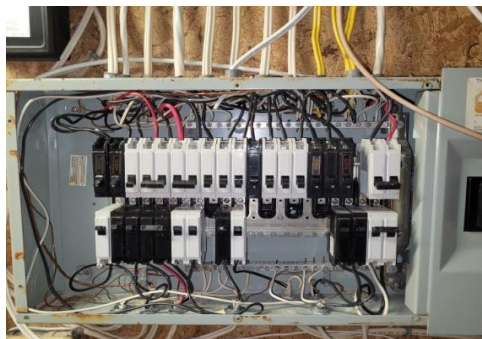
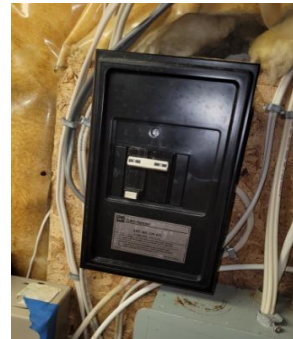
SERVICE ENTRANCE: overall in good repair  
 SERVICE PANEL: overall in good repair  
 Auxiliary Panel: overall in good repair, cover not removed

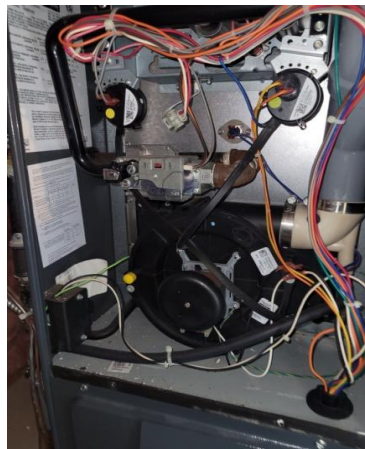
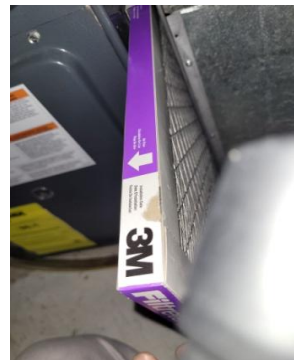
FORCED AIR FURNACE: [service annually](#)

Filter: [replace 1-per-3 months](#)

[recommend obtaining replacement parts/servicing contract](#)

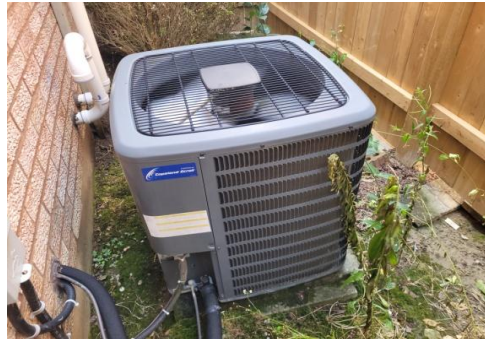
AIR CONDITIONER: [service annually](#)

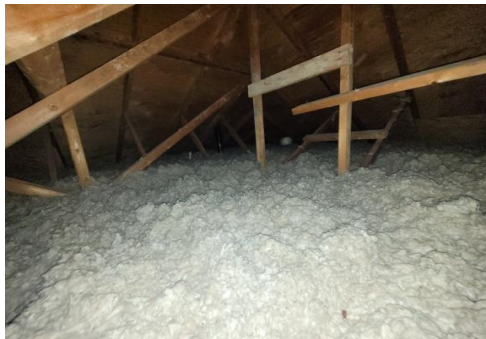
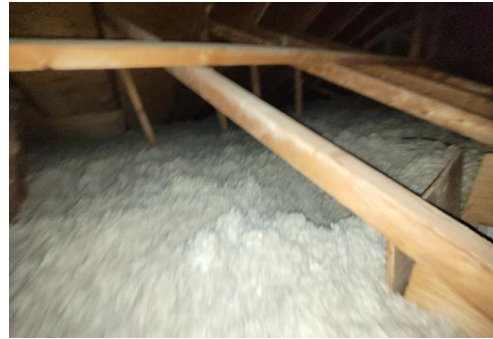
ROOF SPACE: insulation and ventilation is adequate  
can upgrade insulation to improve comfort and efficiency
