# HOME INSPECTION REPORT

281 Delaware Ave  
Toronto

Prepared by: Bob Papadopoulos P.Eng., RHI \*

Inspection Date: [Jan 22 2025](#)

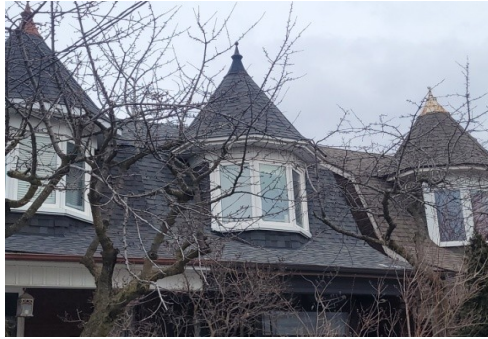
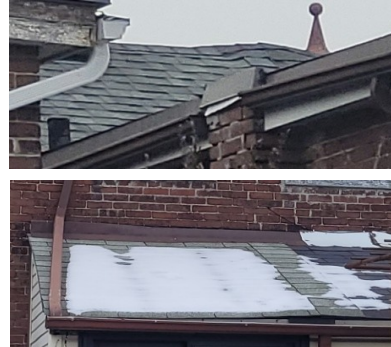
Sloped Surface: overall surface in good repair - reported to be newer  
 Flat Surface: not visible- reported to be newer

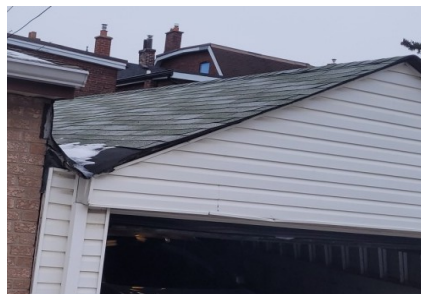
Garage: overall surface in good repair  
 monitor/maintain valley flashing on each side - prone to ice dams

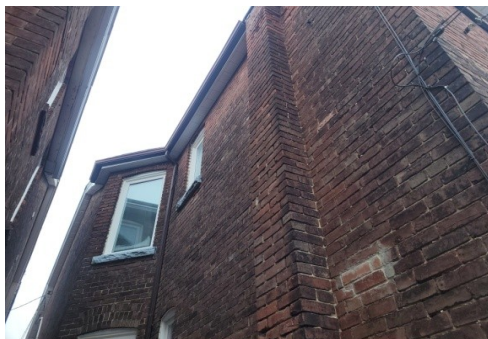
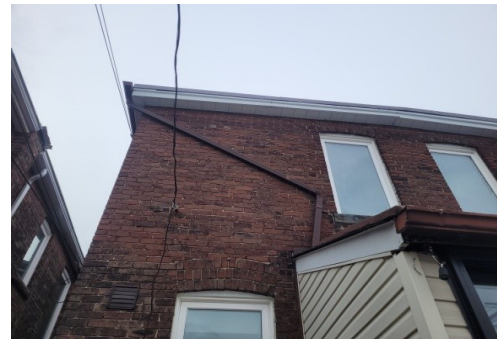
\*\* Downspouts: extend 6-ft away from house

WALL SURFACES:

Brick: overall in good repair, see Structure

Metal Siding: overall in good repair

DOORS/WINDOWS: overall in good repair

Note: Maintain Gutters & Downspouts annually. Extend Downspouts at least 6-feet away from the house

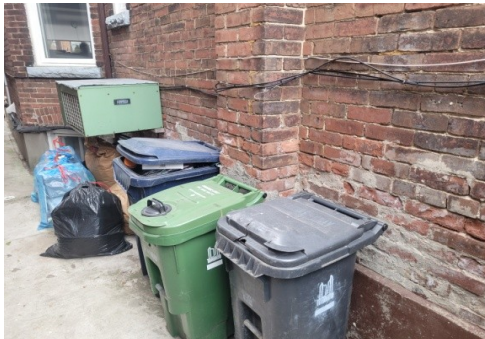
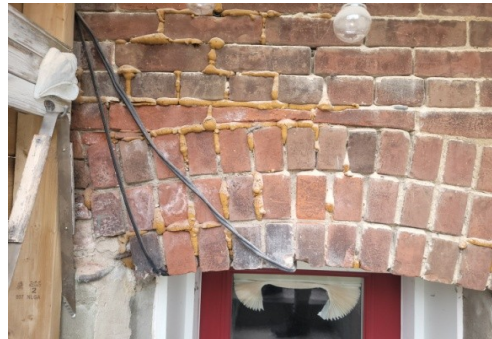
WALLS: typical surface spalling/mortar deterioration, repair as required  
 Masonry Arches: use mortar not spray foam for repairs

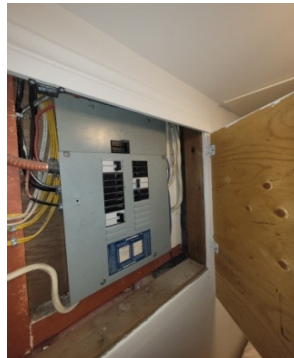
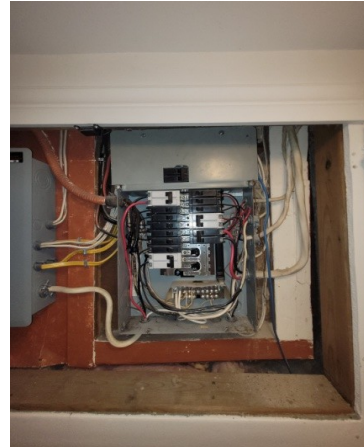
SERVICE ENTRANCE: **overall in good repair**  
 SERVICE PANEL: **overall in good repair**  
 Auxiliary Panel: **overall in good repair**

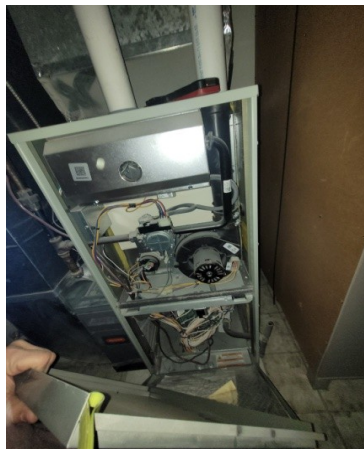
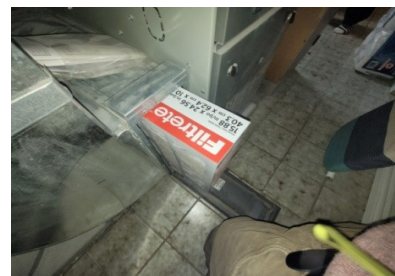
FORCED AIR FURNACE: [service annually](#)  
[recommend obtaining replacement parts/servicing contract](#)  
Filter: [replace 1-per-6 to 12 months](#)

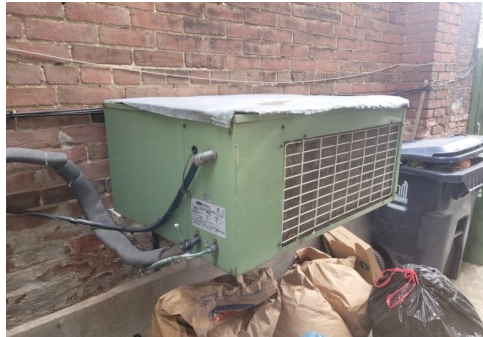
AIR CONDITIONER: not tested: should be serviced before using old unit, continue servicing until replacement becomes necessary

Refrigerant Lines: repair/replace insulation on refrigerant lines
