HOME INSPECTION REPORT

193 Wright Ave

Toronto

Inspection Date: [Feb 20 2025](#)

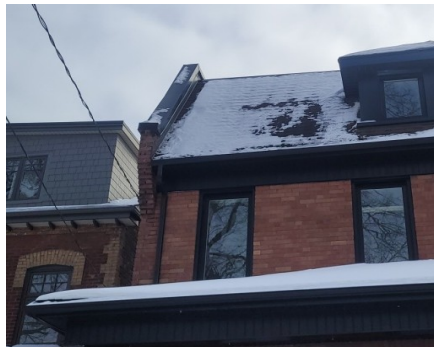
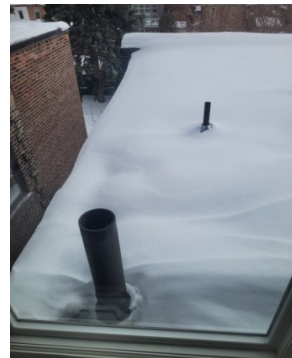
Roofing: mostly not visible due to snow
4-yr-old roof surfaces with a typical life expectancy of over 20-yrs.

Note: Recommend Annual Maintenance Contract for Roof Surface, Flashing Details and Chimney(s)

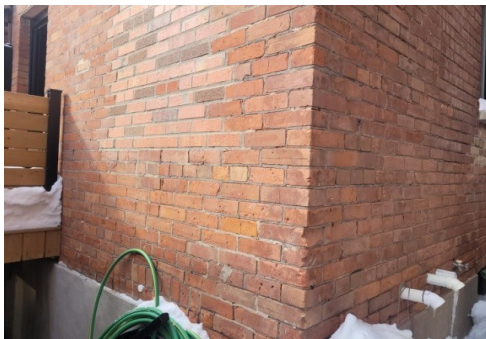
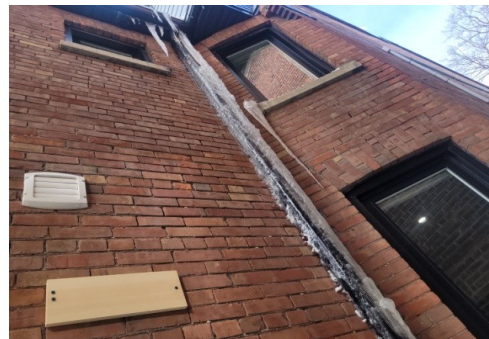
****Gutters/Downspouts:** requires maintenance, ice build up overall typical for present climate

WALL SURFACES: overall in good repair

Soffit & Facia: newly installed

Brick: overall in good repair, typical spalling/worn mortar - maintain as required

DOORS/WINDOWS: newly installed

Note: Maintain Gutters & Downspouts annually. Extend Downspouts at least 6-feet away from the house

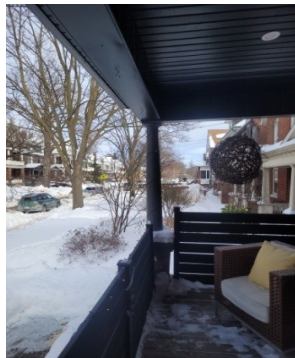
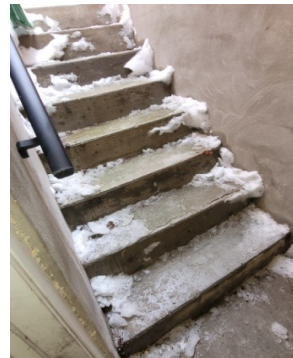
PORCH overall in good repair, column- minor slant, overall typical though monitor

****BASEMENT WALKOUT:** overall well built

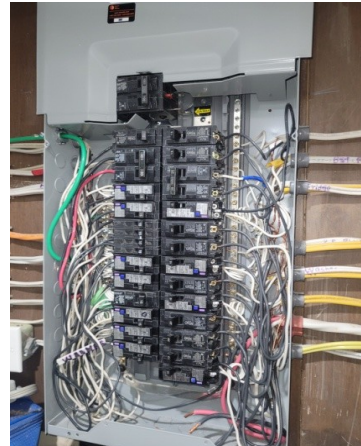
SERVICE ENTRANCE: **newly installed**
 SERVICE PANEL: **newly installed**

Miswired Outlet(s): **3rd level units - overall minor repairs**
 GFCI: **provide to rear exterior outlet**

Note 1: All recommendations are safety issues - Treat them as high priority.

Note 2: Please ensure accurate labelling on panels.

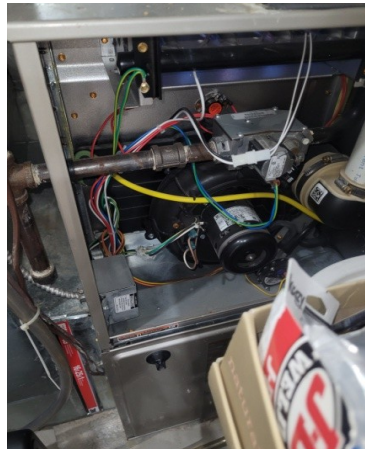
FORCED AIR FURNACE: [service annually](#)
[recommend obtaining replacement parts/servicing contract](#)
Filter: [replace 1-per-3 months](#)

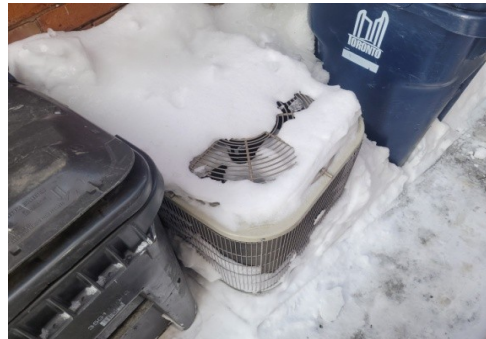
AIR CONDITIONER: [not tested: should be serviced before using](#)

Comments: [3rd level typically more difficult to cool- may require supplemental unit and/or adjust registers as required](#)
