# HOME INSPECTION REPORT

303 Crawford St

Toronto

Inspection Date: [Feb 12 2025](#)

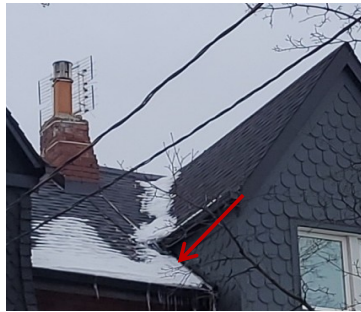
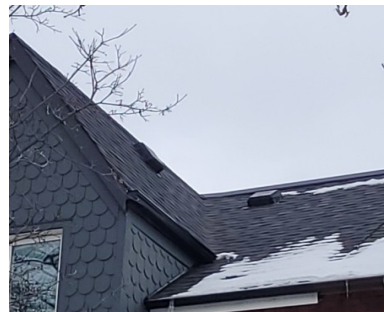
Ice Dams: prone at northwest - monitor

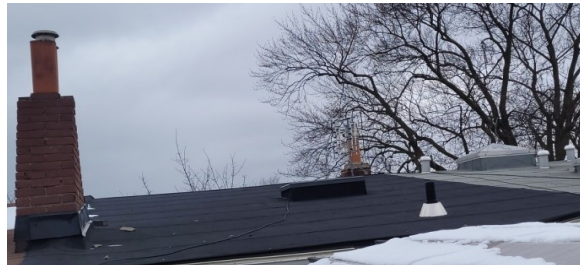
Main Flat: overall surface in good repair

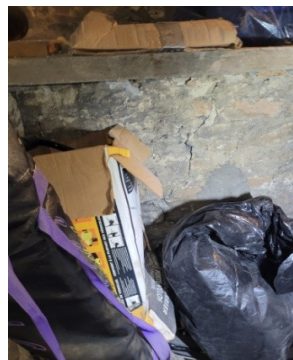
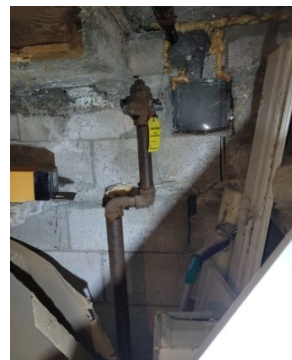
FOUNDATIONS: front under porch: typical settlement cracks  
limited visibility due to storage

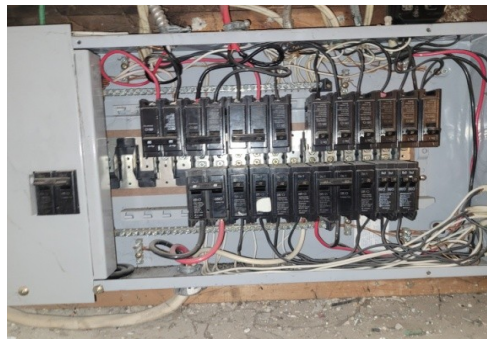
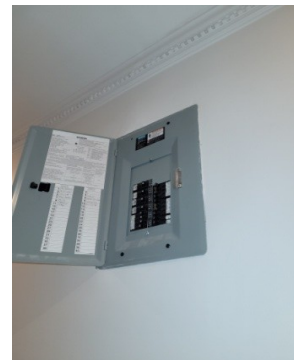
SERVICE ENTRANCE: overall in good repair  
 SERVICE PANEL: overall in good repair  
 Auxiliary Panel: cover not removed due to high location on hall wall

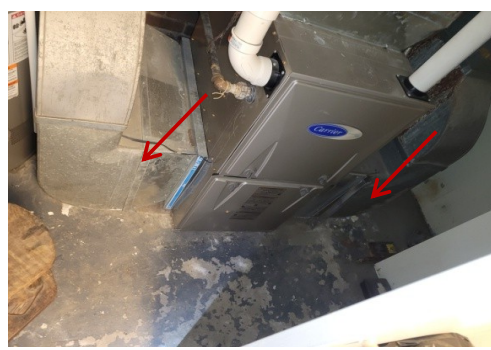
FORCED AIR FURNACE: service annually  
recommend obtaining replacement parts/servicing contract  
Return Ducts: note unit equipped with 2 return plenums which not typical and might effect overall performance of air flow/efficiency  
Filter: 2 filters- replace 1-per-3 months

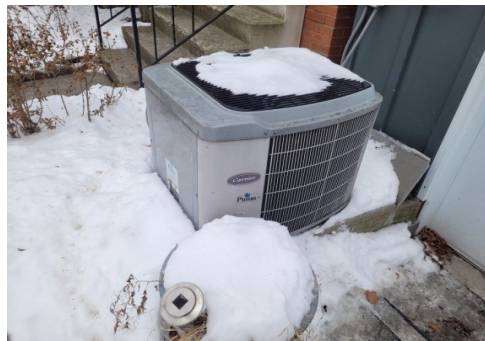
AIR CONDITIONER: **not tested: should be serviced before using old unit, continue servicing until replacement becomes necessary**

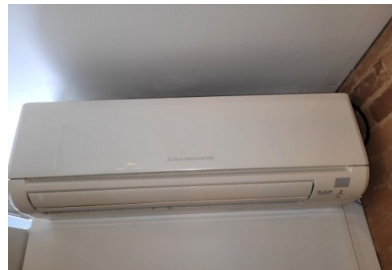
HEAT PUMP: **not tested: should be serviced before using service annually**
