HOME INSPECTION REPORT

12 Melbourne Ave

Prepared by: Bob Papadopoulos P.Eng., RHI *

Inspection Date: [April 23 2025](#)

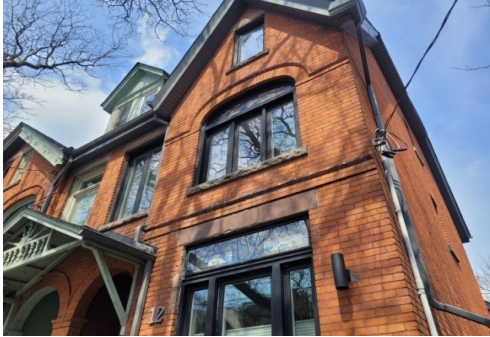
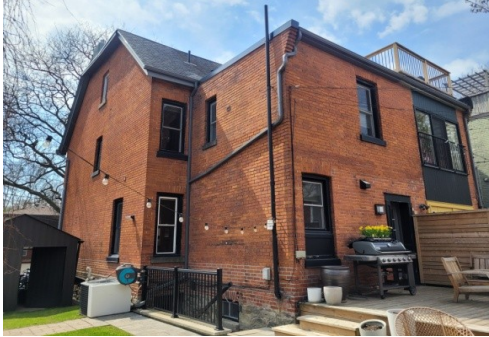
REFERENCE LINK		http://redbrickinspections.ca/docs/3_Exterior_Reference_Guide.pdf	
12 Melbourne Ave		EXTERIOR	
		April 23 2025	
Description			
Gutters & Downspouts: Aluminum:	Downspout(s) Discharge: Various Above Grade	Lot Topography: Flat	Walls & Wall Structures: Brick
Limitations			
Exterior Inspection from Ground Level Storage in Garage			
Observations/Recommendations			
<p>**Gutters/Downspouts: requires maintenance/cleaning</p> <p>WALL SURFACES: overall in good repair</p> <p>DOORS/WINDOWS: overall in good repair, rear door: requires repairs at threshold general maintenance to wood components as required</p> <div style="display: flex; justify-content: space-around;">

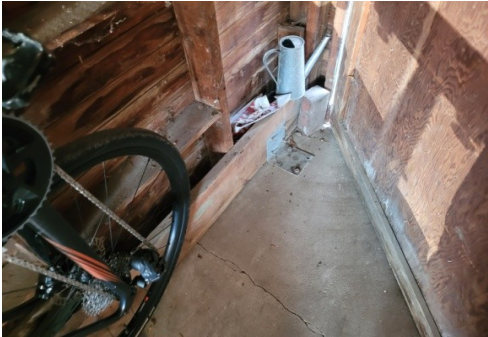
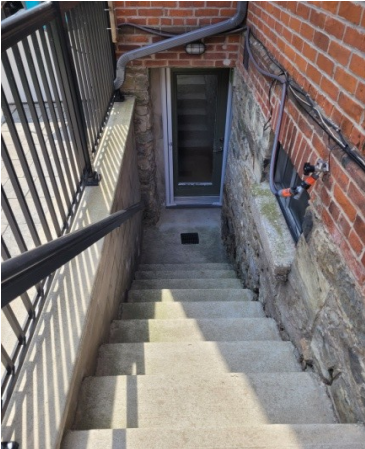
</div> <p>**Driveway(s): concrete cracks: budget to repair</p> <p>PORCH overall in good repair</p> <p>DETACHED GARAGE: overall in good repair, older structure that has had structural repairs and improvements around base perimeter</p> <p>**BASEMENT WALKOUT: overall in good repair</p> <div style="display: flex; justify-content: space-around;">

<p>Note: Maintain Gutters & Downspouts annually. Extend Downspouts at least 6-feet away from the house</p> <p>** Any or all these items may contribute to Basement Leakage. Please see Interior Page</p>

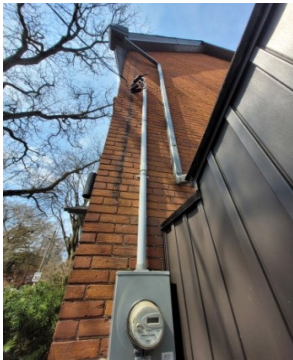
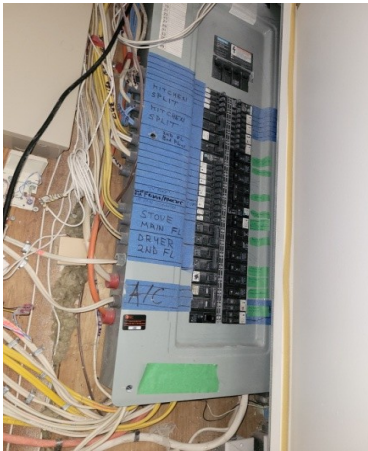
panel obstructed by cabinet - cover not removed			
<div>

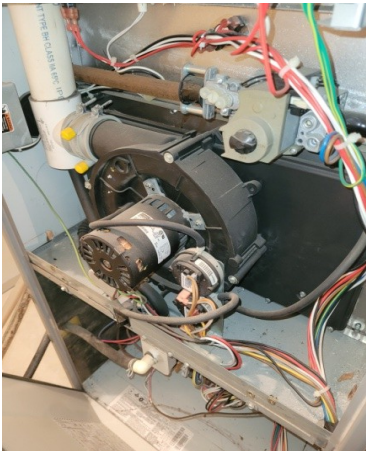
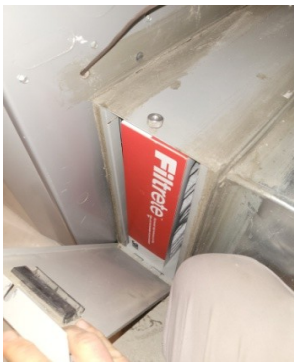
REFERENCE LINK		http://redbrickinspections.ca/docs/6_Heating_Reference_Guide.pdf			
12 Melbourne Ave		HEATING		April 23 2025	
Description					
Description:	Efficiency:	Rated Input:	Approx. Age:	Life Expectancy:	Fuel Type: Shut Off at:
Forced Air Furnace:	High	80 x1000BTU/hr	15 yrs.	20 yrs.	Gas Meter-Exterior
Electric Radiant Heat:					
Exhaust Vent Arrangement: Plastic Through-Wall Vent					
Limitations					
Heat Loss Calculations Not Done					
Observations/Recommendations					
<p>FORCED AIR FURNACE: service annually recommend obtaining replacement parts/servicing contract</p> <p>Filter: replace 1-per-6 to 12 months</p> <div style="display: flex; justify-content: space-around;">

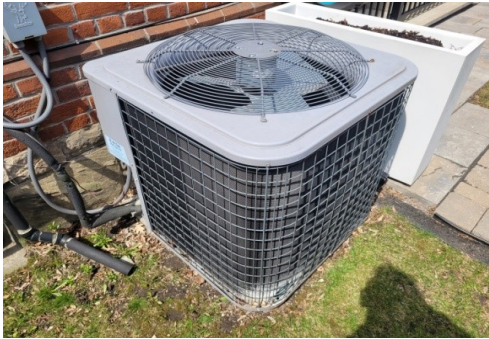
REFERENCE LINK	http://redbrickinspections.ca/docs/7_AC_Heat_Pump_Reference_Guide.pdf		
12 Melbourne Ave	COOLING/Heat Pumps		April 23 2025
Description			
Description:	Cooling Capacity:	Approx. Age:	Typical Life Expectancy:
Air Conditioner (air-cooled):	36 x1,000 BTU/hr	15 yrs. old	15 to 20 yrs.
Limitations			Cooling Performance
			Supply Temp F:
			Return Temp F:
Observations/Recommendations			
<p>AIR CONDITIONER: not tested: should be serviced before using</p> <p>Outdoor Coil: minor corrosion along bottom</p> <div>

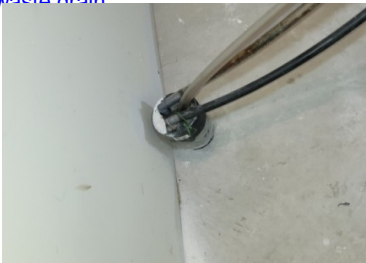
REFERENCE LINK		http://redbrickinspections.ca/docs/9_Plumbing_Reference_Guide.pdf	
12 Melbourne Ave		PLUMBING	
		April 23 2025	
Description			
Service Piping into House:	Main Shut Off Valve at:	Water Flow (Pressure):	
Copper	Basement-Front	Good	
Supply Piping & Pump(s):	Waste Piping & Pump(s):	Water Heater	
Copper	Plastic		
Plastic	Galvanized Steel	Type: Tank-less	
		Fuel Type: Gas	
		Capacity:	
		Age Yrs.: <5	
		Life Expectancy: 15	
Limitations			
Isolating/Relief Valves & Main Shut Off Valves Not Tested		Concealed Plumbing not Inspected	
Kitchen and Laundry Appliances Were Not Inspected		Tub/Sink Overflows Not Tested	
Observations/Recommendations			
<p>WATERMAIN: not determined if replaced to city service</p> <p>SUPPLY PIPING: all piping examined was in good repair</p> <p>WASTE PIPING: all piping examined was in good repair basement floor lowered - typically main drain replaced as well, main drain to city sewer: recommend video-scan, risk of tree roots recommend installing backflow valve to main waste drain</p> <p>Basement Floor Drain: should be cut to floor level - minor</p> <p>Washroom(s): overall in good repair</p> <p>Kitchen(s) overall in good repair</p>
