HOME INSPECTION REPORT

53 Wyndham St
Toronto

Prepared by: Bob Papadopoulos P.Eng., RHI *

Inspection Date: [April 15 2025](#)

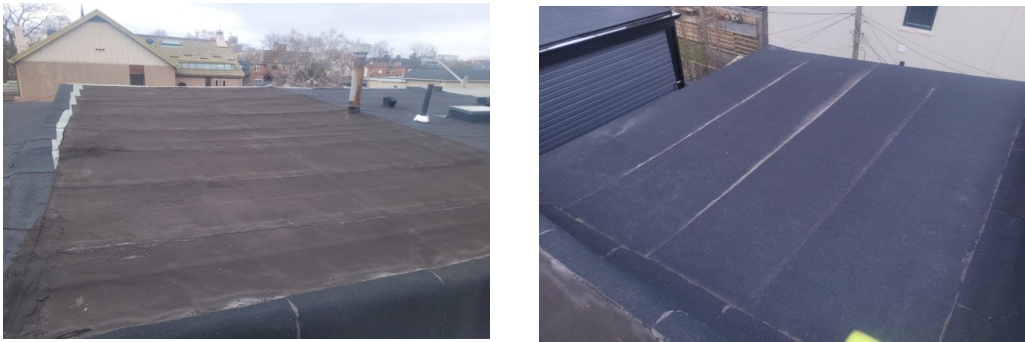
REFERENCE LINK		http://redbrickinspections.ca/docs/2_Roofing_Reference_Guide.pdf		
53 Wyndham St		ROOFING/Chimneys		April 15 2025
Description				
Roofing Material:	Location:	Leakage Probability:	Chimney(s) Type:	Location:
Modified Bitumen:	Upper Flat:	Medium	Metal:	East
Asphalt Shingles:	Slope:	Low		
Modified Bitumen:	Lower Flat:	Low		
Limitations				
Roof Inspected By:	Access Limited By:	Chimney Access Limited By:		
Walking On				
From Edge				
Observations/Recommendations				
<p>Upper Flat: older, patched, continue to monitor/repair, budget to replace</p> <p>Lower Flat: overall surface in good repair</p>

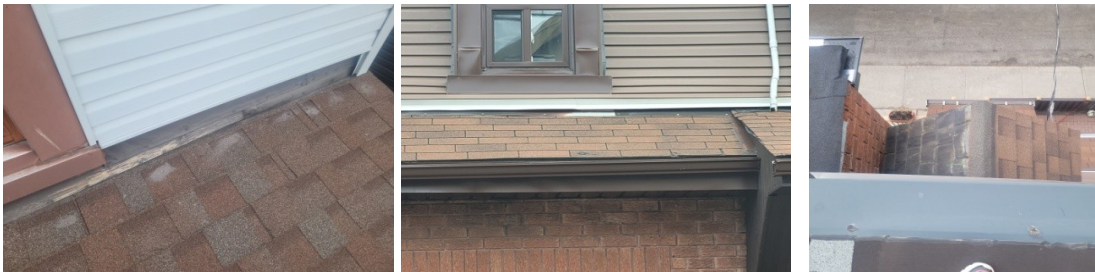
<p>Sloped Surface: overall in good repair, some patched spots- monitor, seal nail heads along edge</p> <p>front dormers (some slate shingles) overall in good repair</p>

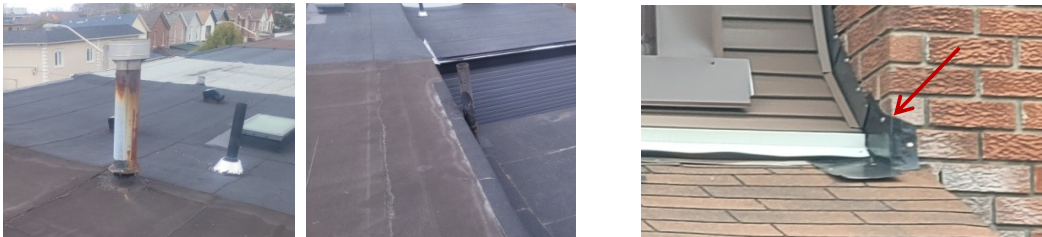
<p>Flashings: chimney/stack: missing proper flashing components, patched instead, monitor</p> <p>Roof/Wall: front: should be sealed properly along northwest wall</p>

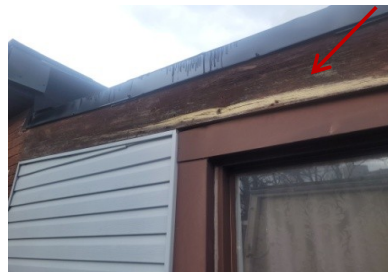
Comments: overall general maintenance to wood components and/or cover with metal flashing

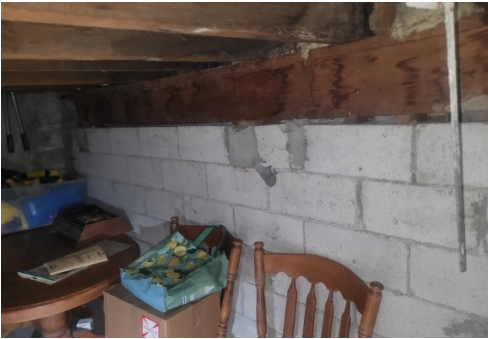
REFERENCE LINK		http://redbrickinspections.ca/docs/4_Structure_Reference_Guide.pdf		
53 Wyndham St		STRUCTURE		April 15 2025
Description				
Configuration:	Foundations:	Floor :	Walls :	Roof/Ceiling Framing:
Basement:	Masonry Block	Wood Joists	Wood Frame (Siding)	No Access
Crawl Space:	Not Visible		Wood Frame(Brick Veneer)	
Limitations				
Restricted Access to:	Foundation Wall Not Visible: <u>90</u> %			
Wall Space				
Roof Space				
Observations/Recommendations				
<p>FLOORS: floors sloping towards south, suspect older condition and overall not unusual for old house, no signs of distress observed indirectly, also appears newer foundation and beam has been installed in the rear of the foundation, further movement not anticipated though continue to monitor</p>

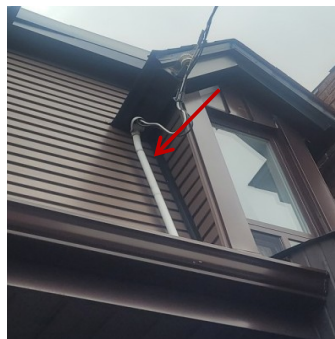
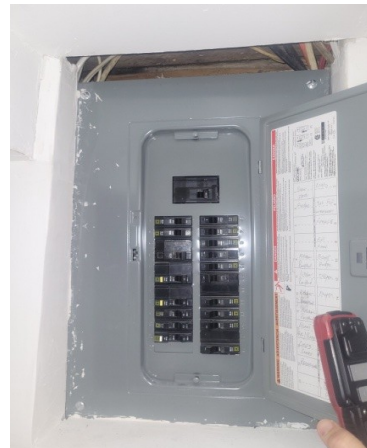
Mast: **loose at wall - requires fastener**

SERVICE PANEL: **panel obstructed by cabinet - cover not removed**
appears to be newer installation

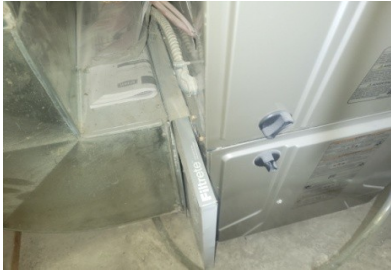
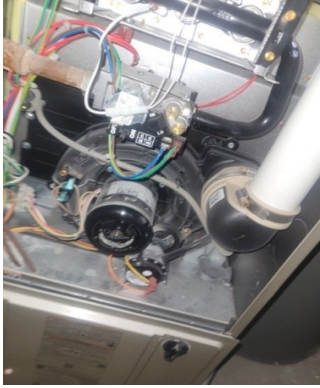
REFERENCE LINK		http://redbrickinspections.ca/docs/6_Heating_Reference_Guide.pdf			
53 Wyndham St		HEATING		April 15 2025	
Description					
Description:	Efficiency:	Rated Input:	Approx. Age:	Life Expectancy:	Fuel Type: Shut Off at:
Forced Air Furnace:	High	60 x1000BTU/hr	2 yrs.	20 yrs.	Gas Meter-Exterior
Exhaust Vent Arrangement:					
Limitations				Furnace Performance	
Heat Loss Calculations Not Done				Supply Temp F: Return Temp F:	
Observations/Recommendations					
<p>FORCED AIR FURNACE: service annually</p> <p>Filter: replace 1-per-3 months</p> <div style="display: flex; justify-content: space-around;">

</div> <p>Comments: washroom: should install baseboard heater</p>

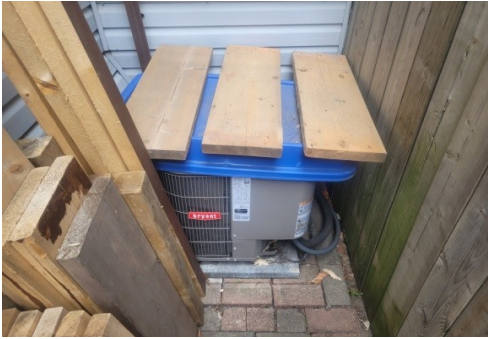
REFERENCE LINK	http://redbrickinspections.ca/docs/7_AC_Heat_Pump_Reference_Guide.pdf		
53 Wyndham St	COOLING/Heat Pumps		April 15 2025
Description			
Description:	Cooling Capacity:	Approx. Age:	Typical Life Expectancy:
Air Conditioner (air-cooled):	24 x1,000 BTU/hr	2 yrs. old	10 to 15 yrs.
Limitations			Cooling Performance
Cannot Test With Low Outdoor Temp			Supply Temp F:
Outdoor Coil Covered			Return Temp F:
Observations/Recommendations			
<p>AIR CONDITIONER: not tested: should be serviced before using</p>
